Evaluating the Effectiveness of 'Natural' Channel Design Projects:

An Introduction and Preliminary Assessment
of Sites in TRCA's Jurisdiction

Final Report 2009

February 2009

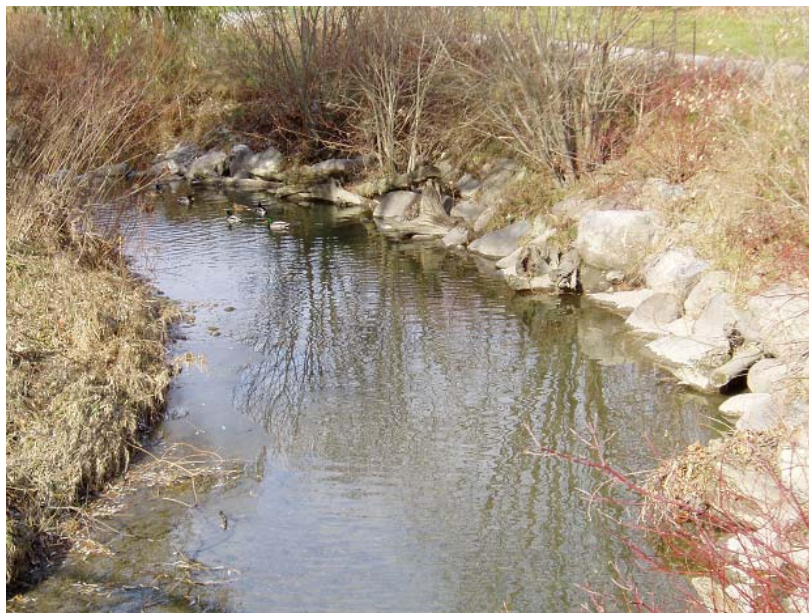
View of channel looking upstream. Note: vegetated rip rap (right bank) and root wad placement.

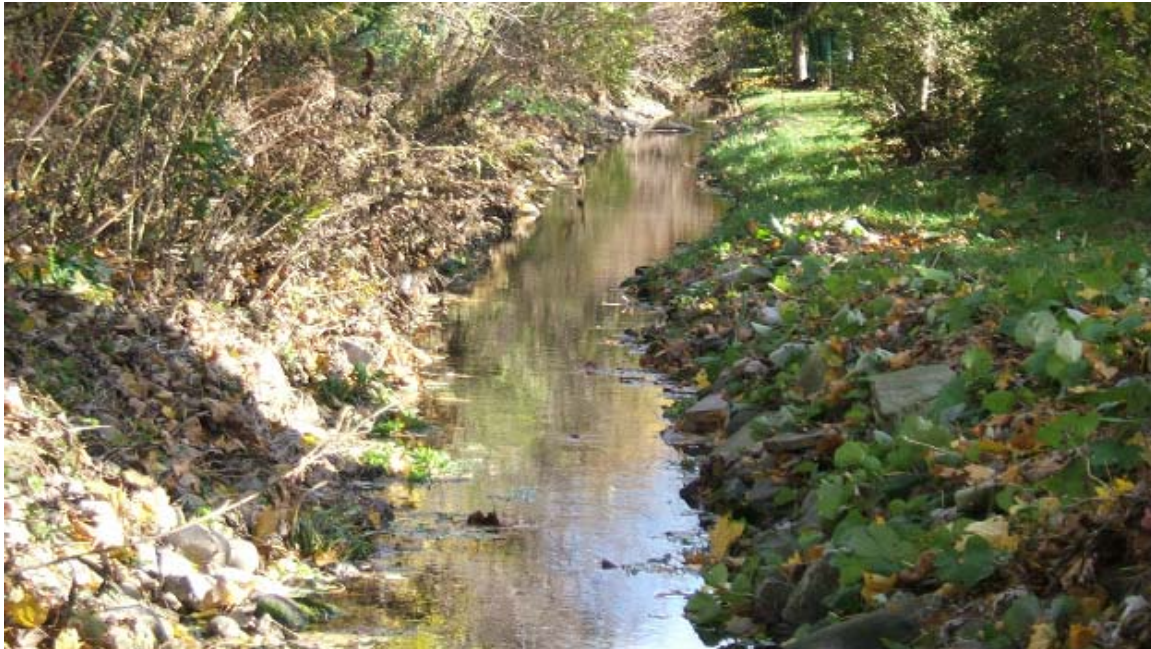
View of channel looking downstream. Note: vegetated rip rap (left bank) and rip rap and residential lawn (right bank).

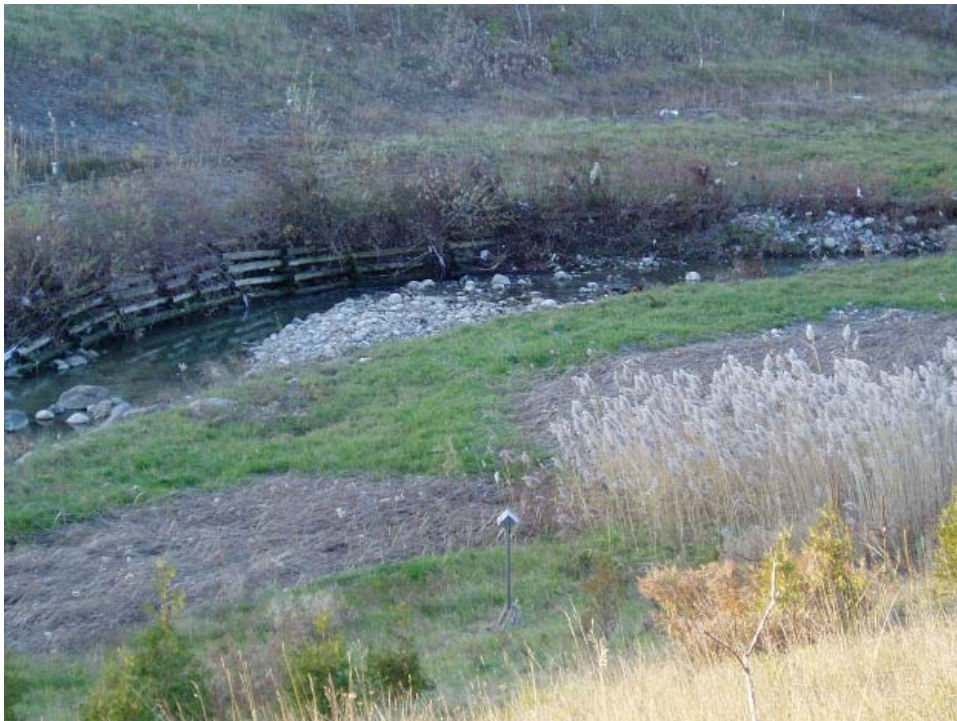
One of several cribwalls installed between Bellamy Road and Markham Road.

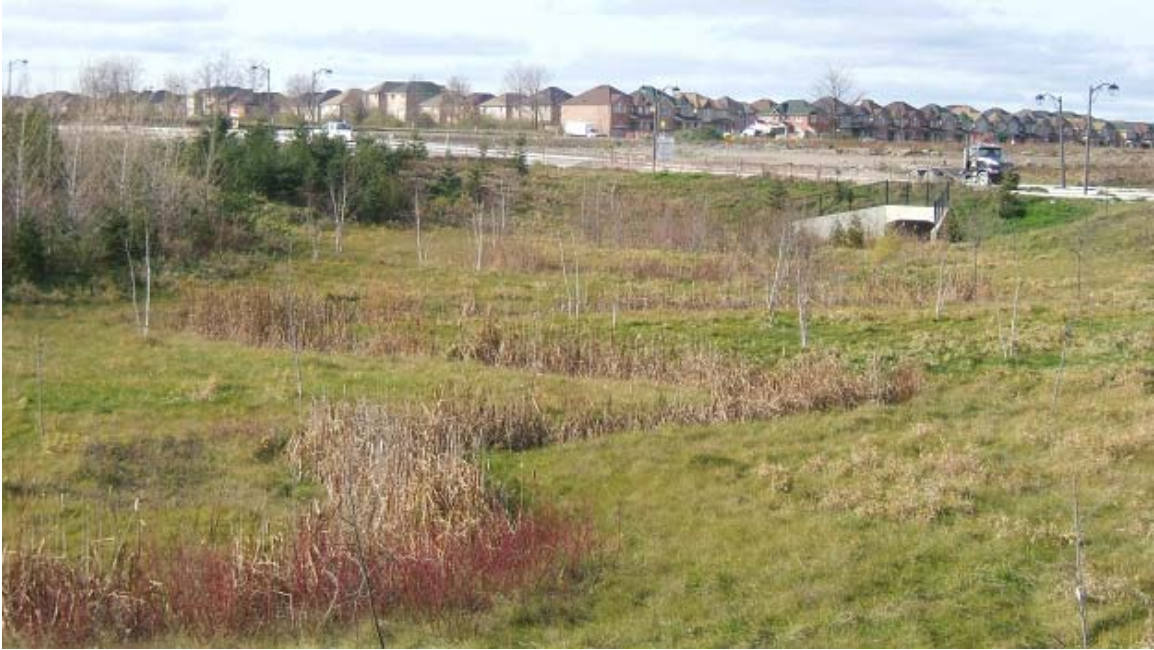
Meandering channel viewed upstream. Note the vegetation in the channel.

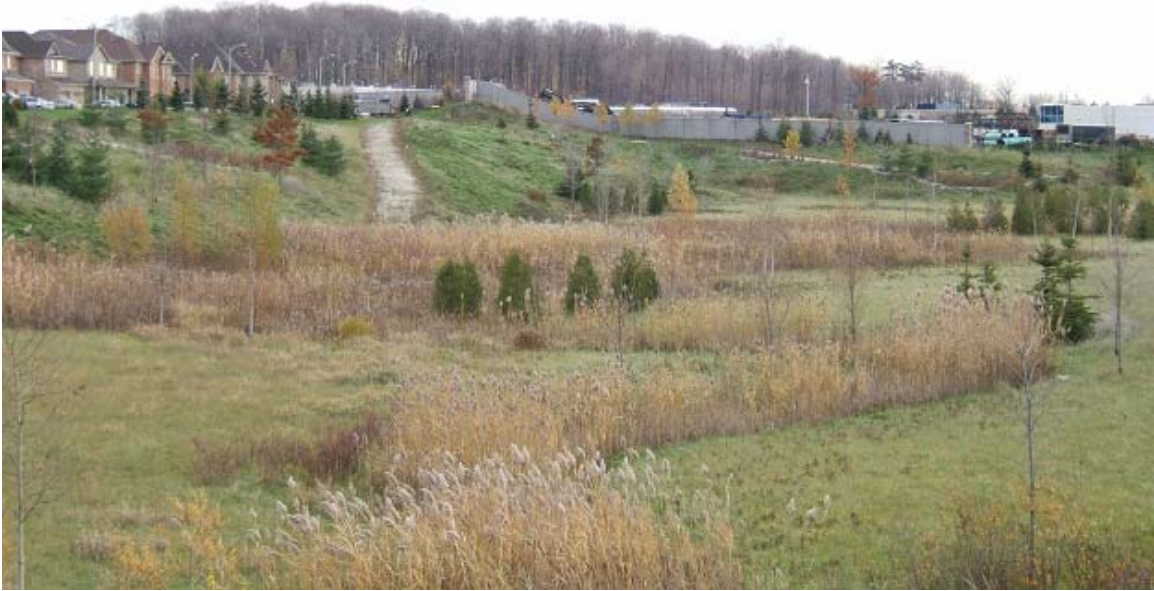
Meandering channel viewed downstream. Note the establishment of vegetation within the channel.

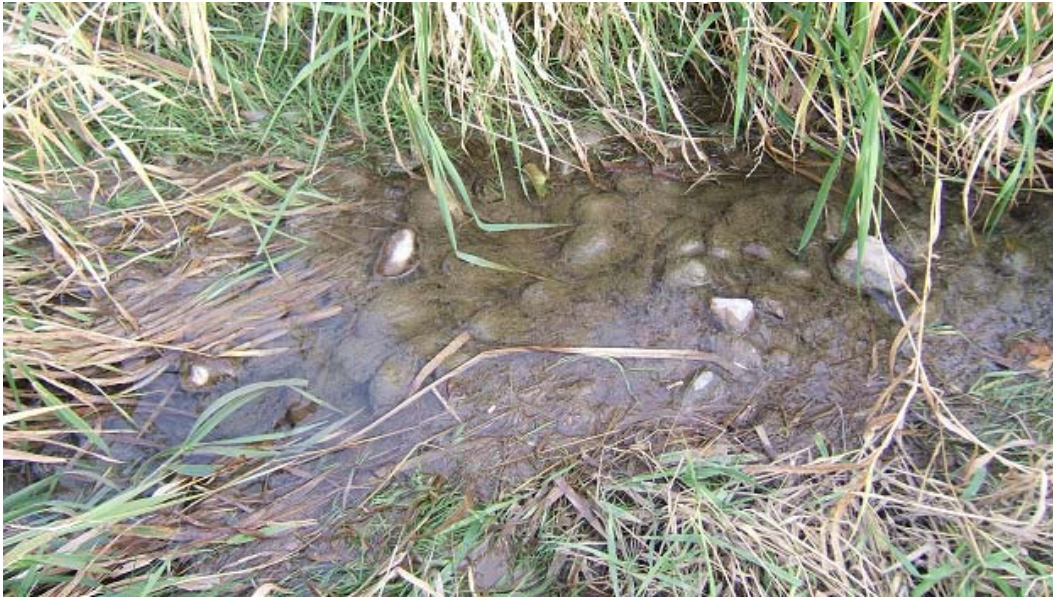
Riffle section with vegetation encroachment.

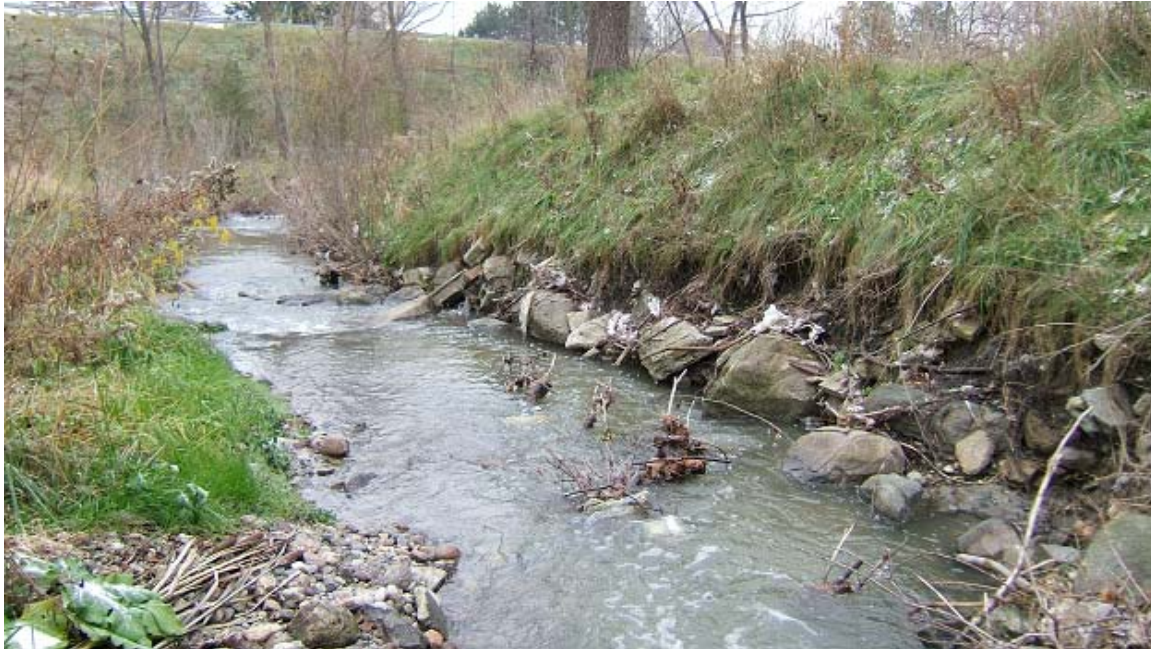
Downstream view of channel at first bend. Note the erosion of the right bank.

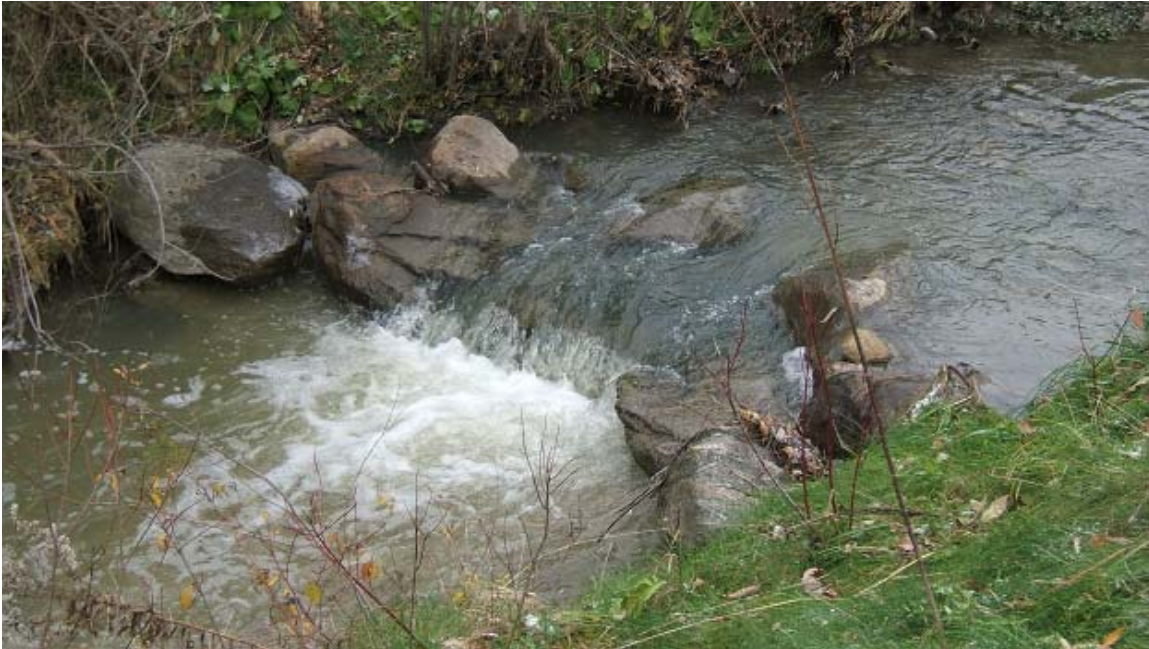
One of ten rock vortex weirs used for grade control.

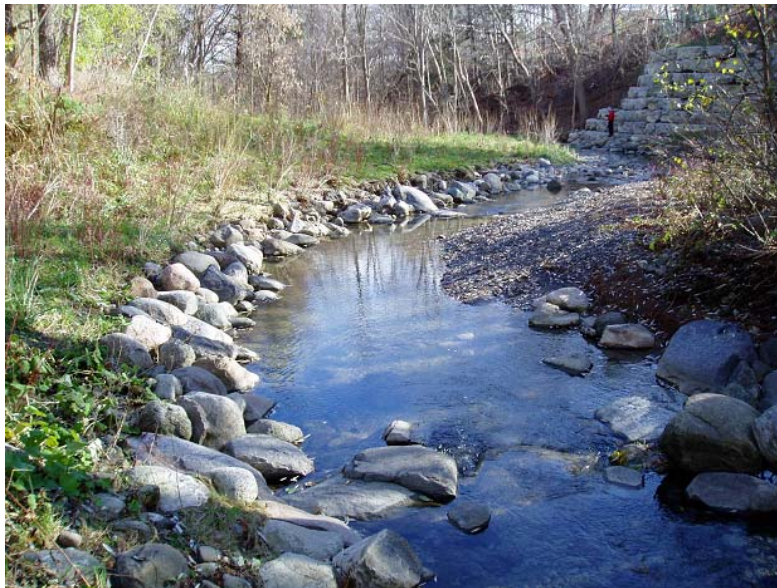
View of channel looking downstream. Note: well developed point bar and minor erosion behind rock treatment. Vortex weir (foreground) appears to be functioning as intended.

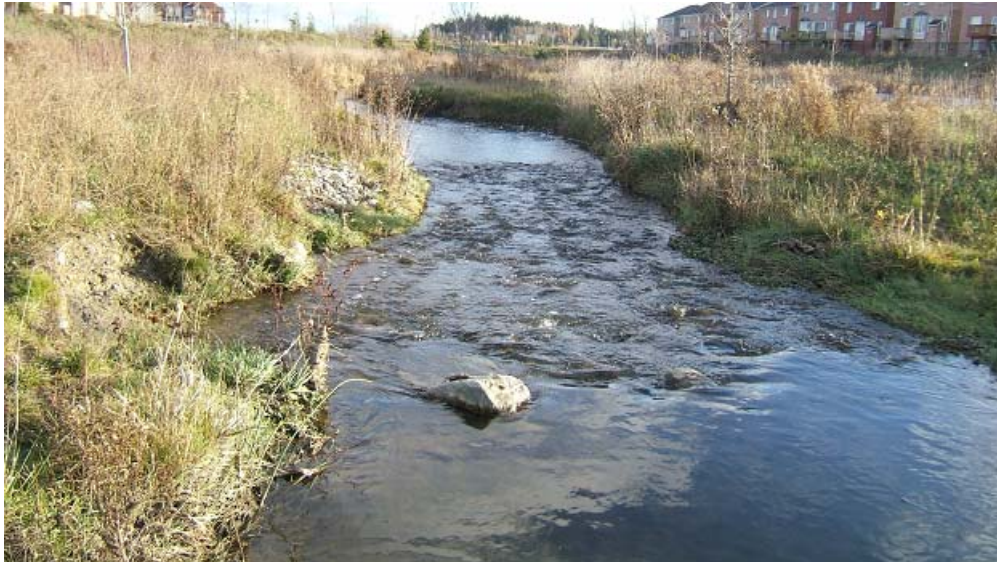
View of channel looking downstream. Note: riffle section appears to be functioning as intended. Some bank erosion and outflanking seen along left bank.

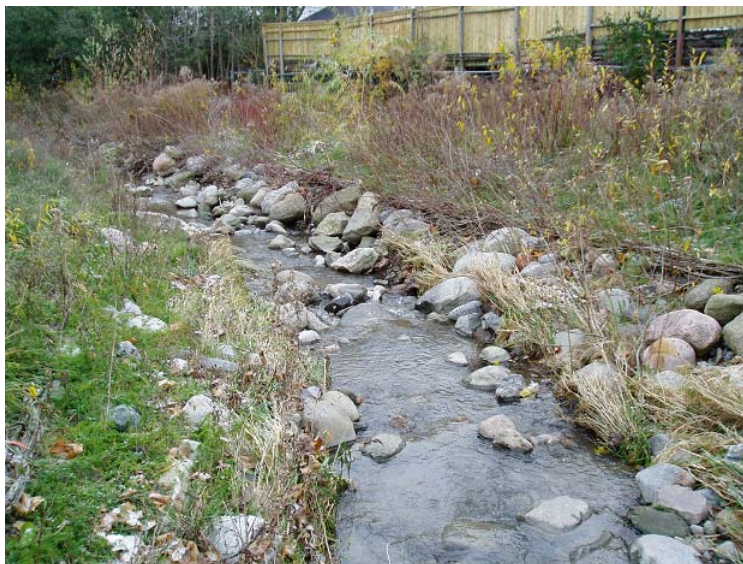
View of channel looking downstream. Note: fascines doing well along right bank.

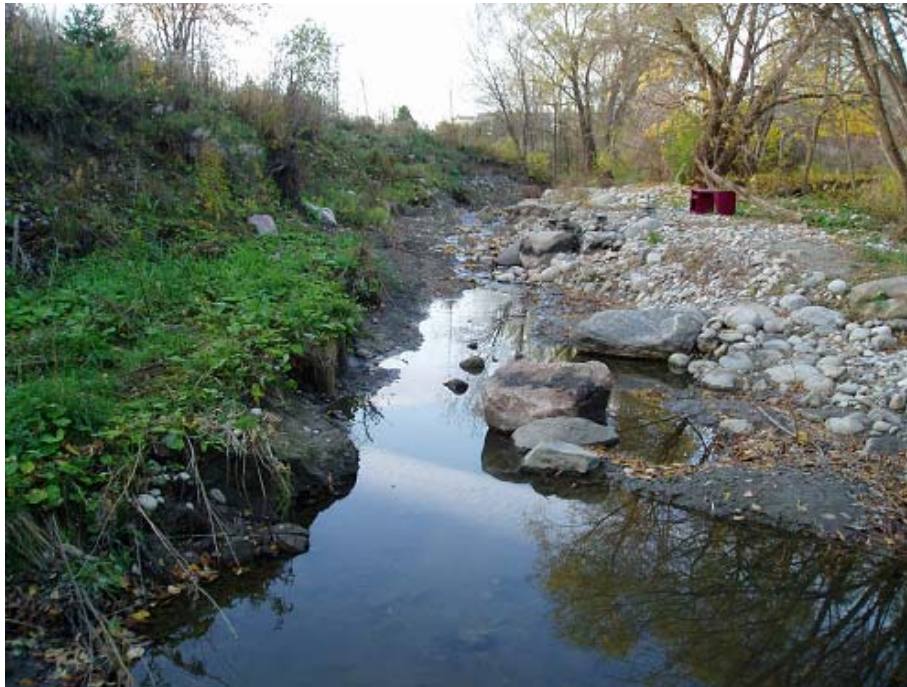
A former riffle-pool sequence viewed upstream. Note the degradation and bank erosion.

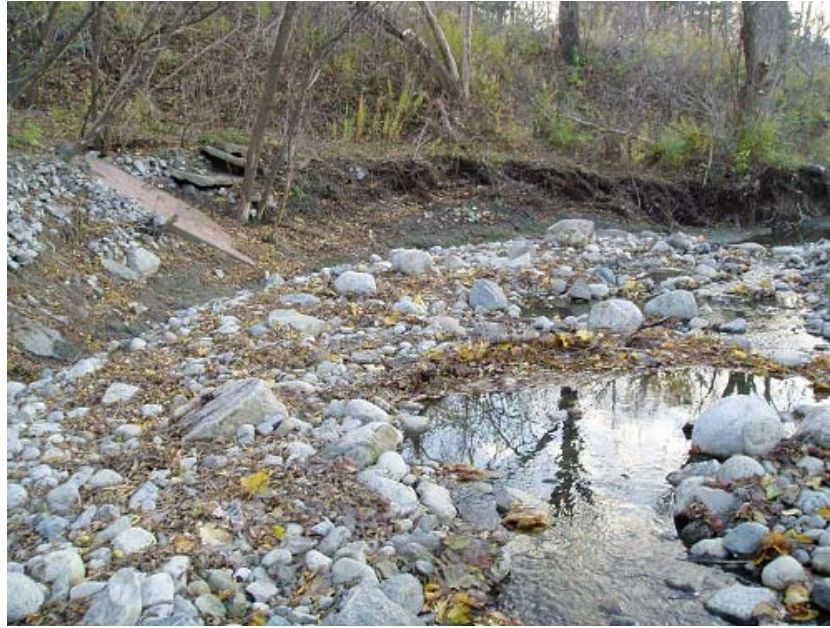
Downstream view of channel bend. Note the degradation and bank erosion.

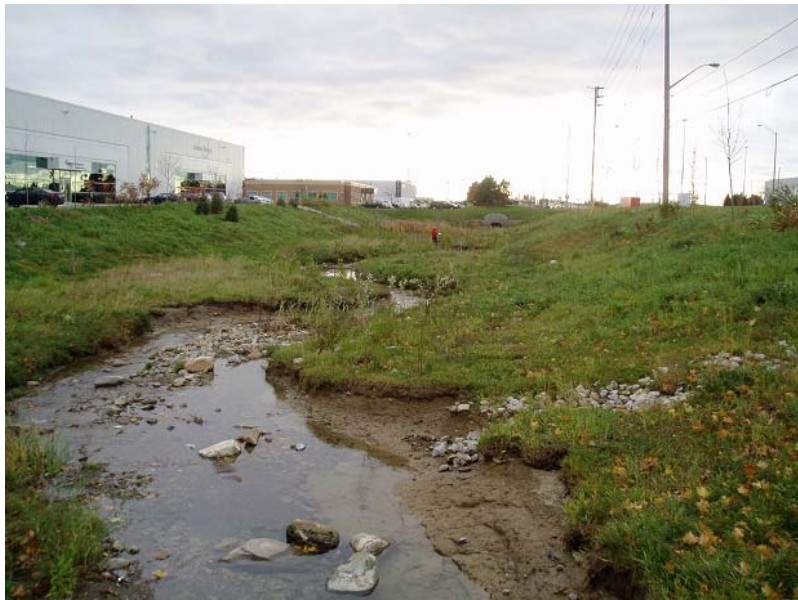
View of channel looking downstream. Note: extensive bank erosion and downcutting.

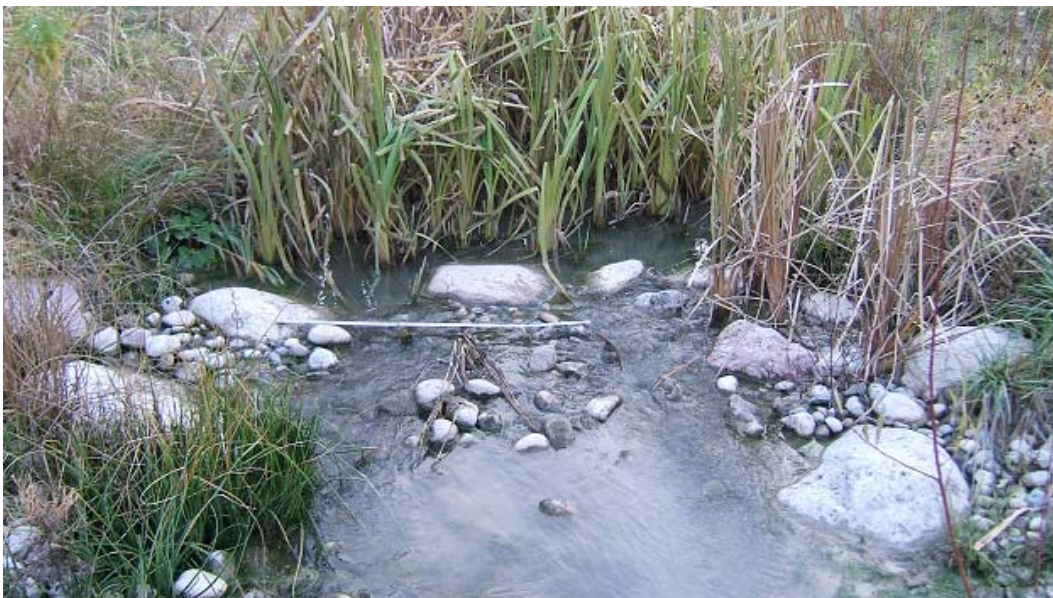
Partially exposed vortex weir and riffle viewed upstream. Note the in-channel vegetation in the upstream pool.

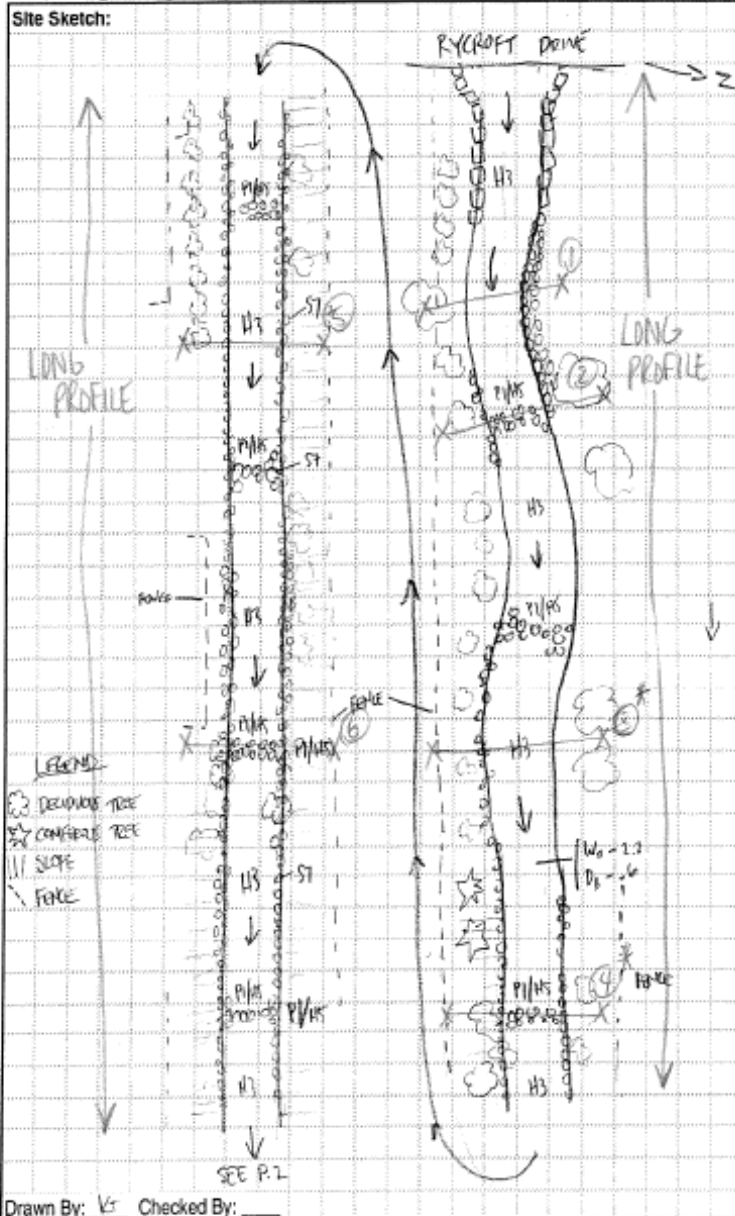
MOST VORTEX WEIRS AT UPSTREAM END
NEAR RYCKOFF DRIVE WASHED D/S
LARGE BOULDERS FOR BANK PROTECTION
ALSO TRANSPORTED D/S
NARROW RITHMUM ZONE BUCKLING
RESIDENTIAL PROPOSED

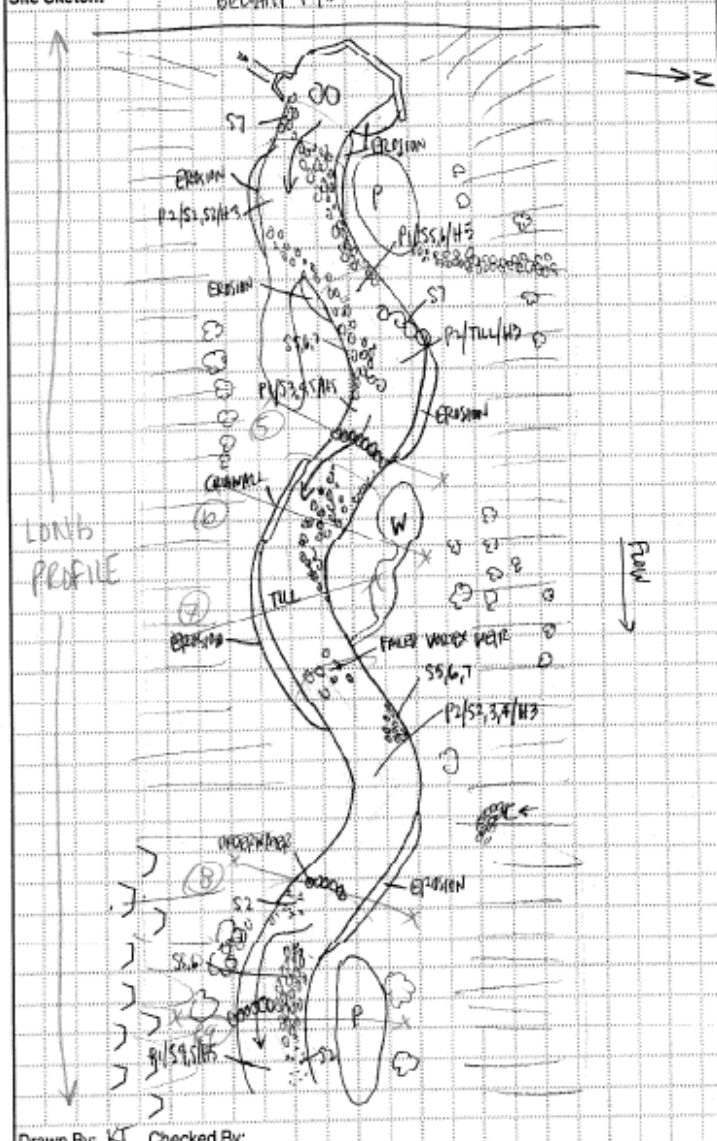
CONSIDERABLE EROSION ON OUTSIDE
OF MEANDER BENDS
RIPARIAN - GRASSES

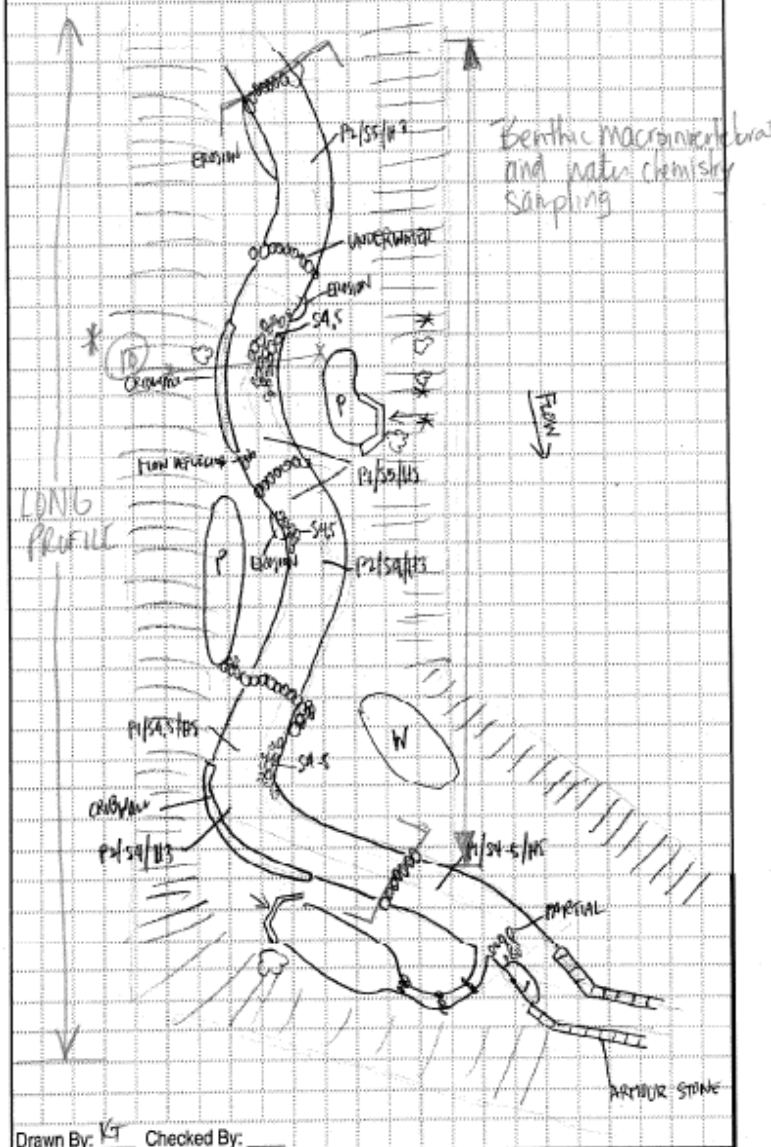
EROSION ON OUTSIDE OF BENDS
RIPARIAN - GRASSES
SHRUBS ON OUTSIDE OF BENDS
