POST-CONSTRUCTION EVALUATION OF STORMWATER EXFILTRATION & FILTRATION SYSTEMS

a.m. candaras associates inc.

October 1997

(Project No. 9321)

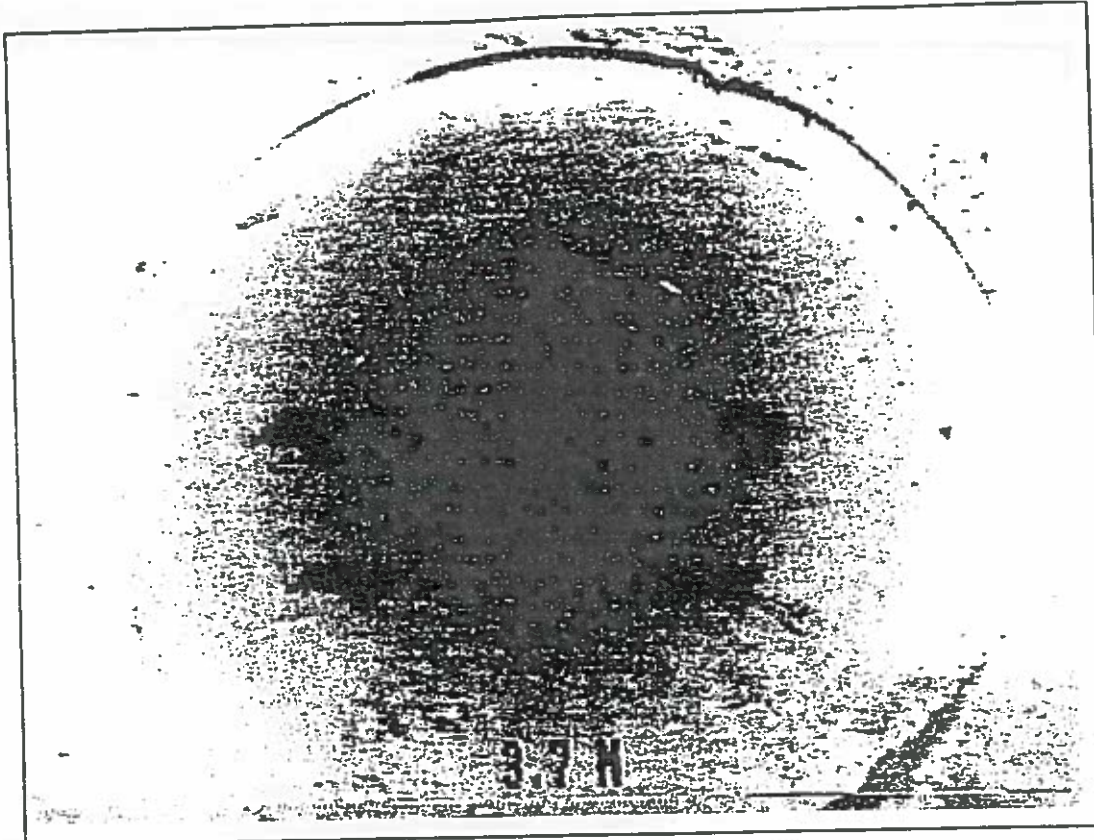
Photo 9.1: Princess Margaret Blvd., July 25, 1994 - Perforated Pipe
Looking downstream from Manhole 2

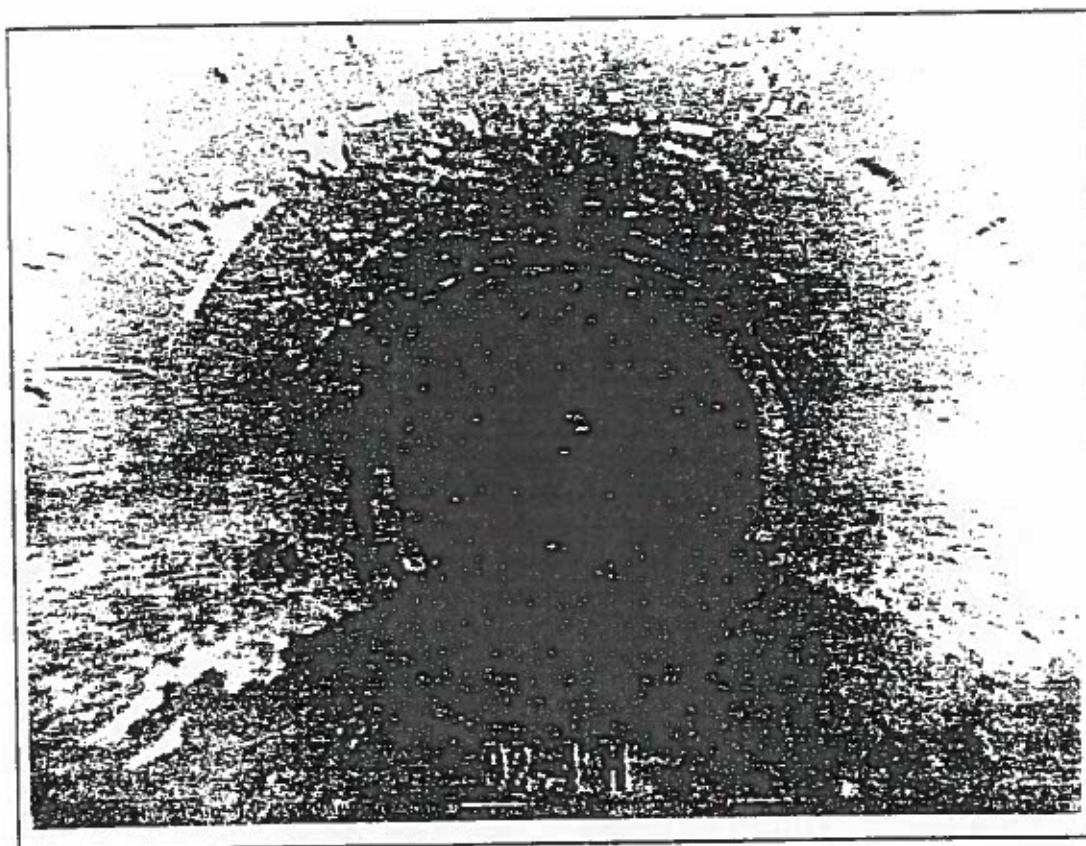
- The EES and EFS continued to function during winter and spring thaw. No monitoring equipment were installed during these months due to possible equipment damage. These observations were based on the absence of water marks on the upstream conventional storm sewer (ie. no overflow).
- Soil bioengineering works carried out at the south end of Queen Mary's Drive indicated no additional bank seepage.
- No loss of mature trees were observed along Queen Mary's Drive and Breacrest Avenue.
- No sign of structural deficiency were found at inlet and outlet connections.
- No pavement settlement on streets occurred in or along either EES and EFS.
- Video inspection of the EES and EFS perforated pipes in November 1994 and December 1995 indicated generally clean pipes other than some minor sediment accumulations in the last 20 m of the system. (Refer to Section 9.6 and Photos 9.2 and 9.4).

Photo 9.2: Princess Margaret Blvd., July 21, 1994 - Perforated Pipe
Looking downstream near Manhole 3

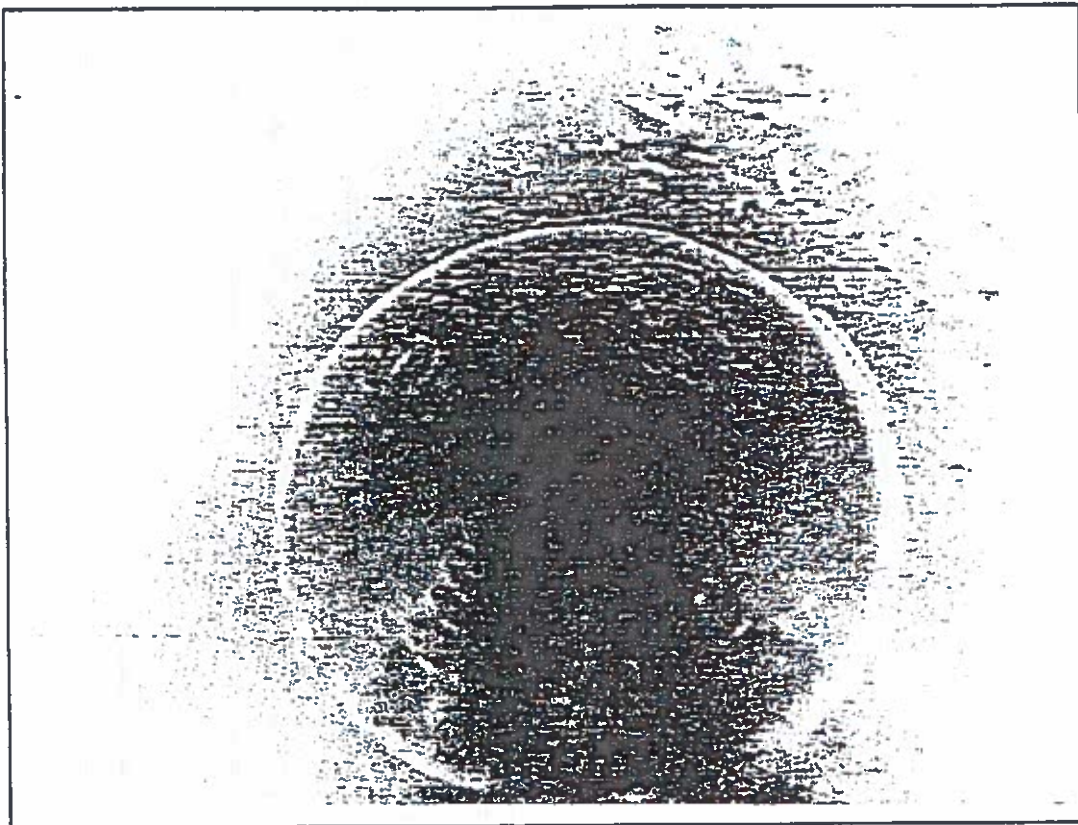
Photo 9.3 Princess Margaret Blvd., December 13, 1995 - Perforated Pipe
Downstream of Manhole 2

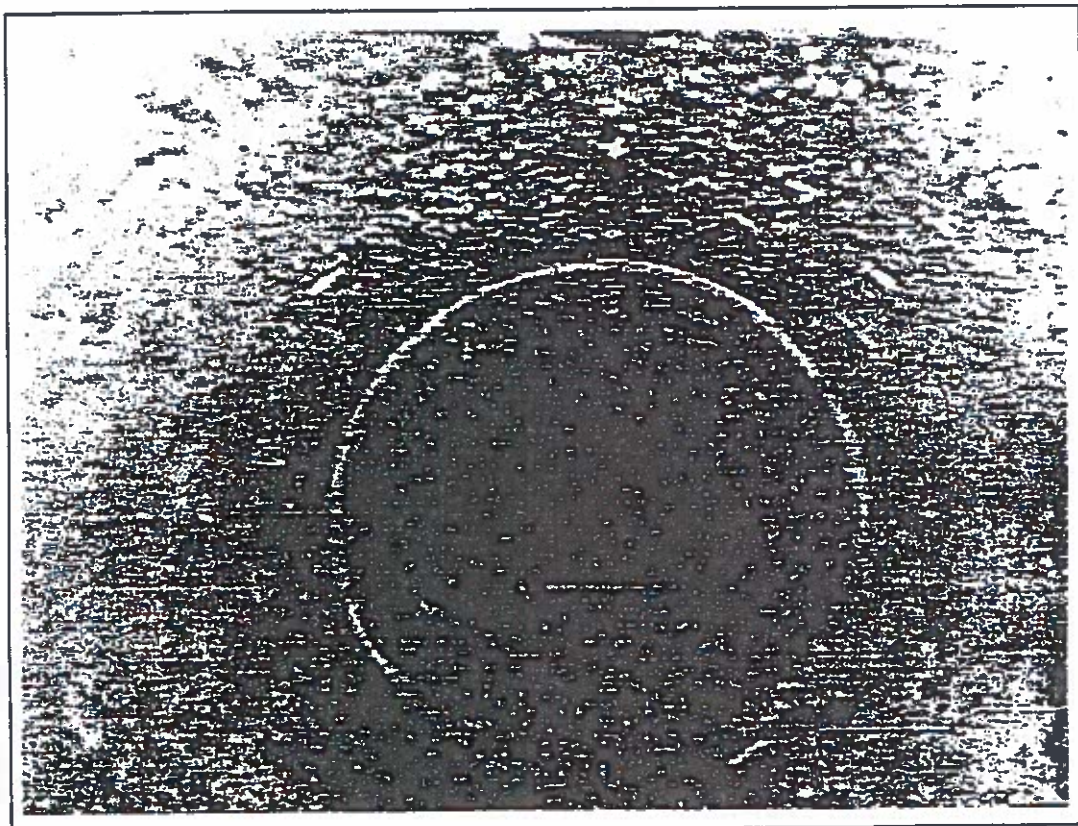
Photo 9.4: Princess Margaret Blvd., December 13, 1995 - Perforated Pipe
Downstream from Manhole 3 (Beginning of sediment)

- Standard sewer system power flushing procedures were found to be effective in cleaning the perforated pipes of the trapped debris and sediments. This approach is recommended when system cleaning is required. Power flushing should be conducted between maintenance holes. The mechanical plugs should be repositioned to the upstream end of the perforated pipes to ensure that the flushed material is trapped within the downstream maintenance hole and the material removed by vacuum truck.

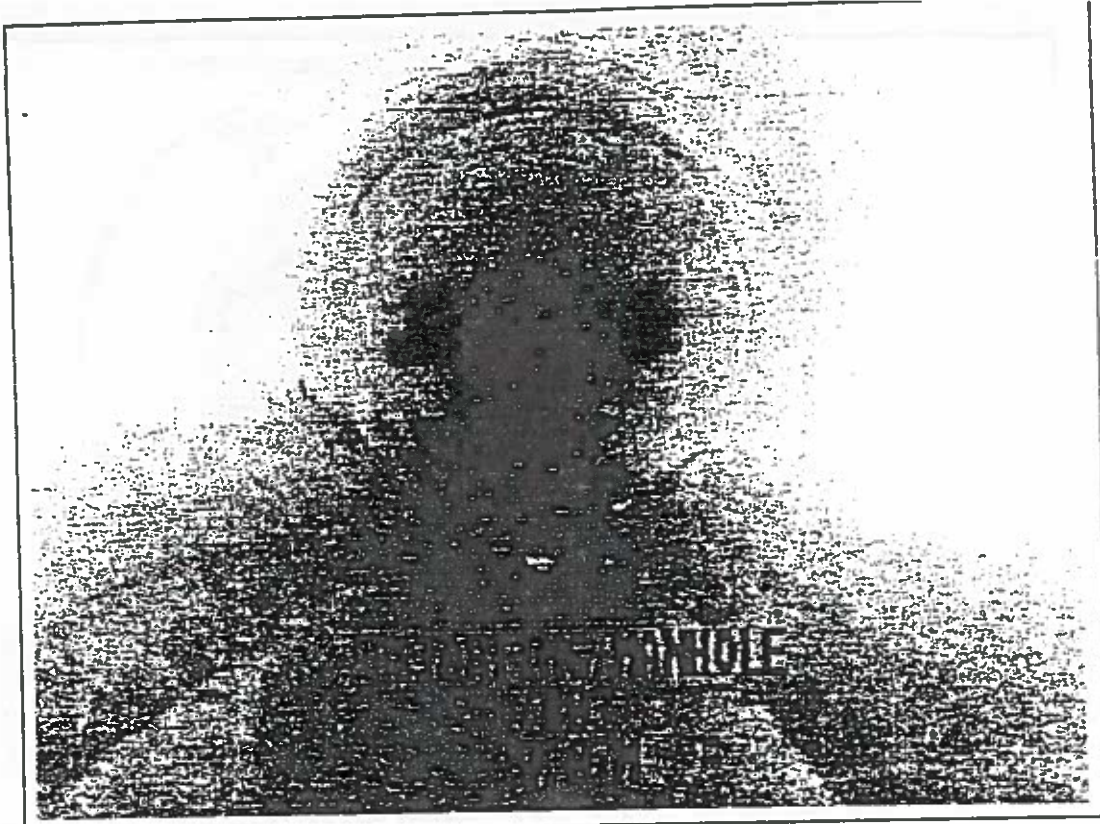
Photo 9.5: Princess Margaret Blvd., December 13, 1995 - Concrete Pipe
Downstream of Manhole 3 (Water mark near springline)

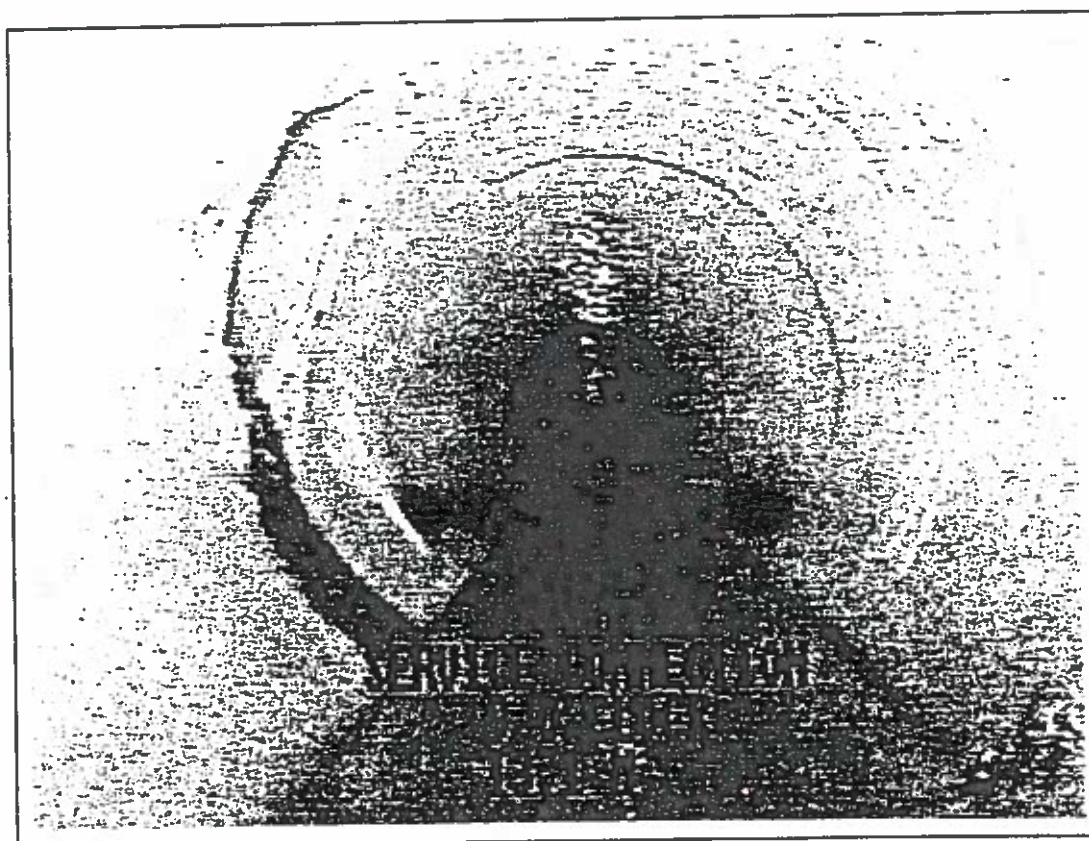
Photo 9.6: Princess Margaret Blvd., December 13, 1995 - Concrete Pipe
Downstream of Manhole 3 (Water ponding and lower water mark from
downstream weir)

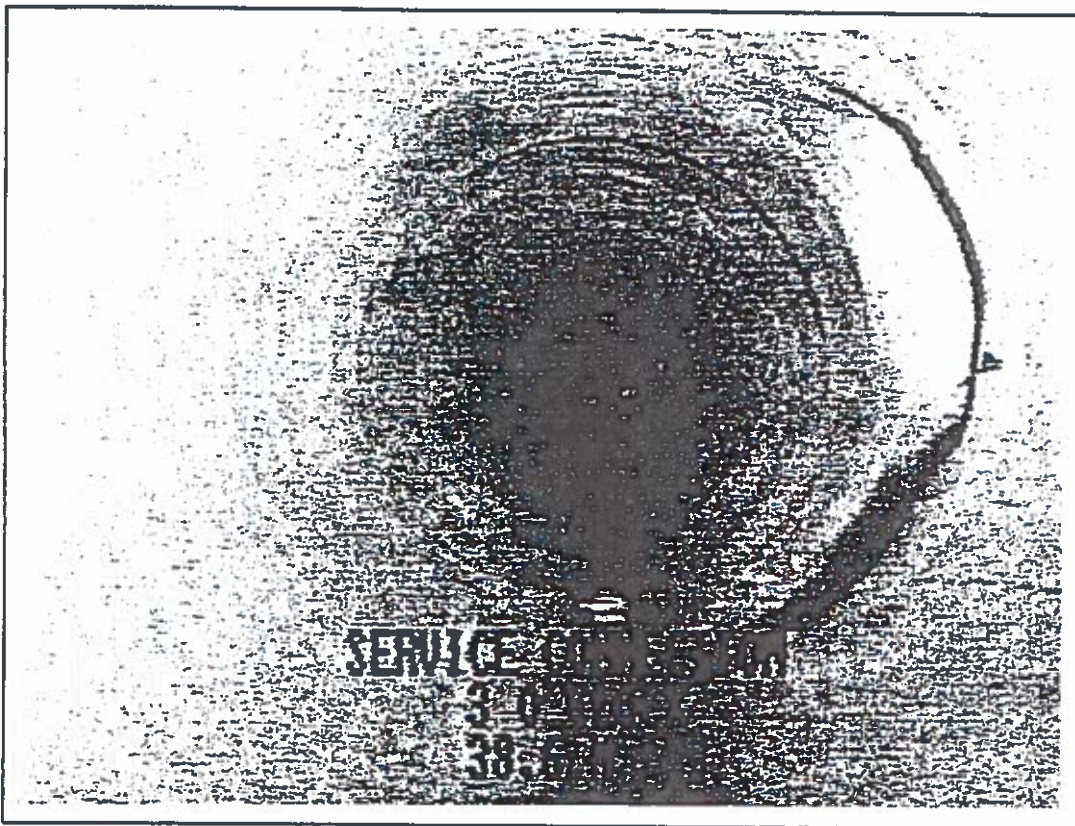
Photo 9.7: Princess Margaret Blvd., December 13, 1995 - Concrete Pipe
Downstream of Manhole 3 (Water mark over invert)

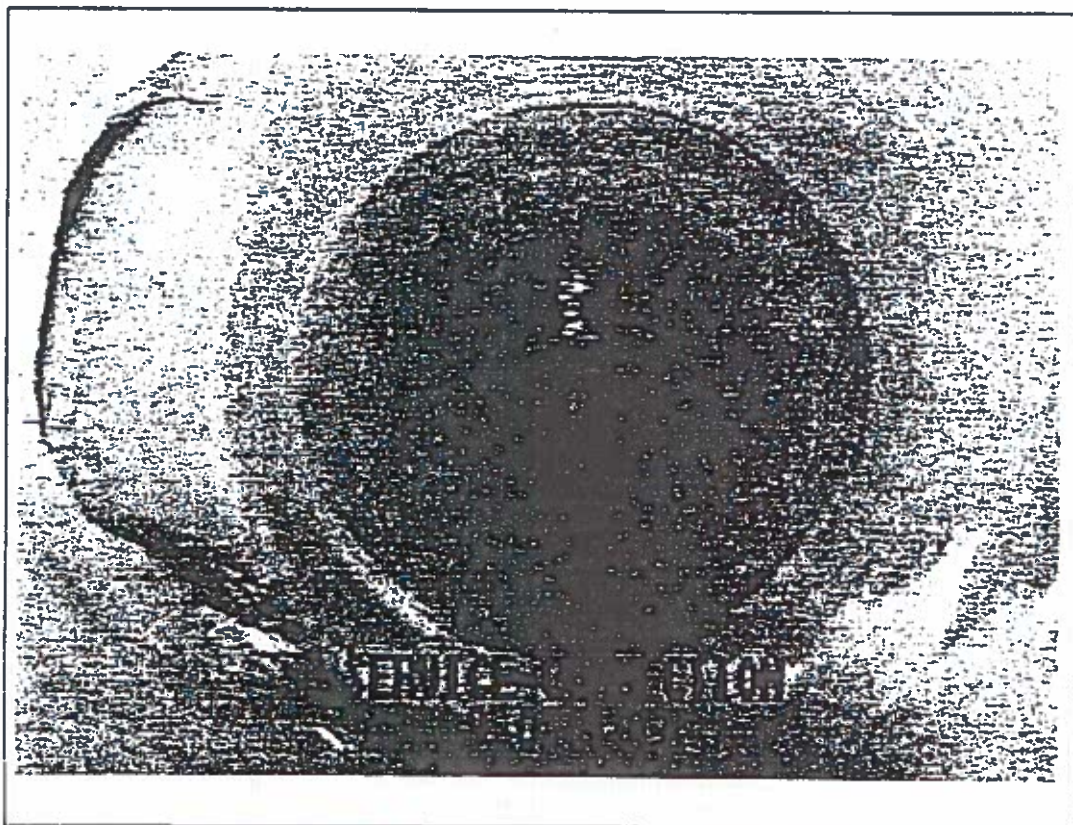
Photo 9.8: Princess Margaret Blvd., December 13, 1995 - Concrete Pipe
Downstream of Manhole 3 (Water mark over invert)

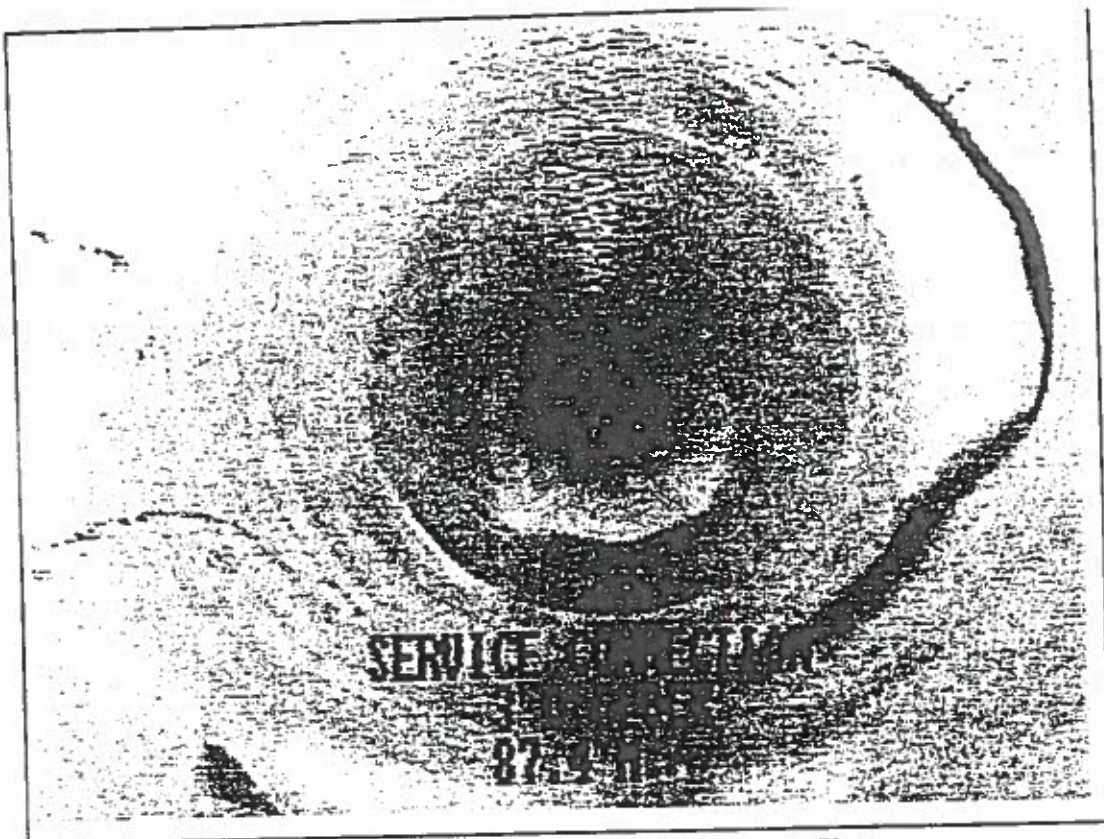
Photo 9 9: Princess Margaret Blvd., December 13, 1995 - Concrete Pipe
Downstream of Manhole 3 (Minimum water marks and cracks on left side)
