Winter Mechanical Dredging of a Stormwater Pond

CASE STUDY

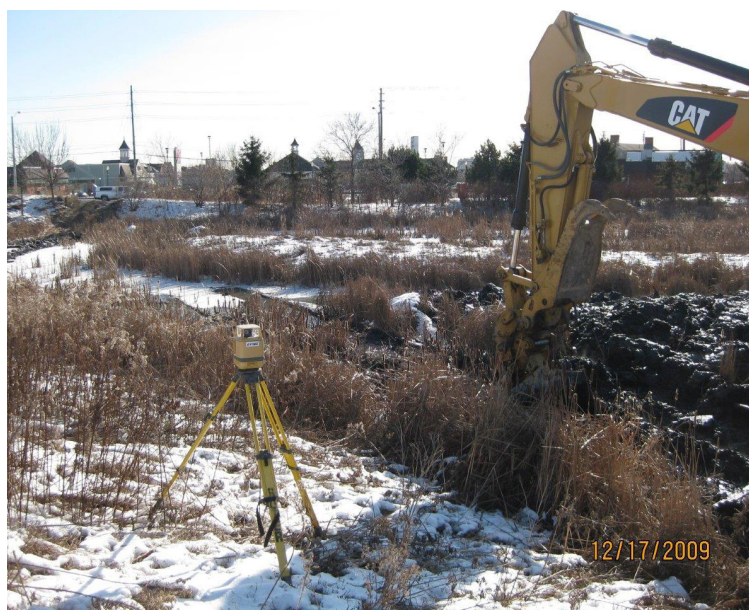
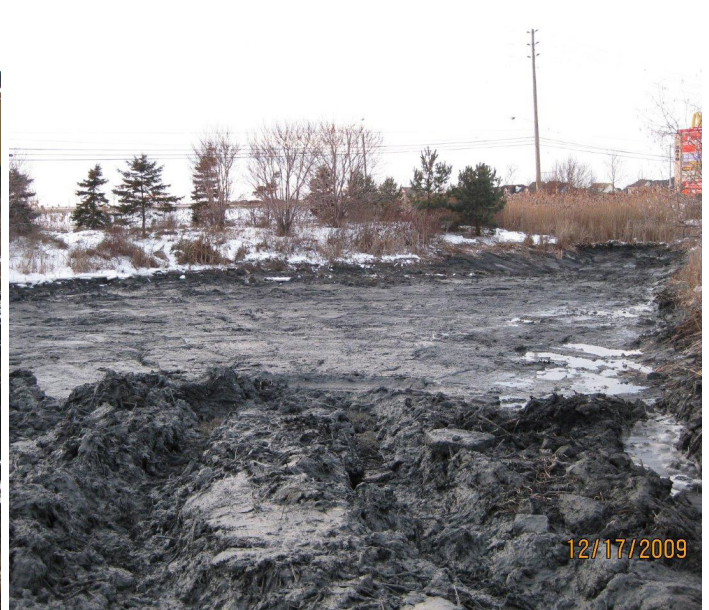
Figure 2. (Left) Excavator removing wet sediment at Pond 51; (Right) Close-up view of the wet sediment at the pond bottom. Sub-zero temperatures have contributed to some freezing of the water-based muck.
