Low Impact Development

Permeable Pavements Maintenance

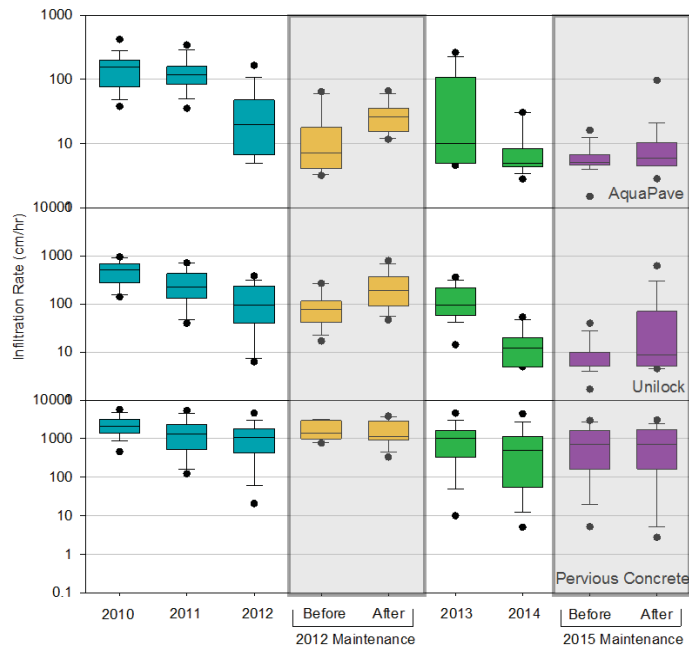
Figure 2. Box plots of surface infiltration rates from 2013 to 2015. Shaded areas show surface infiltration test results before and after maintenance.

Infiltration testing over a five year period showed a rapid decline in surface infiltration during the first two years after installation and only modest improvements in surface infiltration on the permeable interlocking concrete pavements after vacuum maintenance. Vacuum sweeping did not significantly improve the surface infiltration rates on the pervious concrete, where initial and post installation surface infiltration rates were considerably higher (Figure 2). The surface infiltration tests prior to the test of pre-treatment techniques were conducted from 2010 to 2014. In the initial two years after installation, permeability of the narrow jointed pavement (Aquapave), the wide jointed pavement (Eco-Optilock) and the pervious concrete (Hydromedia) declined by 87, 70 and 43%, respectively. After maintenance of the PICPs, there was a statistically

significant ($p < 0.05$) increase in median surface infiltration rates from 20 to 94 cm/h on the narrow jointed PICP, and 26 to 187 cm/h on the wide jointed PICP. A reduction in median surface infiltration was noted for the pervious concrete, but the change was not statistically significant. In 2013, one year after maintenance, surface infiltration rates on all pavements showed similar rates to the year before maintenance (2012), but rates continued to decline to critical levels in the following year, signaling the need for repeat maintenance (Drake et al, 2012; Sehgal et al, 2018).

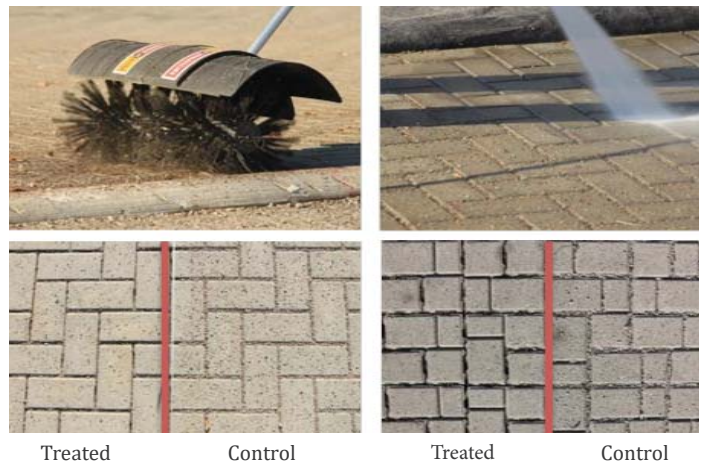
Figure 3. Appearance of pavements after power brushing on the Aquapave pavement (left) and pressure washing on the Eco-Optilock pavement (right). Pretreatment helped to dislodge sediment and fines embedded in the joints near the surface.

Pretreatment techniques helped remove clogging material within the upper one to two centimeters of the PICP joints. The absence of fines in the joints after pre-treatment was visibly obvious after vacuum maintenance (Figure 3) and was also evident from the large amount of sediment that was removed and remained on the surface of the pavers. However, these techniques were only effective in removing the material close to the surface. Sediment and fines more deeply embedded in the joints remained in place. Since these pavements had been in place for close to six years, the fines likely penetrated much deeper than one or two centimeters, although tests of clogging materials were not conducted. This may help to explain why the second maintenance cycle in 2015 was less effective than the initial maintenance in 2012 in the areas that did not undergo pre-treatment. It should be noted that the pervious concrete did not show any visible signs that clogging material had been removed after pre-treatment. Fines within the pervious concrete appeared to be more deeply embedded and less easily dislodged by surface treatments.

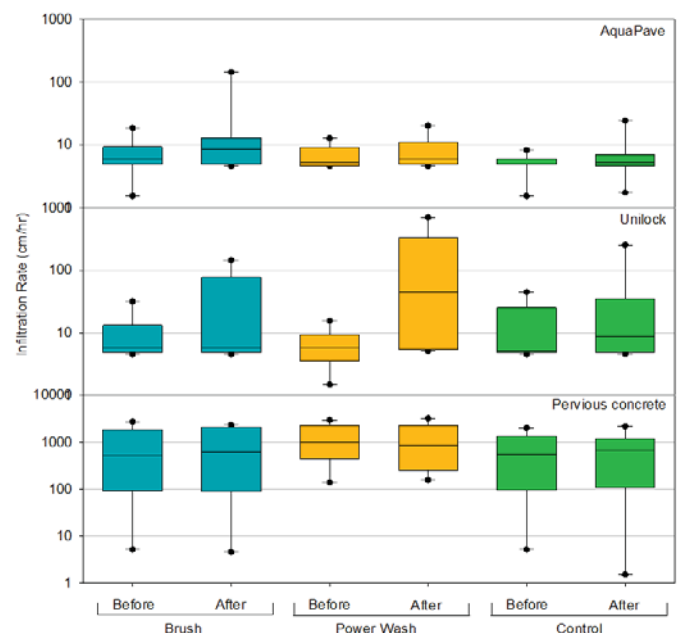
Figure 4. Box plots of surface infiltration rates before and after maintenance. From left to right, treatments were (i) power brush followed by vacuum maintenance; (ii) power wash followed by vacuum maintenance, and (iii) vacuum maintenance only.

Results after vacuum cleaning showed no significant change in infiltration on the plots cleaned with the power brush, but notable improvements in 44% of the areas of the Eco-Optiloc plot that was power washed. The pervious concrete plot showed no significant change for any of the treatments (Figure 6 and Table 1), providing further evidence that alternate methods are needed to restore permeability to poured pavement surfaces. These results are consistent with the earlier maintenance trials in showing that the narrow jointed paver

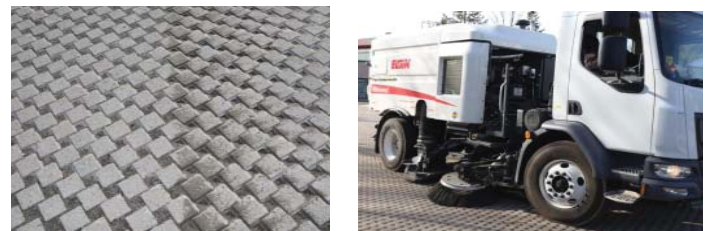
Figure 5. Pavement before maintenance and vacuum sweeper in action.

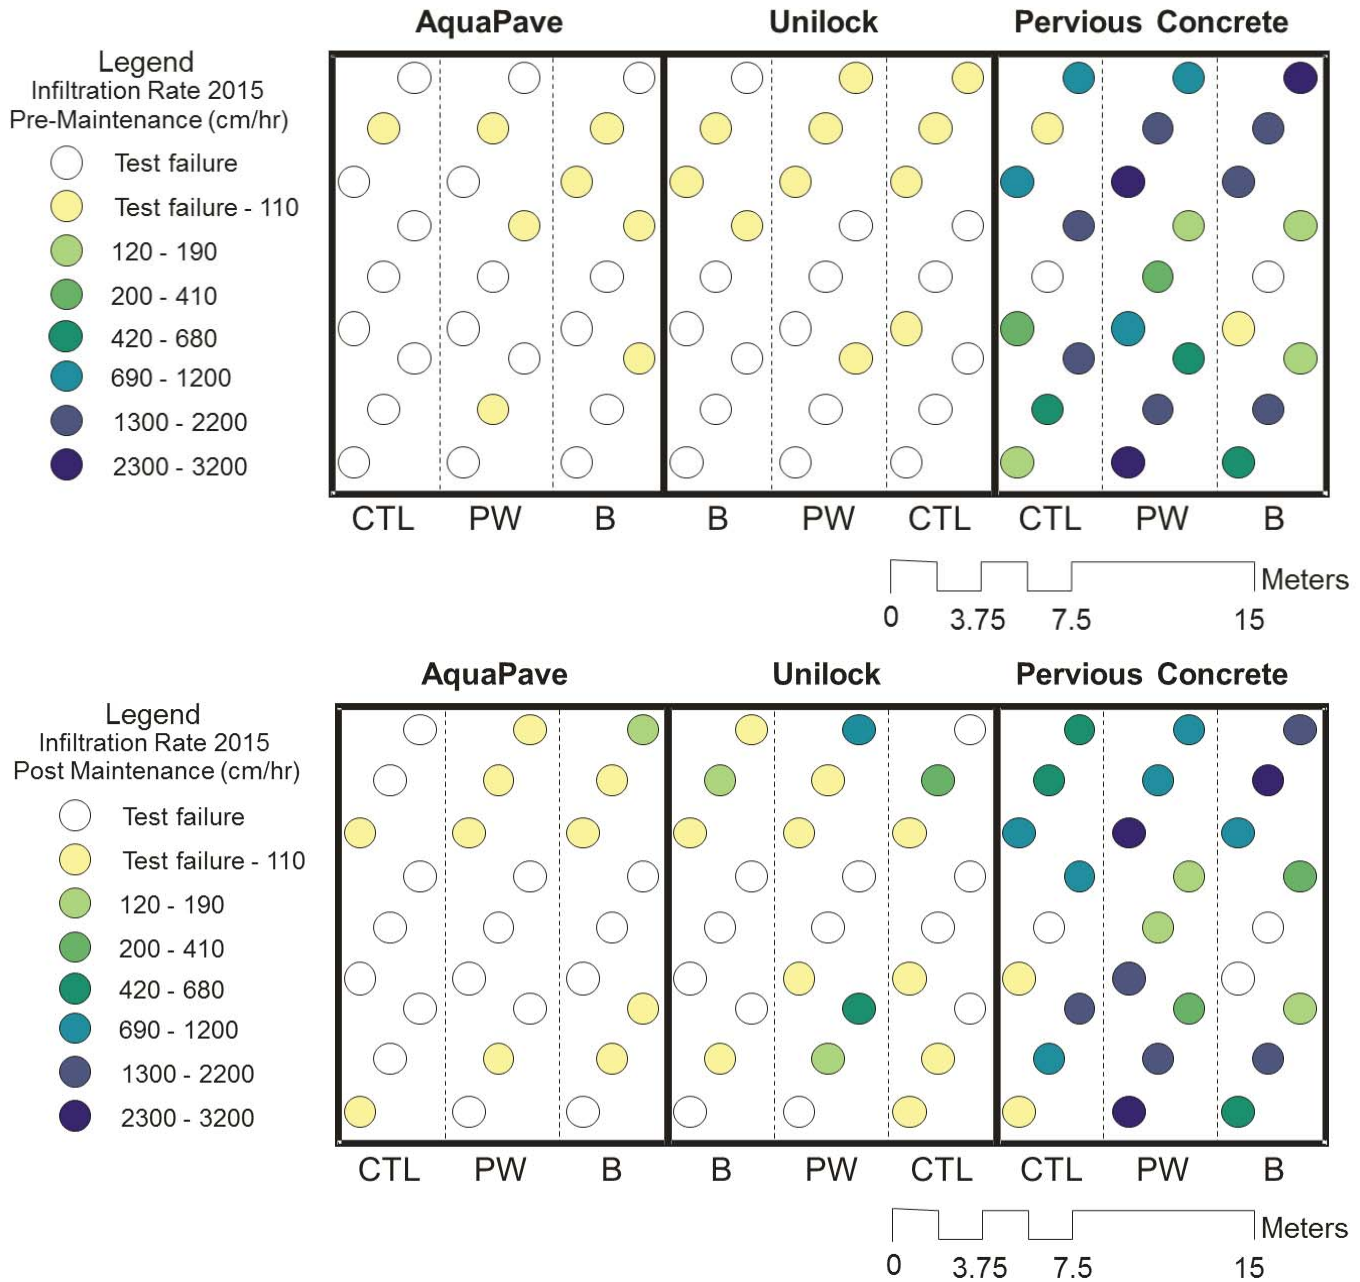
with smaller stabilizing aggregate in the joints resists cleaning to a greater degree than the wide jointed paver. The wider jointed paver showed an increase in median infiltration from 7 cm/h before cleaning to 45 cm/h afterwards. However, as shown in Figure 6, the improvements were primarily limited to only four of the nine test areas. The drive lane showed lower permeability than the parking stalls, and these areas were more resistant to improvements through cleaning by all tested methods.

Figure 6. Spatial distribution of infiltration on the three pavements before (top) and after (bottom) maintenance. Note: CTL = vacuum maintenance only. PW = power wash plus vacuum maintenance. B = power brush plus vacuum maintenance. (Drake et al, 2012)

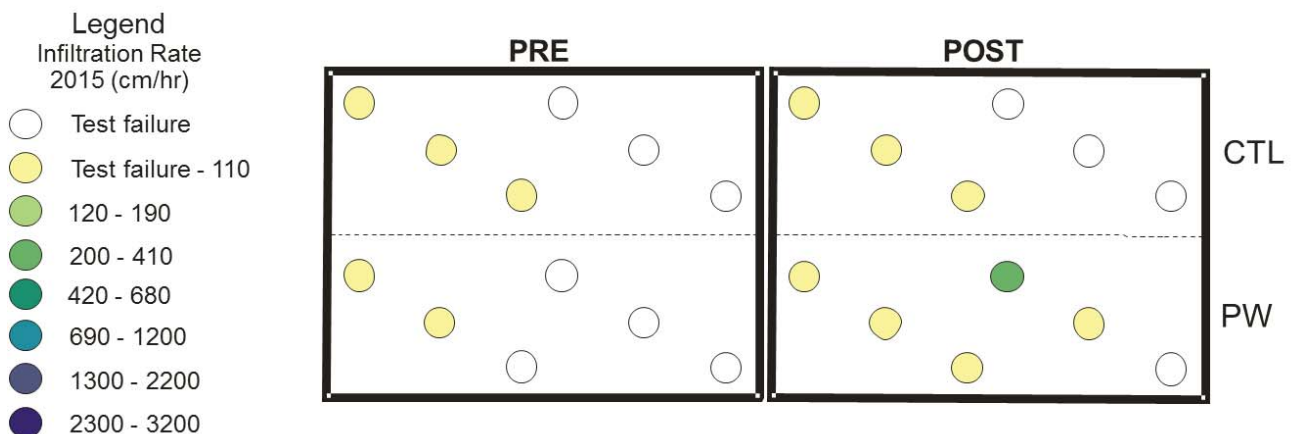
Pre-treatment on the more severely clogged and older eco-stone pavement showed modest improvements in 50% of the test areas, whereas vacuum cleaning alone showed no improvement both overall and within individual test areas (Figure 7 and Table 2). The power brush was not tested at this site. The increase in average infiltration rates rose from 7 cm/h before power washing and vacuum seeping to 80 cm/h afterwards. This result combined with the noted improvements in infiltration on the Eco-optiloc paver at the permeable pavements research facility suggest that power washing can be an effective measure in loosening and dislodging joints, thereby rendering vacuum maintenance somewhat more effective. However, the practice appears to work only on PICPs with larger joint openings or with drainage cells, as was the case with the Eco-stone product (see Figure 7). Both the Eco-Optiloc and Eco-stone products had similar open areas (approximately 12%).

Figure 7. Spatial distribution of infiltration on the older and more severely clogged permeable pavement at Earth Rangers before and after maintenance. Picture shows pavement before maintenance and vacuum sweeper in action. Note: CTL = vacuum maintenance only. PW = power wash plus vacuum maintenance.
