# Existing Building Commissioning of Kortright Visitor Centre

## PROJECT SUMMARY

<b>Building Name:</b>	Kortright Visitor Centre
<b>Type:</b>	Mixed-use; Office; Community/Rec Centre; Convention Centre
<b>Location:</b>	Vaughan, Ontario
<b>Project:</b>	Retro-commissioning of a mixed-use institutional building
<b>Commissioning Scope:</b>	Retro-commissioning of heating and cooling system, domestic hot water system, lighting, and ventilation system. Performed using internal staff.
<b>Size of Commissioned Area:</b>	Approximately 30,000 ft <sup>2</sup>
<b>Total Commissioning Investment:</b>	Approximately \$40,000 of staff time was spent for planning, investigation, and reporting (not including staff training). An additional \$5,000 of staff time was used for implementation. Costs increased due to documentation gaps, overall lack of visual indicators of system parameters, and the state of repair of systems.
<b>Estimated Energy Cost Savings:</b>	\$8,500 per year (for <i>all</i> measures identified but some not implemented yet)

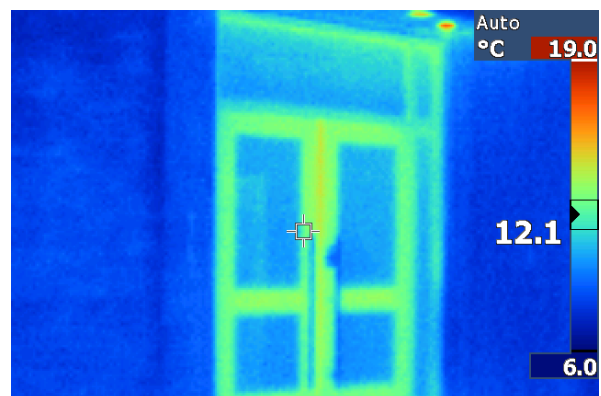
Figure 3. Infrared thermograph showing heat loss through the east entrance. It is difficult to see but there is a faint red line between the doors indicating air leakage. The weather stripping should be inspected and replaced if necessary. Also, shown in the top right, is an exterior soffit light. There are 50 of these lights operating 24/7 with a cumulative power draw of 475 W.

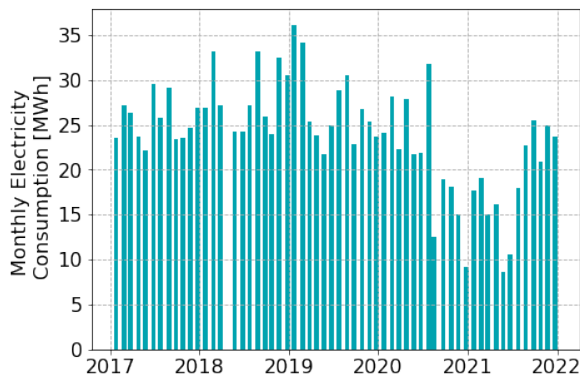
Figure 4. The facility has a baseload electricity consumption on the scale of 23 MWh per month and a relatively weak dependence on heating and cooling degree days. Note that the baseload decreased by nearly 15 MWh per month throughout 2020 and 2021 related to COVID-19.

Based on 3-years of consumption from 2016 to 2019 (normal operation before COVID-19) the average annual electricity load was 313 MWh. Utility analysis, the lighting audit, and other engineering calculations were used to estimate that the geothermal system accounts for approximately 20% of the annual load, lighting accounts for another 20%, and the remainder is plug loads, the commercial kitchen, and DHW. Ventilation was not included in this breakdown because it was believed to be non-functional during this time period.

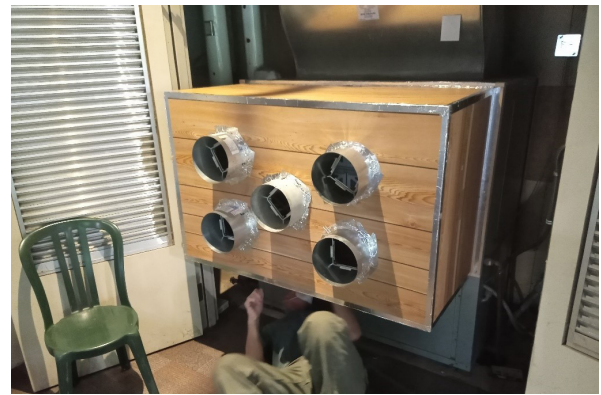
- **The temperature rise on the glycol side of the heat pumps was very low for most heat pumps** except for the heat pump within the DOAS. This is a consequence of the unbalanced system and the pump operating at a constant high speed. This wastes pump energy.
- **The airflow for some heat pumps was notably lower than that in the TAB report, and higher for others.** The blower settings should be adjusted to achieve the right airflow.

Figure 5. As part of the diagnostic monitoring, a custom airflow monitoring set-up was used by the EBCx team to check the operating parameters of the GSHPs.
