# Performance Evaluation of Rainwater Harvesting Systems

Toronto, Ontario

Toronto and Region Conservation Authority  
under the  
Sustainable Technologies Evaluation Program

May 2010  
(Revised June 2011)

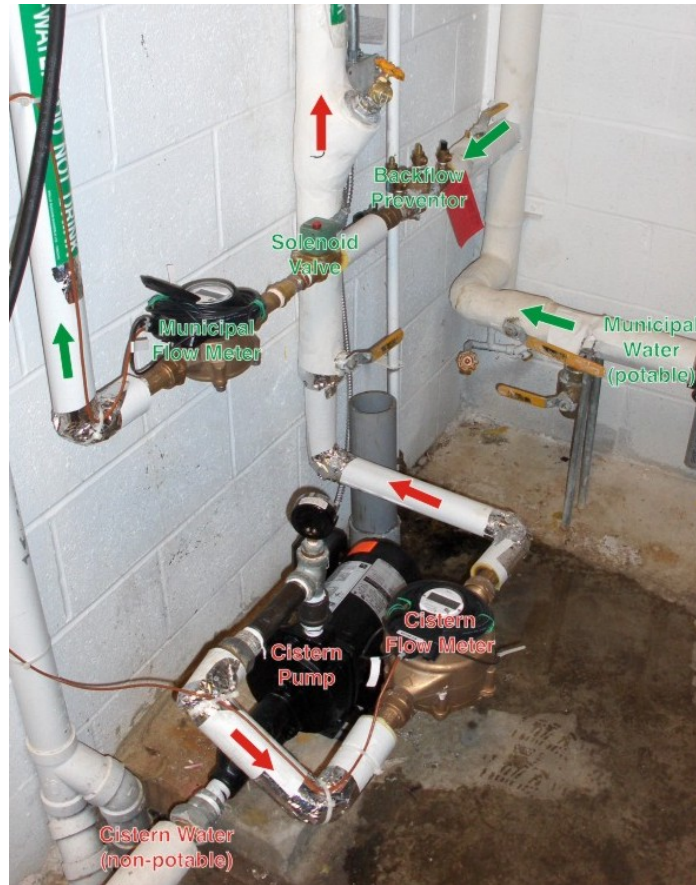
**Figure 4.2:** Flow meter schematic inside Metro Label printing facility.

Two positive displacement magnetic drive flow meters were installed inside Metro Label on the municipal water line (potable) and the cistern water line (non-potable) downstream from the pressurization pump (Figure 4.2). The meters are connected to a four channel logger and are downloaded once every two

weeks. The municipal water contribution only occurs when there is insufficient water in the cistern during dry or cold weather, or when the system malfunctions. The municipal supply is controlled using a backflow preventer and solenoid valve.

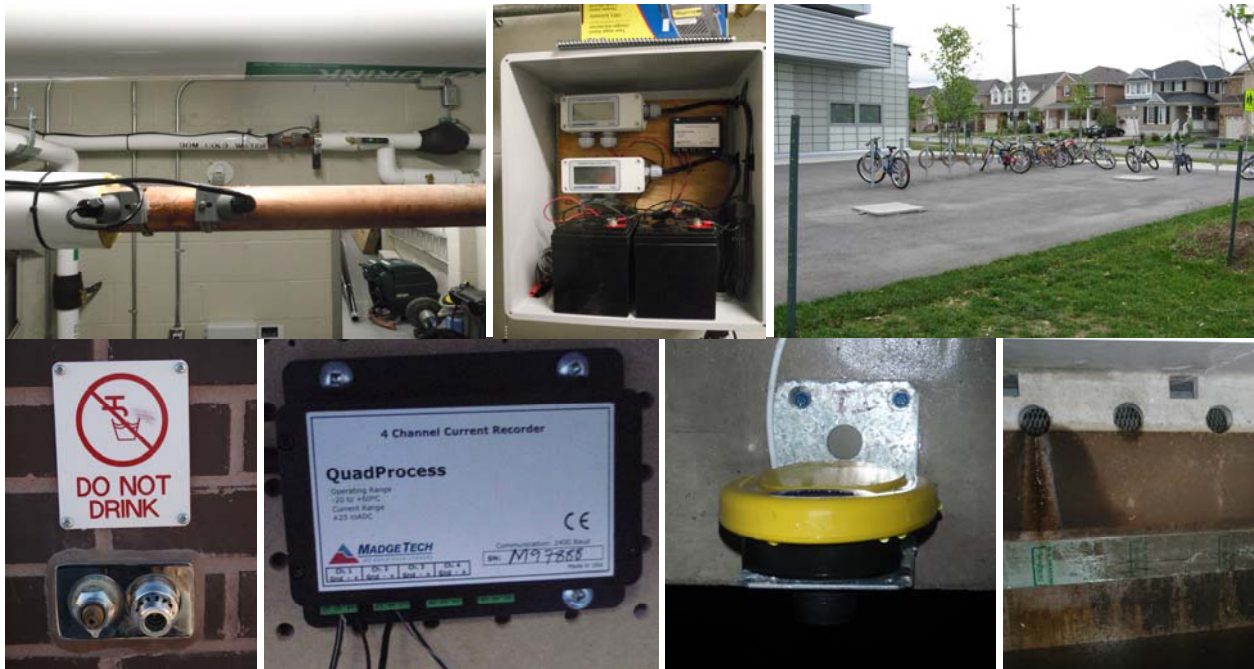
**Figure 4.7:** Brookside public school monitoring equipment. Clockwise starting from upper left- ultrasonic clamp-on flow meters; flow logger; ground level view of cistern access points; weir inside cistern; ultrasonic level sensor in storage chamber, data logger for ultrasonic level sensors; outside hose bib used for irrigation.

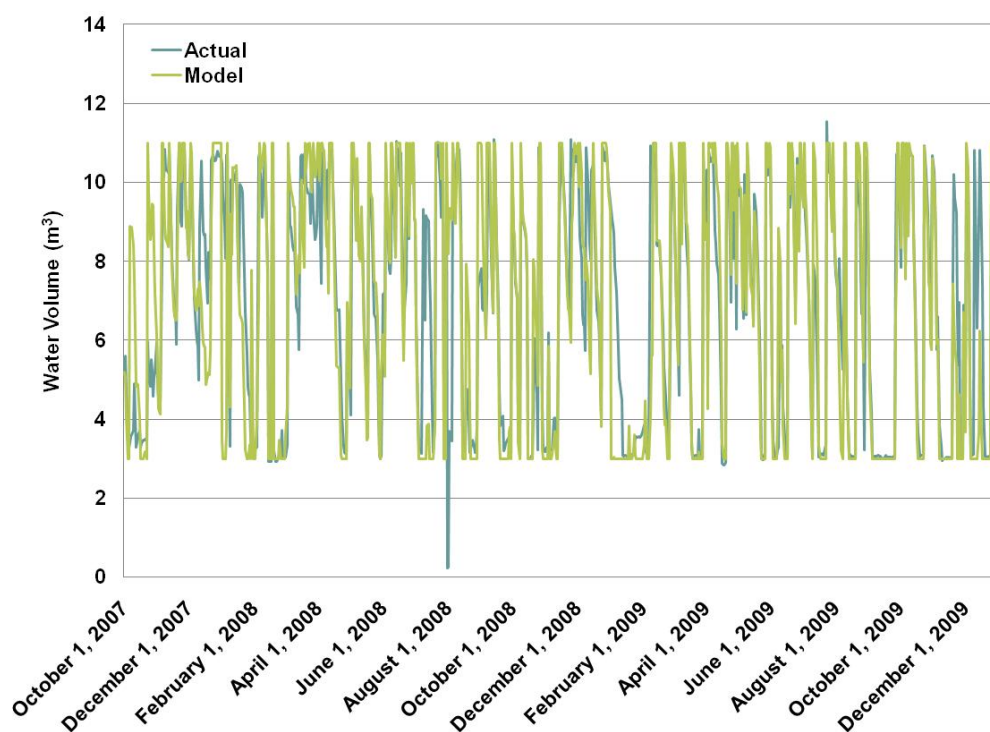
**Figure 4.8:** Actual and modelled cistern water volumes at the printing facility

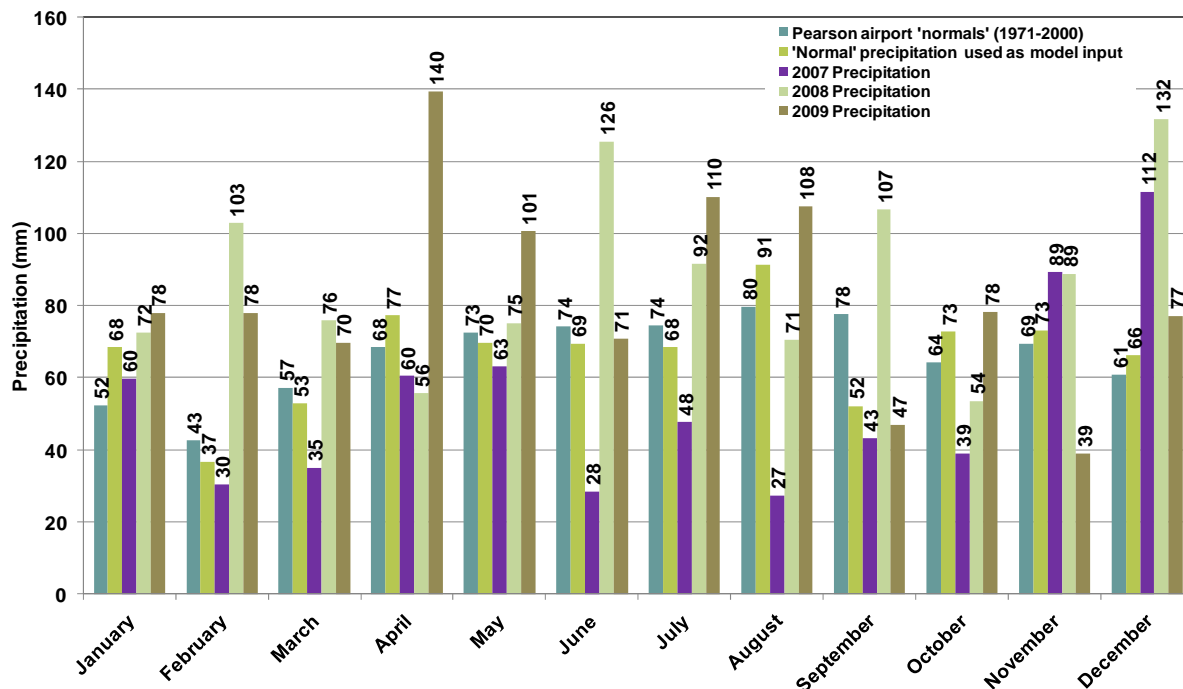
**Figure 5.1:** Precipitation in 2007, 2008 and 2009 at the Metro Label printing facility, monthly precipitation 'normals' from Pearson airport, and 'normal' precipitation data used as model input (see text for explanation).

Figure 5.1 presents precipitation data used in this evaluation, the 'normal' precipitation record that was used to model cistern performance, and the 30 year Pearson Airport 'normals' (monthly averages for the period from 1971 to 2000). The model 'normals' differ from the Pearson 'normals' because the latter are only available as monthly totals, and a daily data set was needed for modelling purposes. Since there was no one year that adequately represented the historical 'normals', a daily precipitation record was compiled from different months over a series of years (1990-1996). The model 'normals' match the Pearson Airport 'normals' reasonably well with a difference of less than 1% in total annual precipitation. Actual precipitation in 2007 was over 26% drier than normal, with most of the difference occurring in the summer. By contrast, actual precipitation in 2008 and 2009 was over 20% wetter than normal. Precipitation for the other two sites was similar to the printing facility and is therefore not presented here.

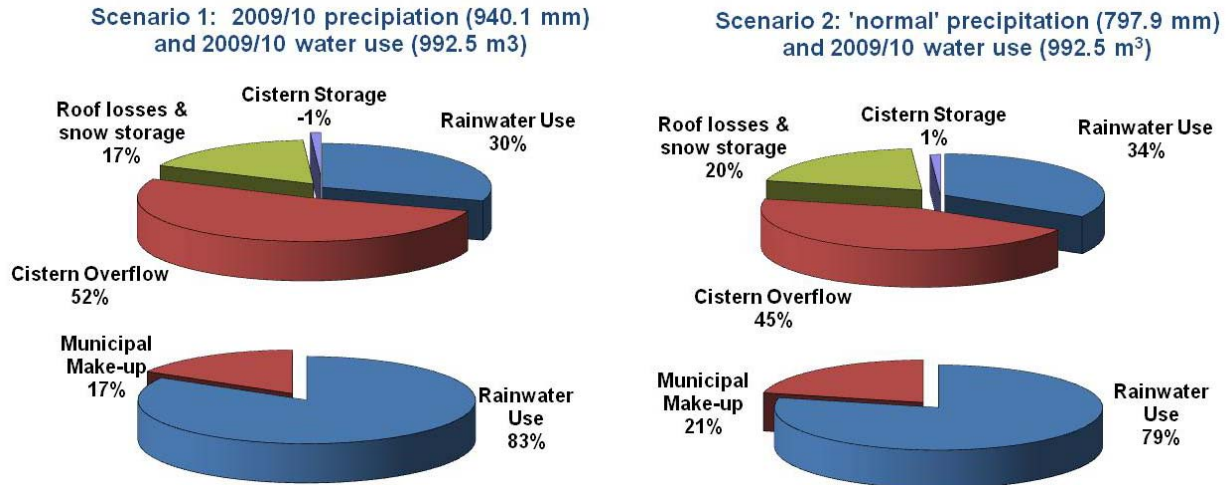
**Figure 5.7:** Summary statistics for the 2009/10 and 'normal' year scenarios for Brookside public school

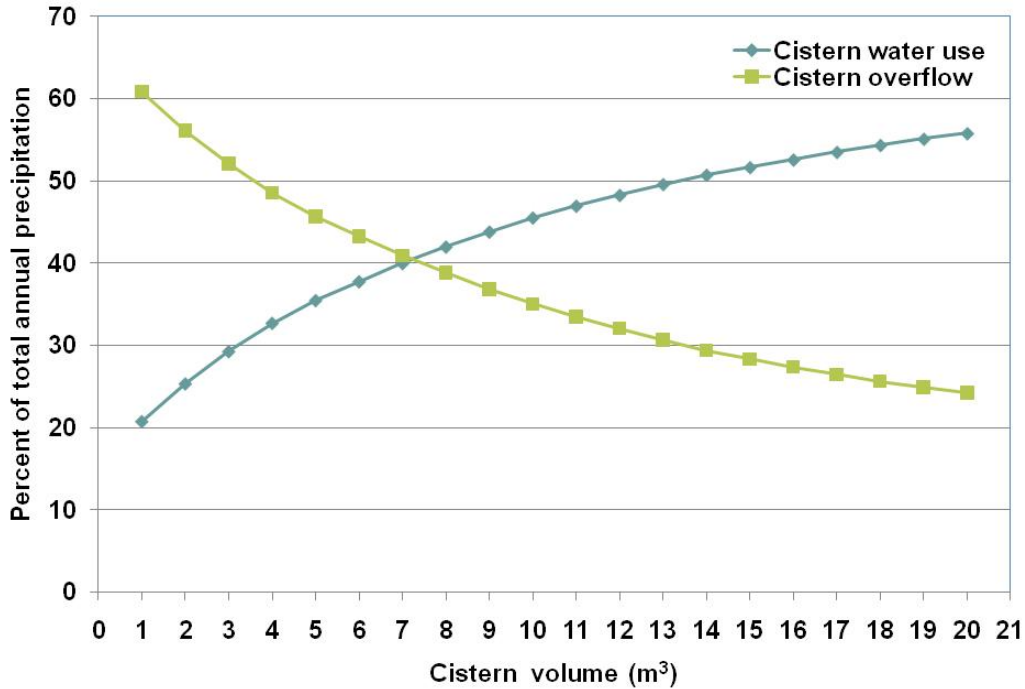
**Figure 5.8:** Model estimates of cistern water use and cistern overflows in relation to cistern volume for the printing facility.

At the printing facility, this 'optimum' volume of available rainwater storage (not including the minimum unused volume) is achieved at 12 m<sup>3</sup> under 2007 and 2008 non-potable water demand conditions, and at 14 m<sup>3</sup> under the higher demand volumes observed in 2009. This latter storage volume is 5 m<sup>3</sup> larger than the 9 m<sup>3</sup> of rainwater storage available for use at the printing facility under current operating conditions; hence the system is undersized.

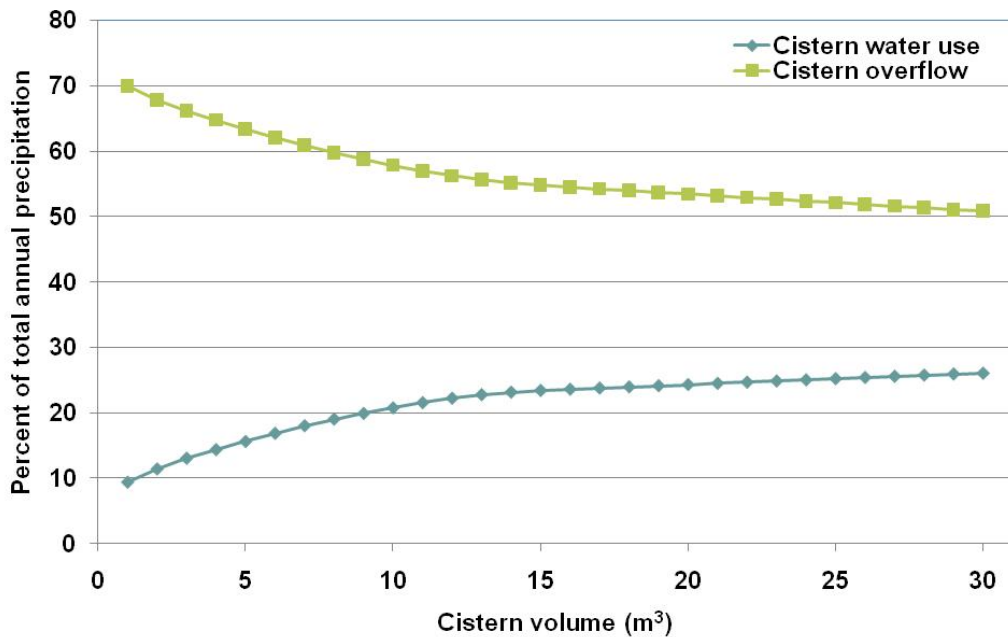
**Figure 5.9:** Model estimates of cistern water use and cistern overflows in relation to cistern volume for the high rise apartment building.<sup>3</sup>

<sup>3</sup> The model was altered such that municipal make-up was provided only when needed, rather as a set volume added to the cistern. This allowed for a range of cistern sizes to be modelled.

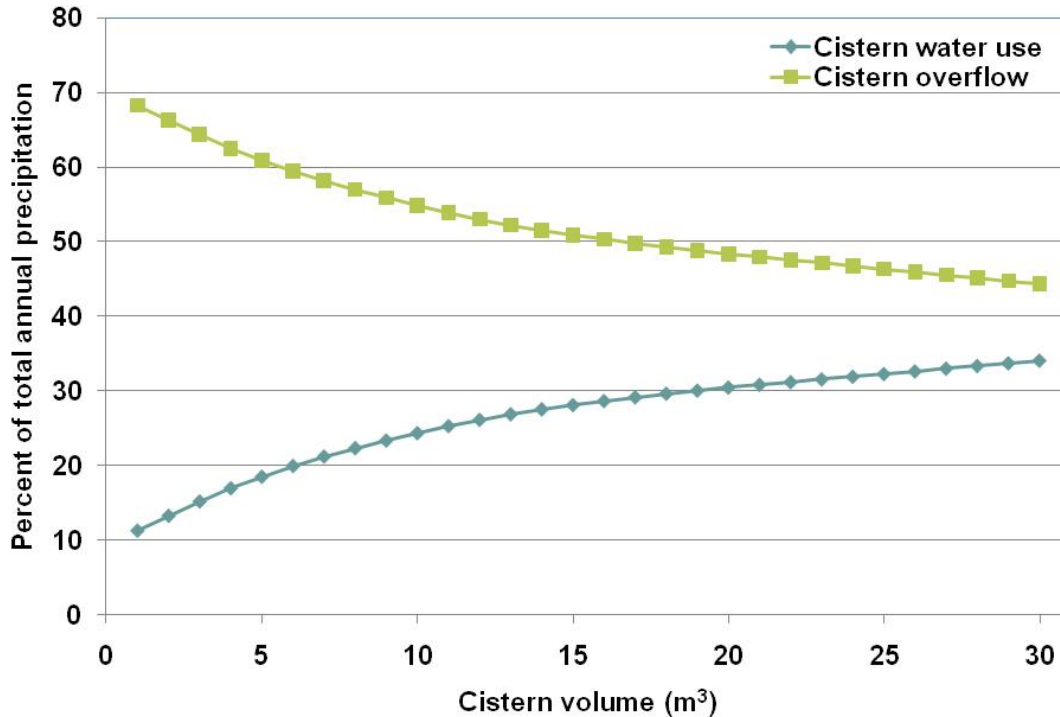
**Figure 5.10:** Model estimates of cistern water use and cistern overflows in relation to cistern volume for the public school.

The public school system was found to be considerably oversized with an optimal size just over half that of the existing available rainwater storage. The curves for the school are flatter than the other sites, resulting in lower incremental rates of improvement as cistern size increases. This can be caused by a number of factors including the inter-relationship between catchment size, cistern size and water demand, as well as by the pattern of water use in relation to the supply of rainwater to the cistern. Both the high rise and public school systems have the capacity to incorporate additional future uses if available.
