Restoration Services Centre Facility

CASE STUDY

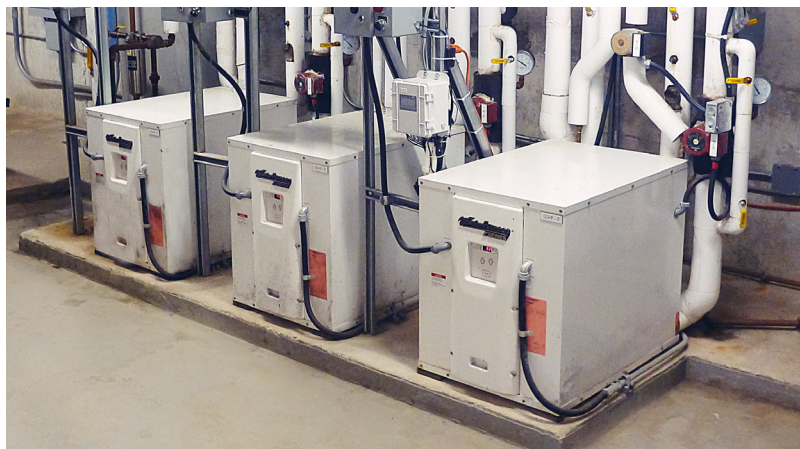
Figure 1. Three water-to-water heat pumps in the basement mechanical room of the Restoration Services Centre facility.

The Restoration Services Centre is a 12,000 ft² two-storey building that includes both office space and a garage. The geexchange system is composed of three 5-ton water-to-water heat pumps, each having its own slinky-style horizontal ground loop. The heat pumps operate in parallel to charge a buffer tank that provides heated or chilled water used for radiant in-floor heating and forced-air cooling. The radiant system also provides supplemental cooling under certain conditions. The system is controlled by a building automation system (BAS). The garage is not connected to the geexchange system and is heated using natural gas radiant tube heaters. This area is maintained at 12°C since the doors are opened frequently.

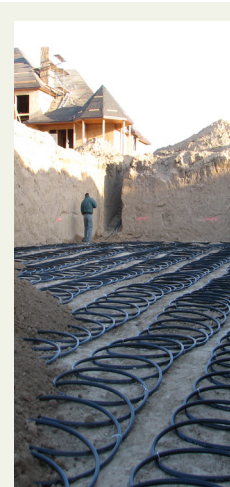
Horizontal ground loops are often the cost effective option in situations where there is ample space available. There are different types of horizontal ground loops including two-pipe, four-pipe, six-pipe and slinky-style designs.
