# University of Toronto Scarborough Campus CASE STUDY

## Featured practice:

- Bioretention
- Dry pond

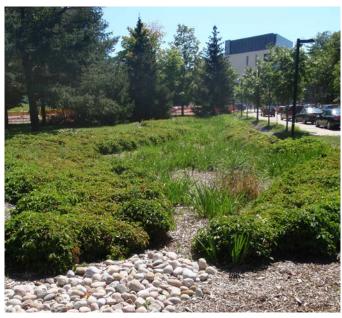
Figure 1. Original bioretention at the west campus entrance traffic loop Prior to the East Arrival Court retrofit, which increased the impervious area by 1.5%, the area was comprised on four parking lots. The existing conventional stormwater infrastructure was retrofitted to accommodate the Low Impact Development (LID) designs. The water balance objective - retention of a 5 mm rainfall event on site - is met through the use of the LIDs. Soil testing for the site indicated that the soils located below the parking surfaces were appropriate for infiltration measures. As well, groundwater drilling indicated rather low groundwater levels that would allow for proper operation of the bioretentions. parking area, passenger pick-up/drop-off area and dedicated bus terminal

The retrofit of the EAC is one of the many initiatives that the university has undertaken to green their campus and make sustainability a priority. The campus is home to four LEED certified buildings: the Student Centre (Silver), the Instructional Centre (Silver), the Pan Am Sports Centre (Gold) and the Environmental Science and Chemistry building (ESCB, certified Gold). The buildings contain a variety of green energy features, from solar panels to geothermal systems to earth tubes, as well as sustainable water technologies for reduced consumption and improved runoff management. The Low Impact Development (LID) practices that have been incorporated into buildings on campus include two rainwater harvesting systems, four green roofs and an infiltration gallery that receives excess stormwater from the ESCB and the Instructional Centre. Also on the campus at the west entrance is a large, well-established bioretention area which was constructed in 2004.

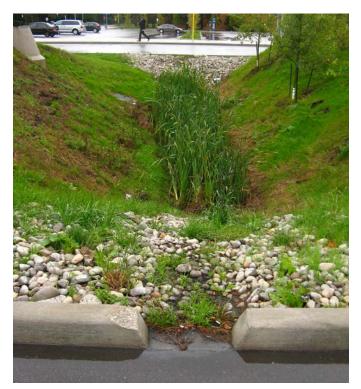
Figure 3. Dry pond in the centre of the EAC bus loop

A dry pond was constructed the centre of the bus loop to receive all flows from the curb inlets around the bus loop, as well as overflows from two of the bioretention areas. The pond has a storage area of 1200 m2 and provides a storage volume of 1,120 m3, which exceeds the site stormwater management requirements. It provides stormwater runoff attenuation and infiltration and improves water quality by providing an opportunity for sediment deposition, filtration and pollutant uptake by plants. When the dry pond reaches its storage capacity, excess water is directed to depression storage in a wooded area through the storm sewer.

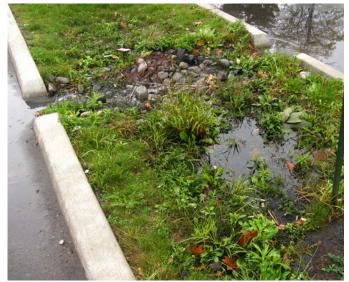
Figure 4. Bioretention inlets in parking lot traffic islands

A total of four bioretention areas are located within the East arrival court, providing a total of 470 m3 of stormwater storage. Along the perimeter of the parking lots on the east and south sides, two bioretention areas discharge overflows to the sewer system which in turn discharges to Highland Creek. The remaining two bioretentions located within traffic islands in the visitor parking lot and curb inlets around the bus loop convey excess flows into a dry pond.
