# **POWER QUALITY ASSESSMENT OF SOLAR PHOTOVOLTAIC INVERTERS**

The Living City Campus, Vaughan, Ontario

Final Report

January 2016

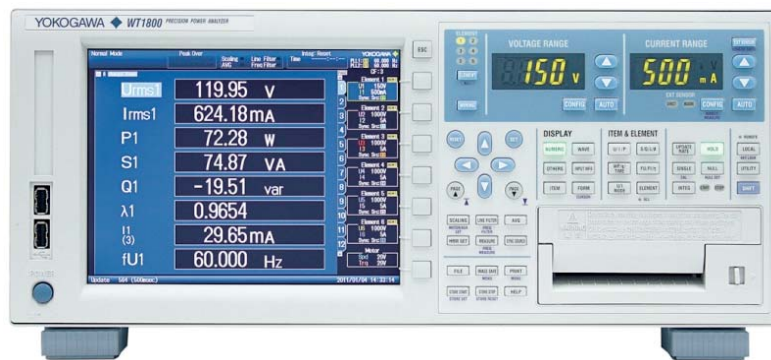
**Figure 2.1:** The Yokogawa WT180 PQA is a high-end bench-top PQA used in this study.

The Yokogawa WT1800 (Figure 2.1) is a high-end bench-top PQA. It has direct inputs up to 50A and is capable of measuring both AC and DC power with a basic accuracy of  $\pm 0.1\%$ . It is equipped with high-frequency waveform capturing, produces parameterized power quality metrics up to the 500<sup>th</sup> order and can operate with logging intervals as short as 50 ms.

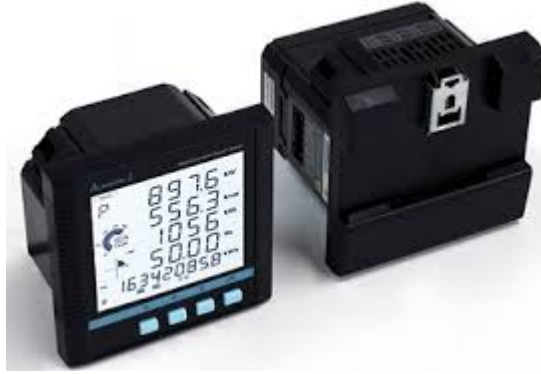
**Figure 2.2:** The Acuvim IIW PQA was used to monitor power quality at partner sites.

The Acuvim IIW (Figure 2.2) is a low-cost power meter designed with a wide-range of functionality useful for power quality measurement applications. It can act as a networked device, communicating using Modbus TCP/IP, or act as a standalone datalogger. It integrates with additional I/O modules, expanding its functionality beyond that of a power meter. It has waveform capturing that can be triggered manually or based on pre-configured power quality events. Importantly, it produces harmonic distortion parameters up to the 63<sup>rd</sup> harmonic. In this project, the Acuvim IIW was integrated into a portable instrumentation box with an uninterruptible power supply, IMT PV irradiance sensor and cellular modem, to be deployed at partner sites.

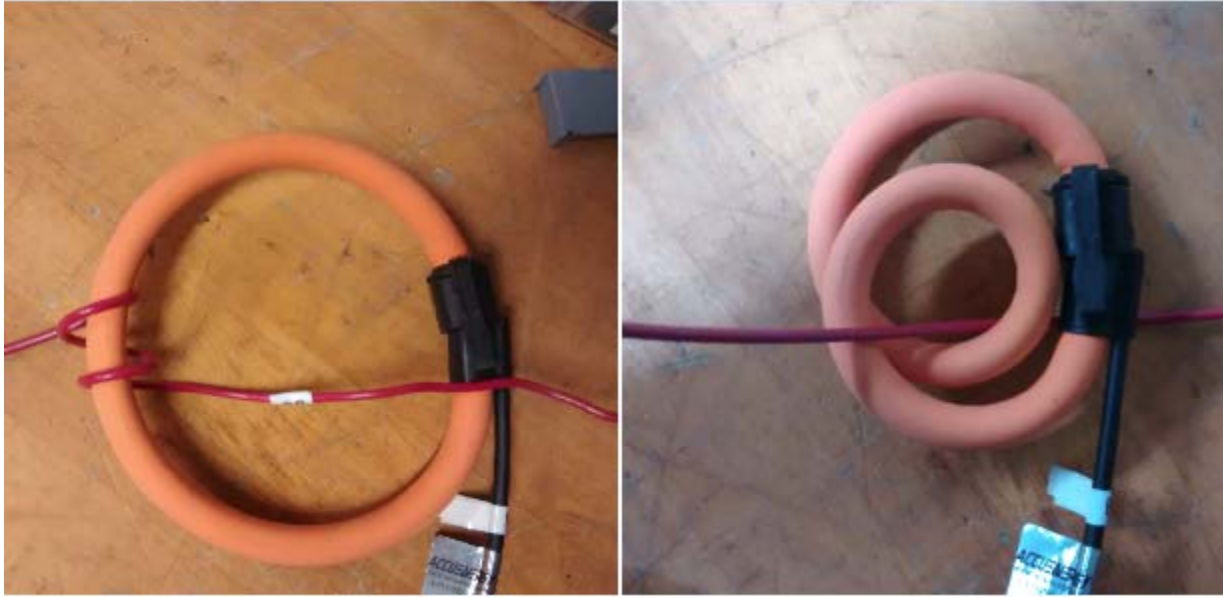
**Figure 2.3:** The magnitude of the current was increased by either (left) wrapping the wire around the CT or (right) wrapping the CT around the wire.

For the purposes of verification, the remote monitoring boxes using the Acuvim IIW PQA were used in parallel with the Yokogawa WT1800 to monitor the power quality of a PV installation at the Living City Campus (LCC). This is described in greater detail in Appendix B, which shows that there is good agreement between the Acuvim IIW and the Yokogawa WT1800 for all parameters except for the harmonic current measurements when the harmonic current magnitude is small. To improve the current harmonic distortion readings of the Acuvim IIW, STEP worked with Accuenergy to upload custom firmware to the Acuvim IIW devices and then one of two approaches were taken: (i) where possible, additional wire wraps around the CT were used, increasing the current magnitude; and (ii) where additional wire wraps were not possible, the flexible CT itself was wrapped around the wire an additional time, having the same effect. This is illustrated in Figure 2.3.

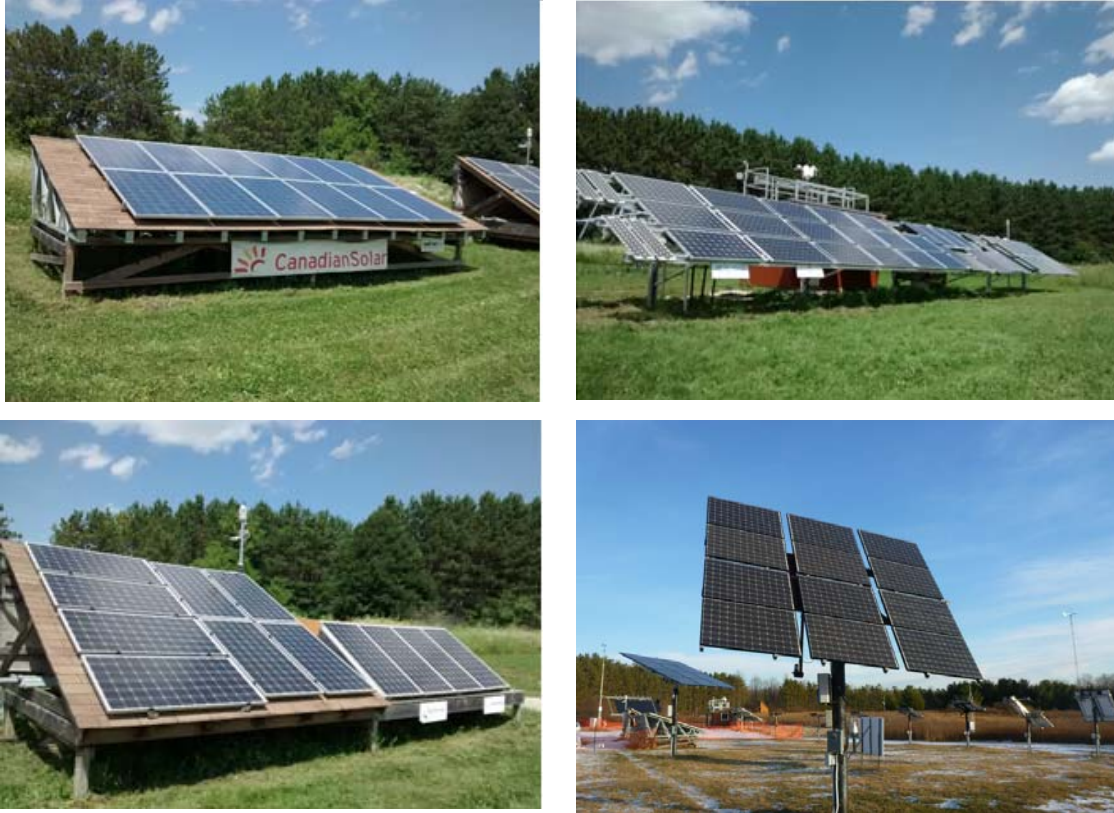
**Figure 3.1.2:** Travelling clockwise from the top left, example PV arrays connected to Inverters A to D are shown, respectively. In the case of Inverters C and D, there are actually multiple inverters and therefore, those presented here are not exhaustive of all inverters on the property.

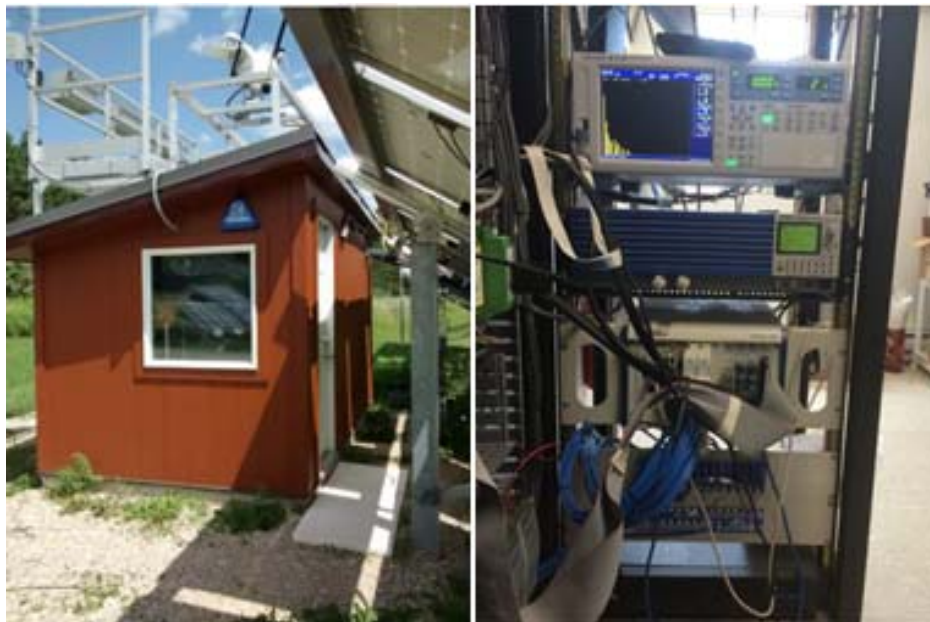
**Figure 3.1.3:** (Left) A small hut housing PV instrumentation is the primary load on the section of the EPS being monitored for power quality. (Right) The Yokogawa WT1800 is installed on a server rack within the hut.

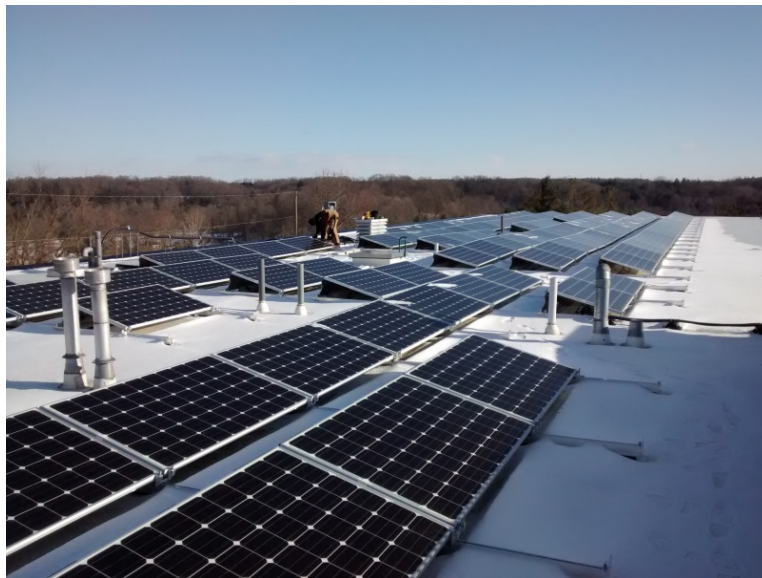
**Figure 3.2.1:** The Restoration Services Centre facility has a 38.9 kW rooftop PV array.

The TRCA Restoration Services Centre (RSC) Facility is located in Vaughan, ON. The rooftop PV installation was mounted in December, 2015 (Figure 3.2.1). The system is grid-connected under a feed-in tariff (FIT) contract and uses inverters from the same brand, although a newer model, as Inverter D in Section 3.1. For simplicity, the inverters used in this installation will also be referred to as Inverter D. These are single-phase inverters but they make a three-phase 208 V output by connecting them in a delta configuration where individual inverters provide 208 V across two of the lines. System specifications are given in Table 3.2.1.

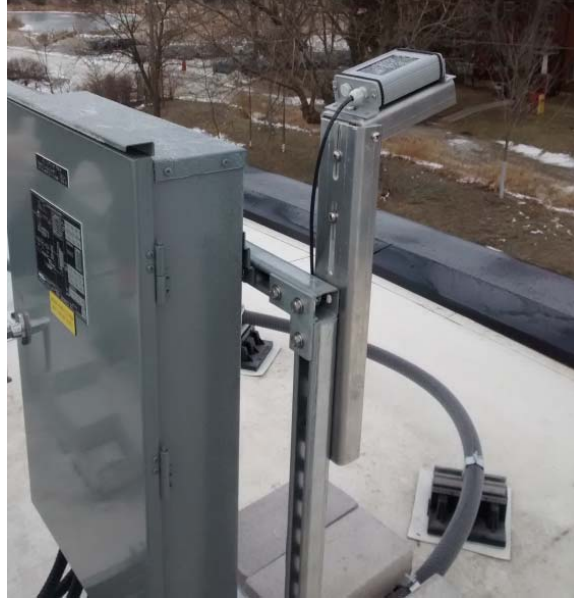
**Figure 3.2.3:** A plane-of-array irradiance sensor is installed on the roof-top adjacent to the AC combiner panel.

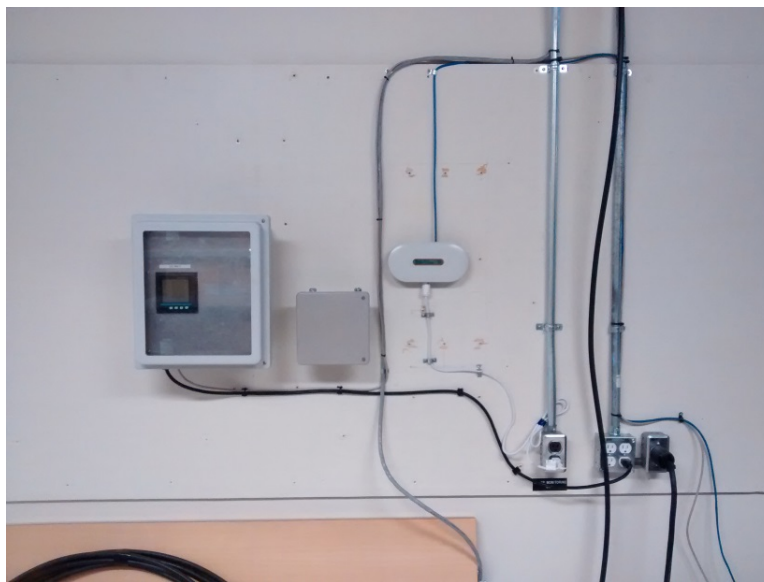
**Figure 3.2.4:** Sensor wires from the rooftop combiner panel penetrate through the roof to terminate at an instrumentation box mounted indoors.

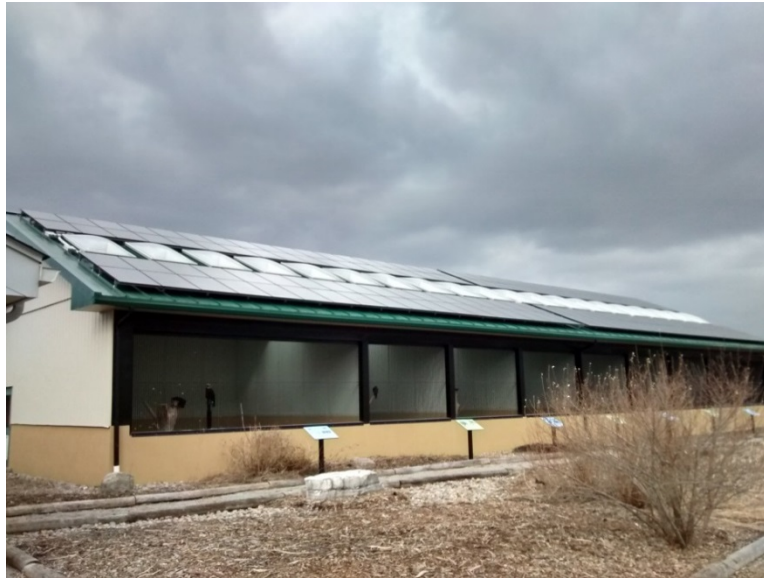
**Figure 3.3.1:** The Aviary building of the Earth Rangers Centre for Sustainable Technology has a 30 kW rooftop PV installation.

The 30kW PV installation, completed in 2007, is installed on the rooftop of the aviary at the Earth Rangers Centre (ERC) for Sustainable Technology in Vaughan, ON (Figure 3.3.1). The system uses 6 single-phase inverters connected in a 3-phase 208 V configuration. System specifications are given in Table 3.3.1.

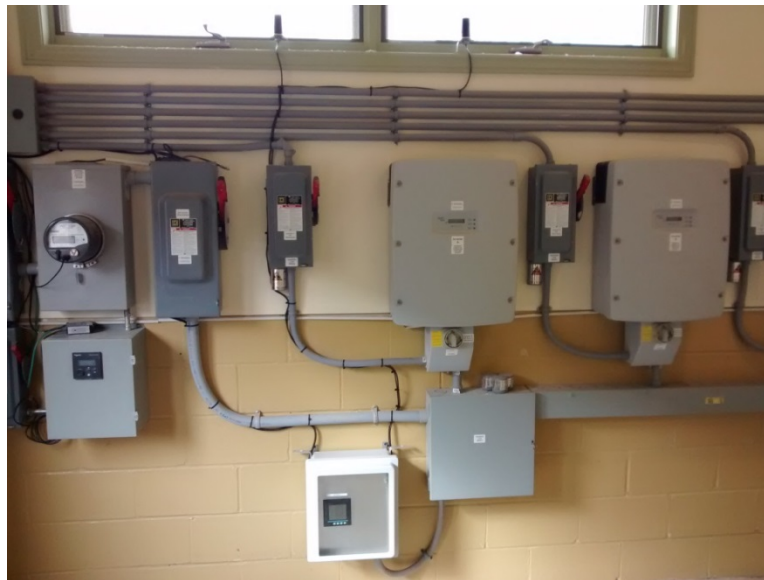
**Figure 3.3.3:** The monitoring instrumentation is installed to the bottom left of the combiner panel. Current is measured using a Rogowski coil CTs wrapped twice around the wire.

The remote monitoring PQA (Figure 3.3.3), was installed in March 2015. Data were acquired remotely using a cellular modem. The measurement is on the secondary side of the transformer rather than the primary because the transformer is the property of the LDC. Irradiance data were available from both of the other two sites installed on the same grounds, within approximately 1 km from each other, and therefore irradiance instrumentation was not installed at this location.

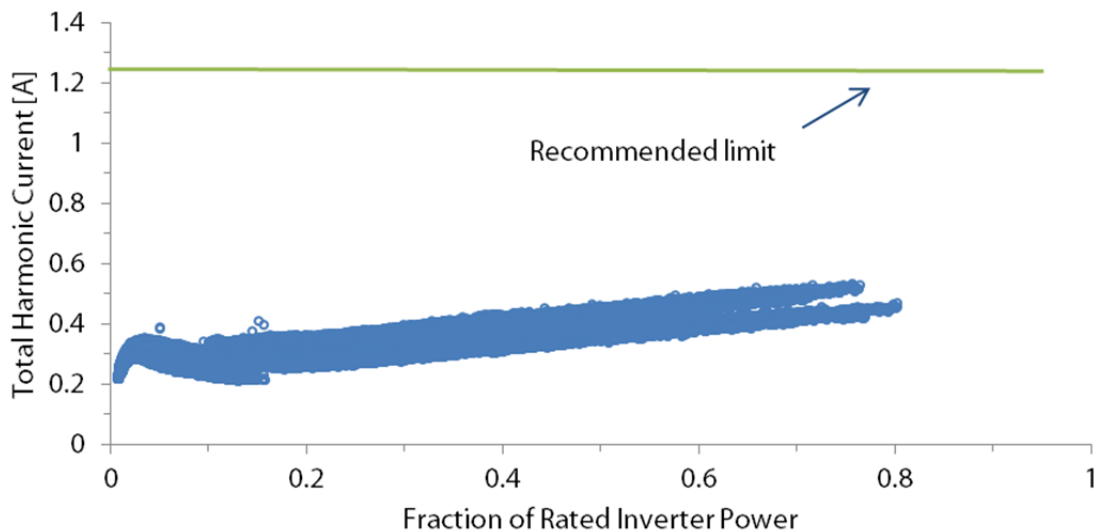
**Figure 5.1:** The total harmonic current limit specified in Table 3.1.3 is never exceeded between March 1<sup>st</sup>/2015 to March 15<sup>th</sup>/2015. Note that the rated current is 25 A. This plot is representative of the entire one year monitoring interval.

Figure 5.1 plots the total harmonic current ( $I_H$ ) as a function of the fraction of rated inverter power for March 1<sup>st</sup>/2015 to March 15<sup>th</sup>/2015. The rated current of the inverter is 25 A. Each data point represents 200 ms of operation. Note that the fraction of rated inverter power is simply the power produced by the inverter at a given point in time divided by the rated power. A small window of time was used in this plot because Microsoft Excel is limited to plotting approximately a million data points. At no point in time during this period did the harmonic current exceed the recommended limit.

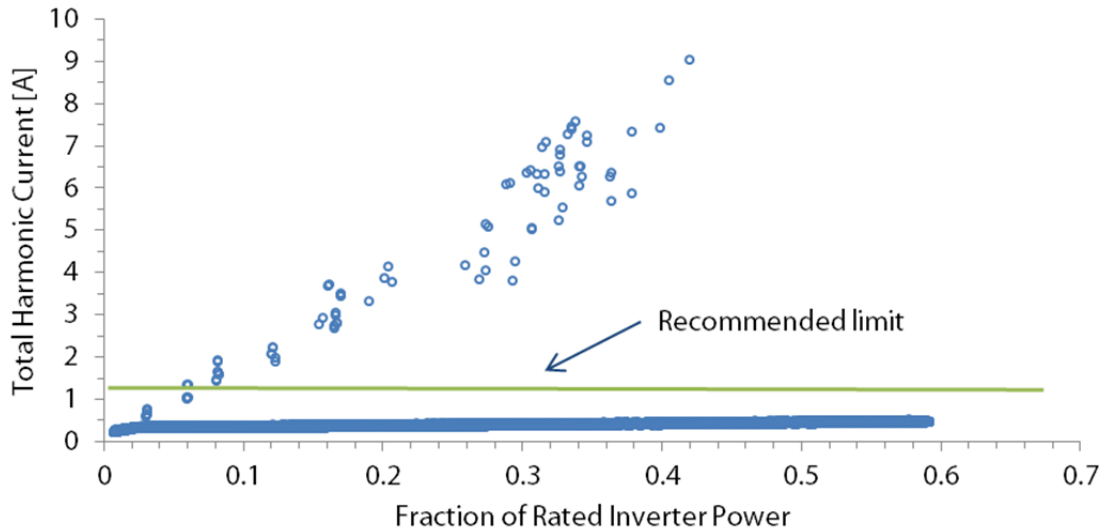
**Figure 5.2:** There were a small number of occurrences in March 2014 where the total harmonic current exceeded recommended limits. This happened in short (approximately 200 ms) intervals during a two-day period and was due to very high harmonic voltages on the network.

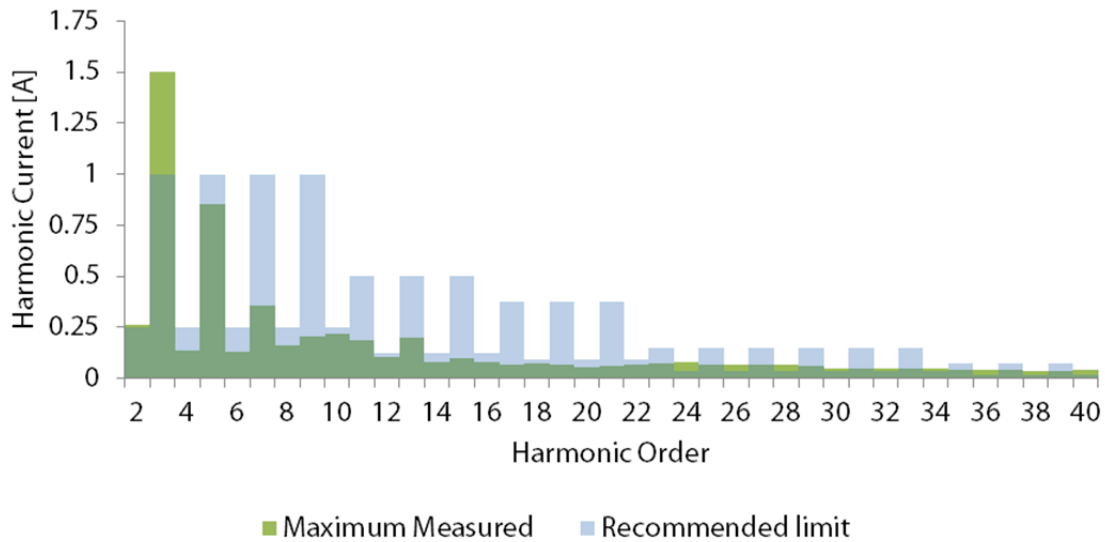
**Figure 5.3:** For March 2015, the maximum measured harmonic current (green) up the 40<sup>th</sup> order is compared with the recommended limits from Table 3.1.3 (blue). The maximum value exceeded the recommended limit for some harmonic orders but this occurs less than 0.006% of the time for any given month.

Figure 5.2 plots the maximum observed individual harmonic current up to the 40<sup>th</sup> harmonic order observed during March 2015 and compares it to the suggested limits shown in Table 3.1.3. The maximum measured value, shown in green, exceeds the suggested limit for several harmonics that are above the 23<sup>rd</sup> order. However, across all months, this occurs with a frequency less 0.006% of the time. There is an apparent discrepancy in that Figure 5.3 shows a 3<sup>rd</sup> order harmonic current as high as 1.5 A while Figure 5.1 shows a total harmonic current that does not exceed 0.6 A. This is due to the fact that 3<sup>rd</sup> order harmonic currents this large are extremely rare and Figure 5.1 only plots a two week window of time. Within this window, the 3<sup>rd</sup> harmonic never exceeded the recommended limit. When the third order harmonic current reaches 1.5 A, it would in fact push the total harmonic currents passed recommended limits – this was just never caught by only looking at two week subsets from each month as was done in the analysis.

It should be noted as well that the over-limit occurrences for the third harmonic order could not be explained in terms of harmonic voltages on the network. This is because further analysis showed that the high 3<sup>rd</sup> order harmonic current emissions occurred when the voltage THD was approximately 3.5%. Since 1.5 A of 3<sup>rd</sup> order harmonic current would on its own represent a current TDD of 6% for this installation, it is not plausible that this high level of current harmonic emission could be explained by a correspondingly low-level of voltage distortion. To summarize, the inverter itself is responsible to some degree for over-limit occurrences but such occurrences are extremely infrequent.

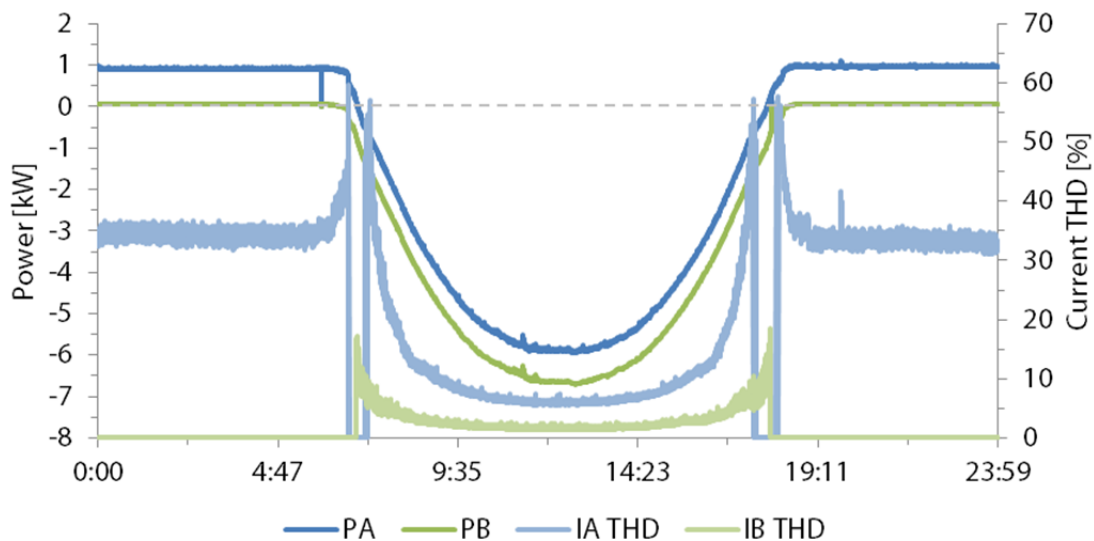
**Figure 5.2.1:** The overnight power consumption shows that the loads are connected to Line A. Line B does not have any apparent load until an air-conditioner begins to cycle on-and-off after April 1<sup>st</sup>/2015.

Data were collected between February 17<sup>th</sup>/2015 and June 22<sup>nd</sup>/2015 at metering point M1 in Figure 3.1.1. Within this time period, approximately 994 hours of data were collected. Figure 5.2.1 shows the power production and current THD for each phase of the 240 VAC split-phase connection over the course of a given day (March 28<sup>th</sup>/2015). It is clear from the overnight power consumption (displayed as positive power) that there are both loads and generation on Line A while it seems for Line B there is primarily generation. Further inspection showed that there is actually an air-conditioner on Line B that begins to cycle on and off after April 1<sup>st</sup>/2015.

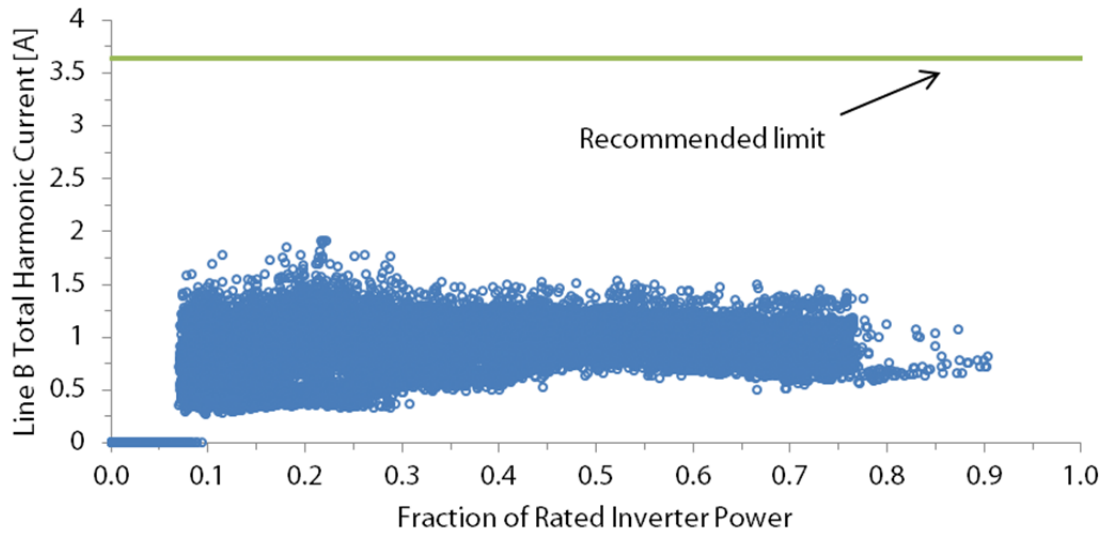
**Figure 5.2.2:** The total harmonic current from the various inverters installed on Phase B of the LCC EPS never exceeds the recommended limit.

Line B is useful for looking at the combined harmonic emissions of multiple inverters operating in parallel with only generation on the line. Figure 5.2.2 plots the total harmonic current as a function of the fraction of rated power at which the inverters are operating. The data have been filtered to include only daytime operation with voltage total harmonic distortion less than 5%. Data between February 17<sup>th</sup> and March 30<sup>th</sup> were used because during this time there were no loads on this phase of the connection. Collectively, the inverters operate at well under the 5% TDD limit (shown in green) illustrated in Table 3.1.2. Note that the rated current of all inverters is 72.9 A.

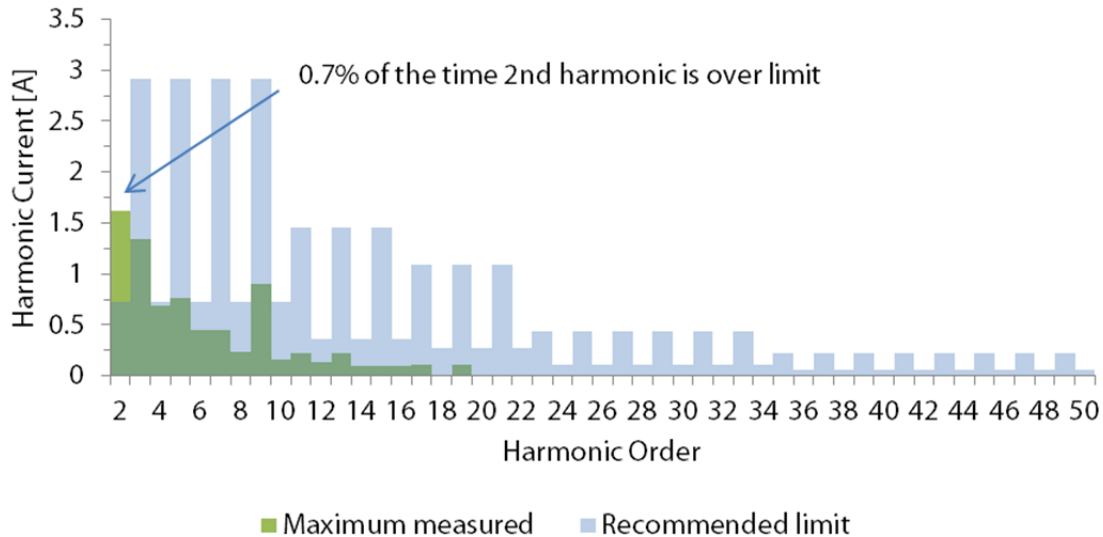
**Figure 5.2.4:** The maximum measured harmonic current for each harmonic order is compared against the recommended limits in the IEEE 1547. The 2<sup>nd</sup> order harmonic current exceeds recommended limits 0.7% of the time.

The harmonic current of each individual harmonic order on Phase B from February 17<sup>th</sup> and March 30<sup>th</sup> (ie. when there are no loads) was assessed against the recommended limits (Table 3.1.2) in Figure 5.2.4. This figure plots both the recommended limit (blue) and the maximum observed harmonic current measured (green) during the monitoring period. The second harmonic order was the only harmonic order observed to exceed the recommended limit and this occurred approximately 0.7% of the time. It was also found that there were no second order harmonic voltages present on the EPS that might have contributed to the second order harmonic current emissions – pointing to the fact that these current emissions are in fact due to inverters on the network.

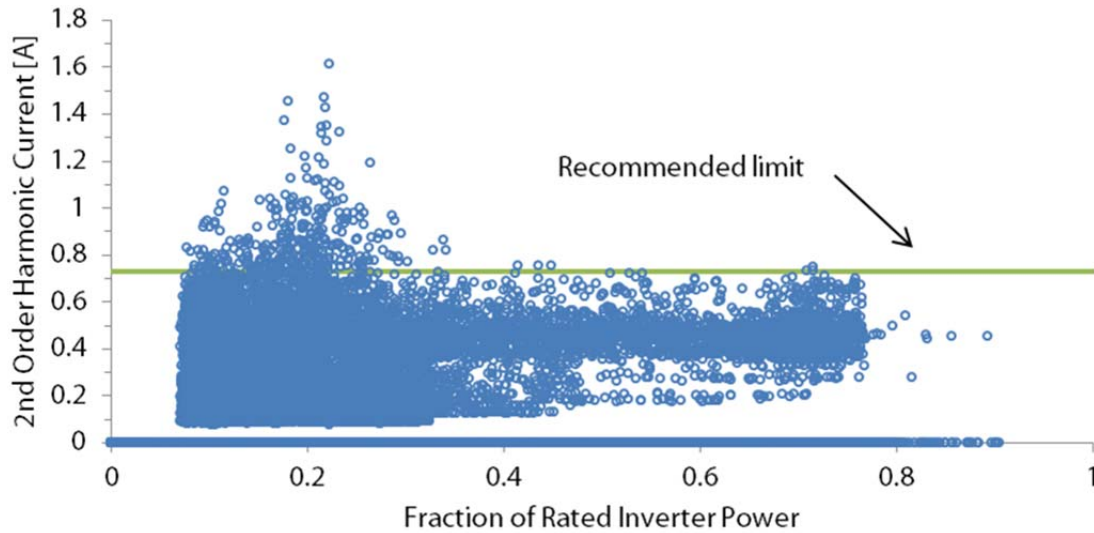
**Figure 5.2.5:** The 2<sup>nd</sup> order harmonic current is sometimes exceeded when the inverters are operating at less than 30% of their collective rated power.

To better understand those situations in which the 2<sup>nd</sup> harmonic order exceeded the recommended limit, Figure 5.2.5 plots the Line B second order harmonic current as a function of the fraction of rated power at which the inverters were operating. Again, data points were instantaneous, taken every 10 s. High harmonic currents were most frequently observed at less than 30% of the rated power.

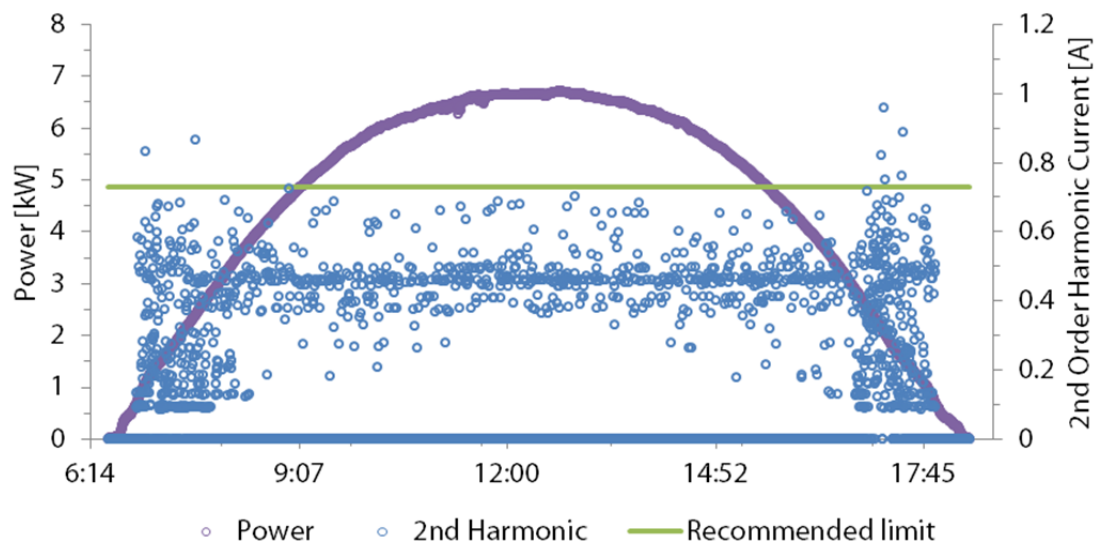
**Figure 5.2.6:** Second order harmonics are worst under low power generation conditions but do appear periodically throughout the day.

Figure 5.2.6 plots the second order harmonic current over the course of a clear sky day. The harmonics are most pronounced in the morning and evening but they are also observed periodically throughout the day in steady irradiance conditions, although during the day they were still under recommended limits.

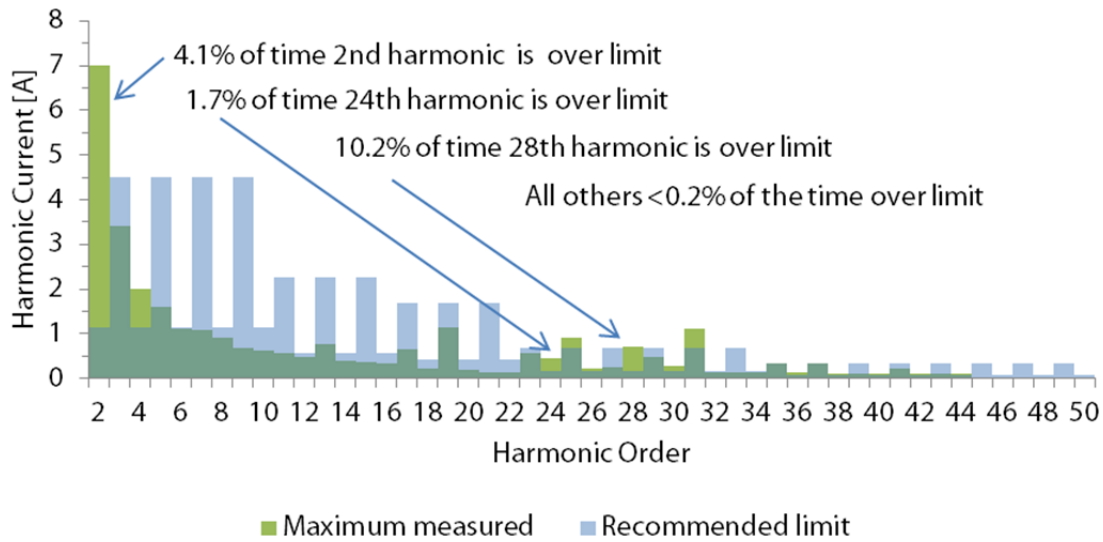
**Figure 5.3.2:** The maximum observed harmonic current is compared against the recommended limit for each harmonic order. The limits are surpassed for several harmonic orders.

Figure 5.3.2 compares the individual harmonic orders against the recommended limits in Table 3.3.2. It plots the maximum harmonic current observed during the monitoring period. Where the maximum is greater than the recommended limit, the figure notes the frequency that the data exceeds the limit. This percentage is in reference to daylight hours where power was being produced and the total harmonic voltage was below 5%. The 2<sup>nd</sup>, 24<sup>th</sup> and 28<sup>th</sup> harmonic currents exceed recommended values approximately 4.1%, 1.7% and 10.2% of the time, respectively. These occurrences did not coincide with corresponding voltage harmonics on EPS, at each of the given orders, and are therefore related to the inverter operation rather than harmonic voltages on the EPS.

Figures 5.3.8 to 5.3.10 provide additional insight towards understanding the results presented in Figures 5.3.1 to 5.3.4. The high harmonic emissions shown in Figures 5.3.1 to 5.3.4 were observed in steady irradiance conditions with low harmonic voltage content, across a large range of inverter power outputs. Yet, the inverters are listed as compliant with both *IEEE 1547* and *CSA 257*. This installation is clearly showing harmonic emissions above what should be expected and at first glance it is not clear why. Figures 5.3.8 and 5.3.9 confirmed to some extent that the Inverter D microinverters are in fact compliant with the power quality limits at 33%, 66% and 100% of rated load. However, it was shown that the harmonic emissions are very high below 20% of rated load.

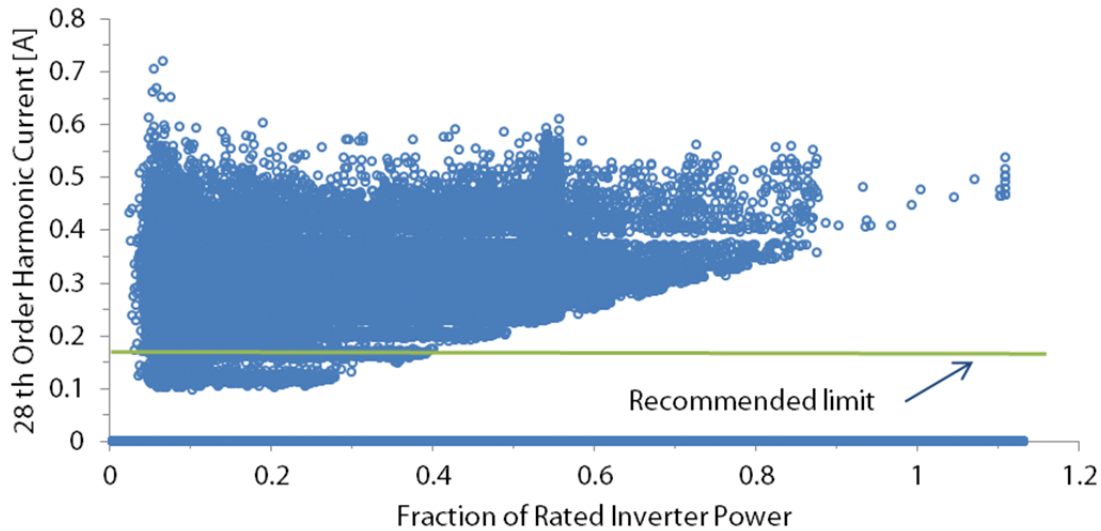
**Figure 5.3.4:** The 28<sup>th</sup> order harmonic current is within the recommended limit 90% of the time.

Figure 5.3.4 plots a similar trend for the 28<sup>th</sup> order harmonic current. In this plot, approximately 90% of the data resides below the green line that signifies the recommended limit.

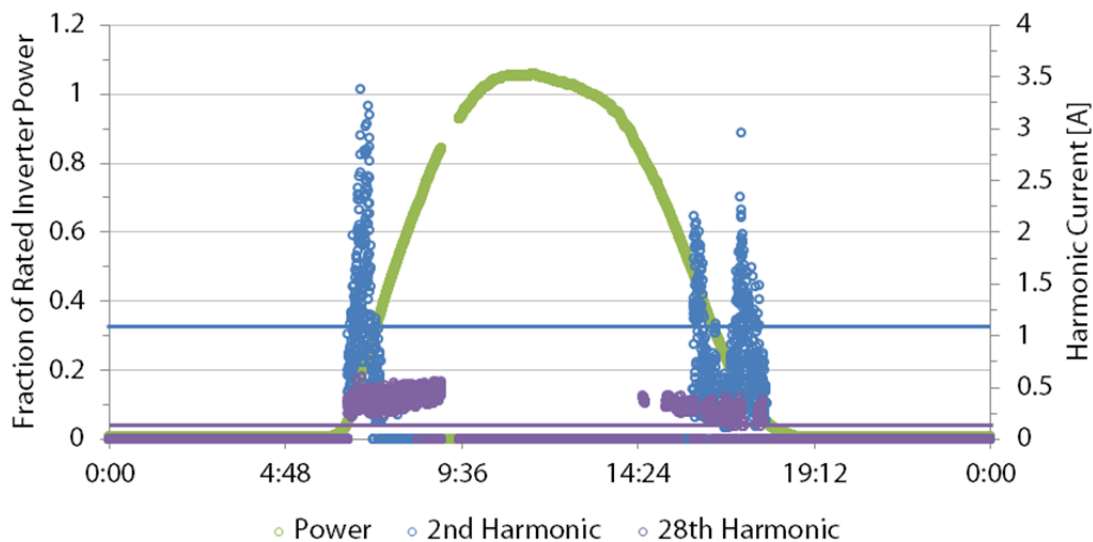
**Figure 5.3.5:** The recommended limit for the 2<sup>nd</sup> and 28<sup>th</sup> is shown as blue and purple lines respectively. The 2<sup>nd</sup> harmonic occurs only at low values of power production. The 28<sup>th</sup> order harmonic does not appear to occur at all once the inverters exceed approximately 80% of their collective rated power.

The high emissions observed in Figures 5.3.1 to 5.3.5 can be explained by noting the fact that the Restoration Services Centre Facility PV installation has modules oriented both vertically on a curtain wall and also at shallow tilt angle on the roof. As a result, the microinverters are not all producing the same level of power. It is feasible that as the sun position changes or if there is shading, some modules will be producing above 20% of the rated load and some, below 20% of rated load, even though the total combined power output itself may be much higher than 20% of rated load.

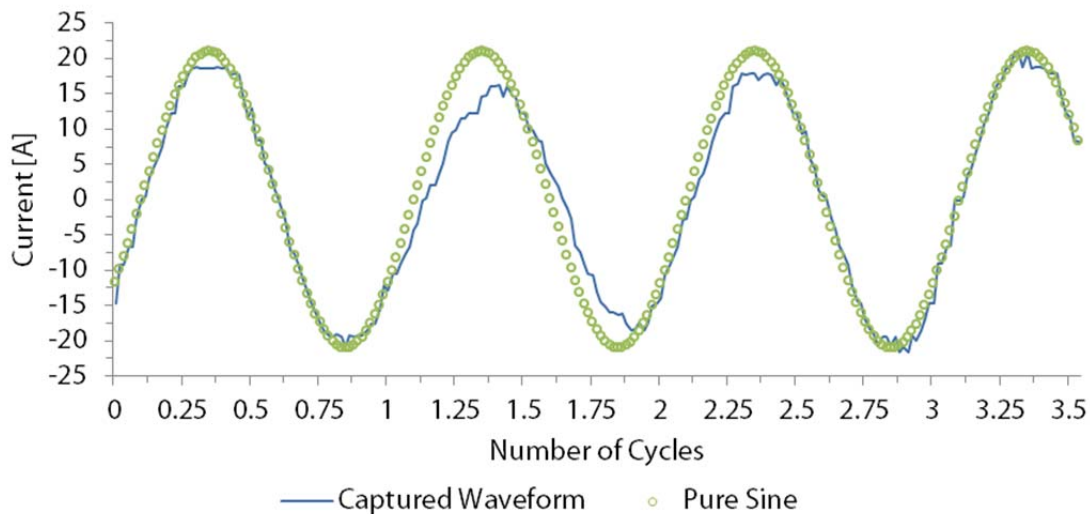
**Figure 5.3.7:** A waveform capture, taken at low operating power, from the Restoration Services Centre Facility shows high harmonic content. The rippling is caused by small magnitude higher order harmonics while the waveform deformation is due to lower order, higher magnitude, harmonic content within the waveform.

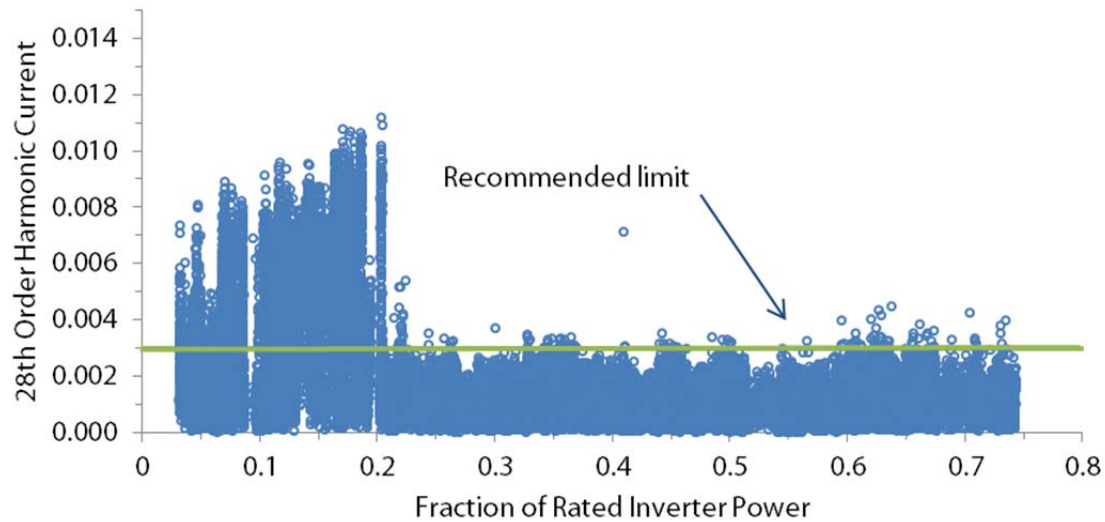
**Figure 5.3.9:** The 28<sup>th</sup> order harmonic current of two Inverter D microinverters operating parallel is very high below 20% of the rated load.

Figure 5.3.9 shows the 28<sup>th</sup> order harmonic as a function of the fraction of rated power from the same time period. According to Table 1.1, the 28<sup>th</sup> order harmonic current should not be greater than 0.15% of the rated current. It follows that for the 2 A rated inverter current, the 28<sup>th</sup> order harmonic current should be limited to 0.003 A. The same trend as in Figure 5.3.8 is present. The harmonic current is generally below the recommended limit above 20% of rated load but can be as much as approximately 4 times the recommended limit below 20% of rated load. These measurements were taken with a voltage total harmonic distortion that was below 5%.

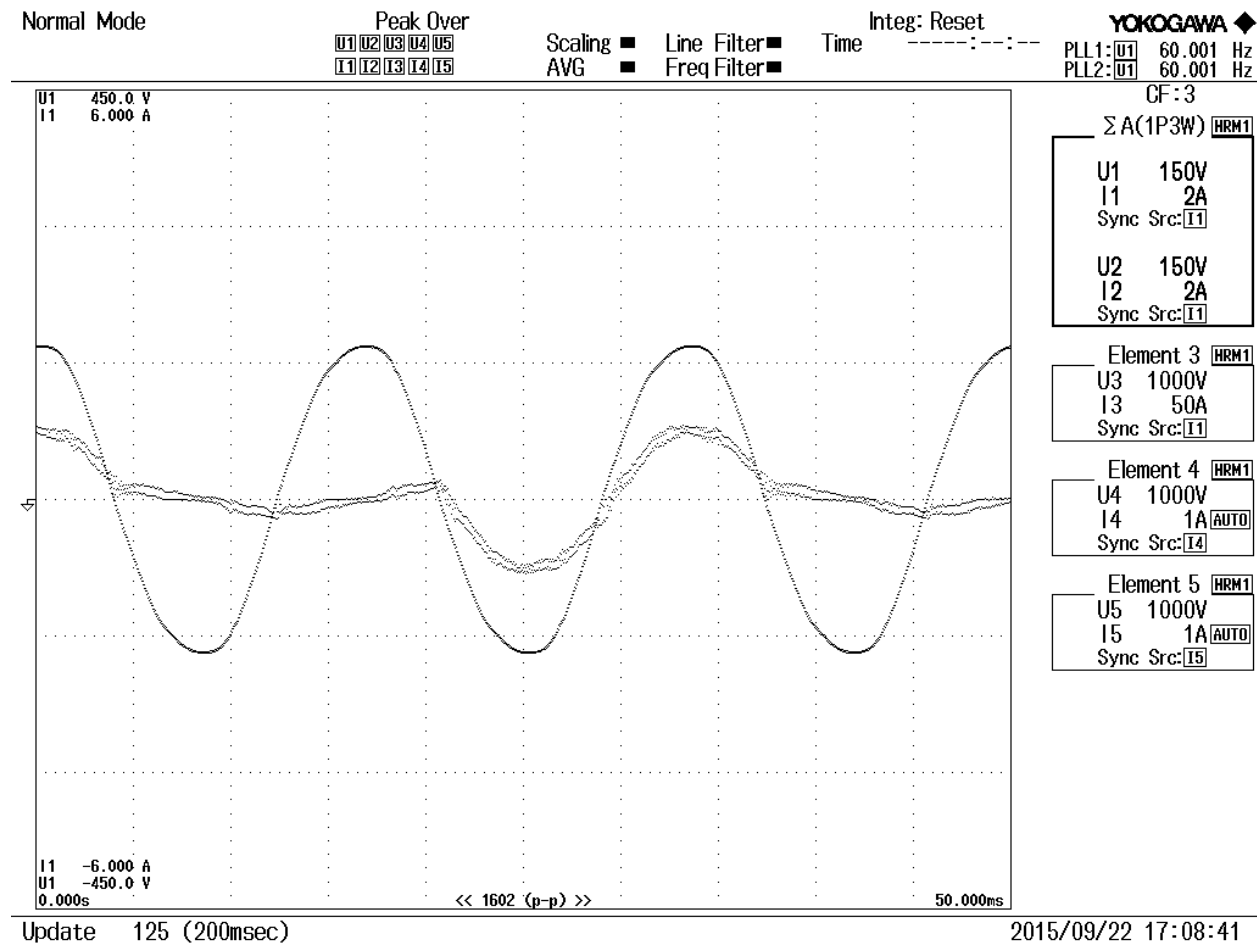
**Figure 5.3.10:** A snapshot of the current and voltage produced by the two Inverter D brand microinverters demonstrates that the current waveform has high levels of harmonic distortion at low load. Voltage is measured from the neutral to one leg of the split-phase connection and is shown to be approximately sinusoidal.

As an example, a screen capture of the high harmonic emissions observed at low power is given in Figure 5.3.10. Shown are both the voltage and current waveforms. The voltage waveform is sinusoidal with low harmonic content but the current waveform has very high harmonic content. The current waveform is non-sinusoidal and the RMS current value, as taken over the time range given in the waveform capture, would need to be determined using integration. However, a simple inspection shows that the waveform peaks at instantaneous current values of  $\pm 1$  A. It follows that a notable distortion of waveform is occurring at non-negligible current values.

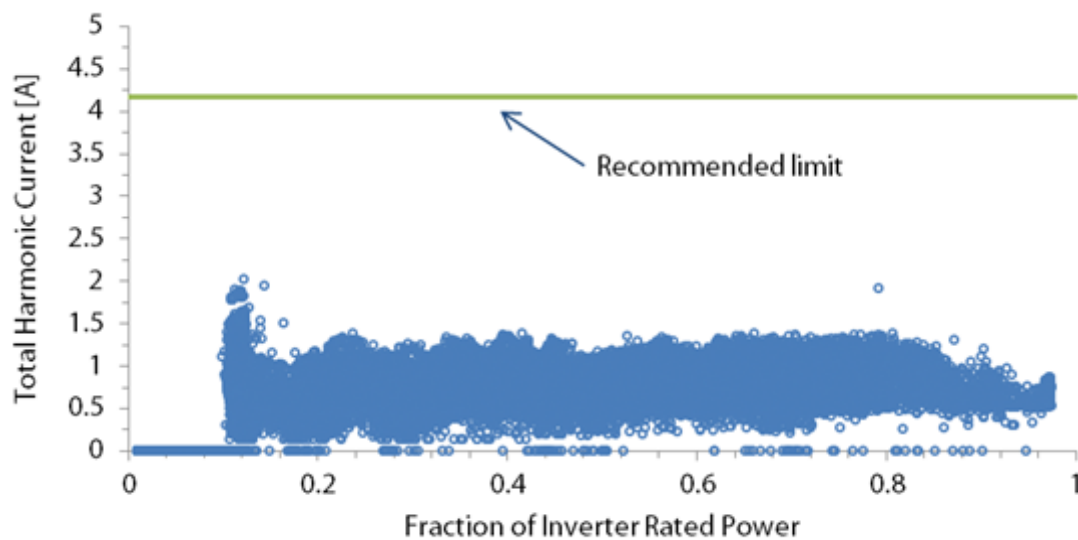
**Figure 5.4.1:** The total harmonic current is well under the 5% recommended limit.

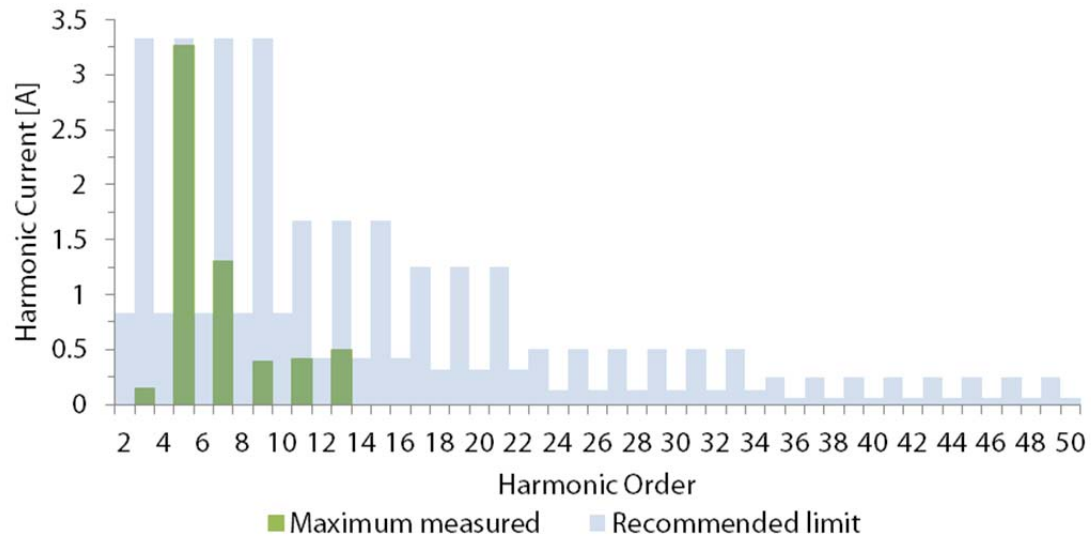
**Figure 5.4.2:** The recommended harmonic current limits for each harmonic order (Table 3.3.2) are compared against the maximum harmonic current measured for each harmonic order during the monitoring period. All harmonic currents were within recommended limits at all times.

Figure 5.4.2 evaluates the individual harmonic distortion factors against the recommended limits in the Table 3.3.2. It demonstrates that all values are within recommended limits at all times.

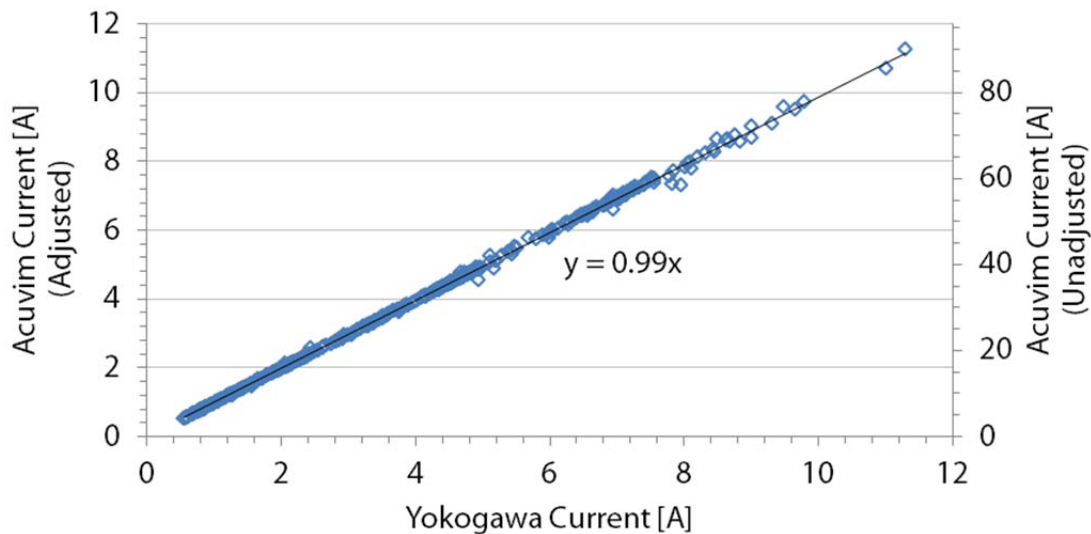
**Figure B.1:** The current measurements of the two instruments agree to within 1%. Wire wraps around the Acuvim IIW's Rogowski coil CT were used to increase the devices accuracy in the low current range. The “Unadjusted” values are the raw measurements read by the Acuvim IIW while the “Adjusted” value is the actual current (i.e. the “Unadjusted” value divided by the number of wire wraps).

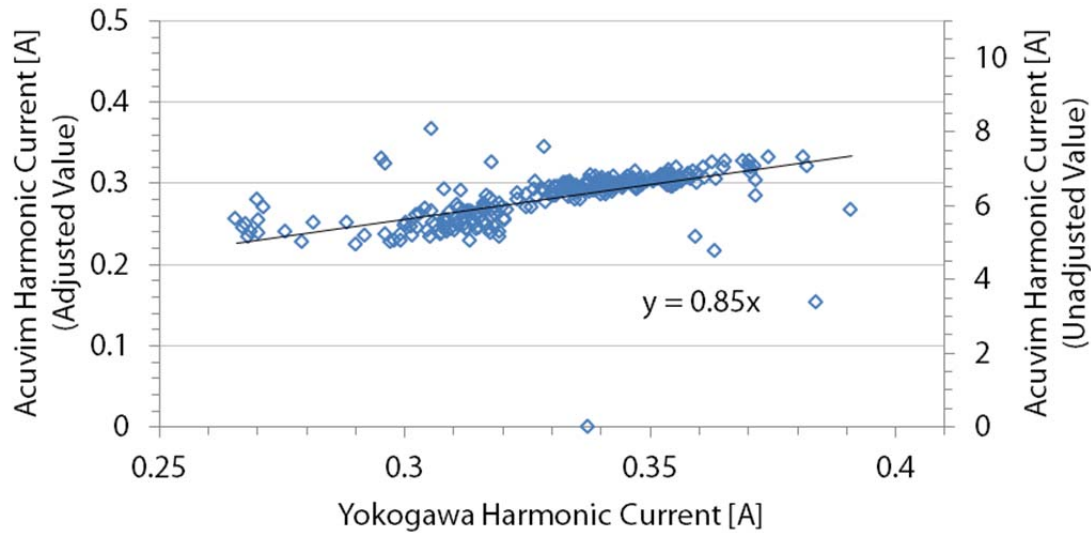
**Figure B.2:** The total harmonic current measurement of the Acuvim IIW is approximately 15% lower than that from the Yokogawa WT1800 when the unadjusted harmonic current is between 4 and 8 A.

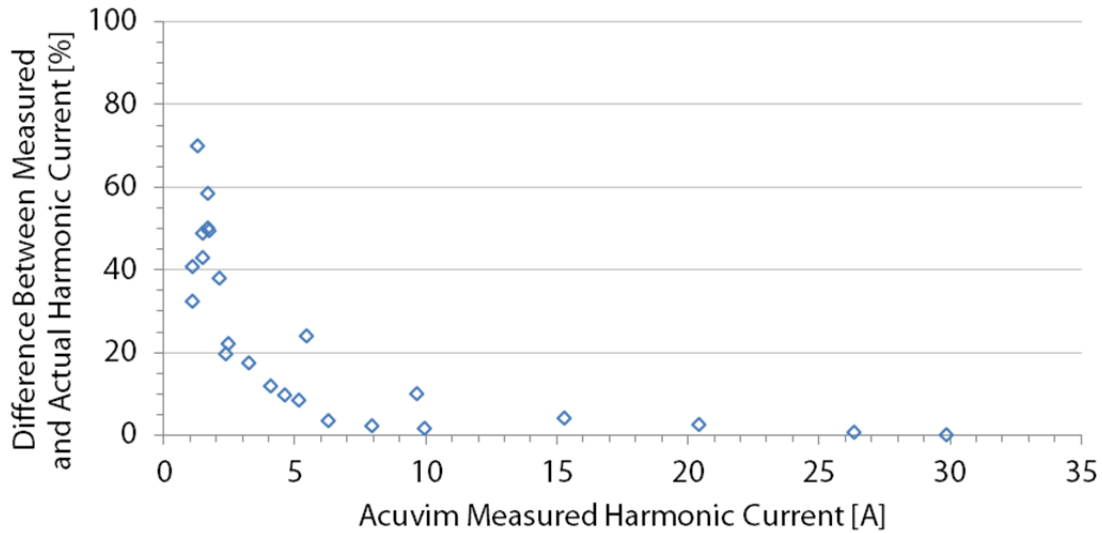
**Figure B.3:** The difference between the estimated actual total harmonic current and that measured by the Acuvim IIW is large when the magnitude of the measured total harmonic current is small. The Acuvim IIW always reads lower than the actual value. Below a total harmonic current of approximately 3 A the Acuvim IIW's total harmonic current measurement is heavily attenuated.

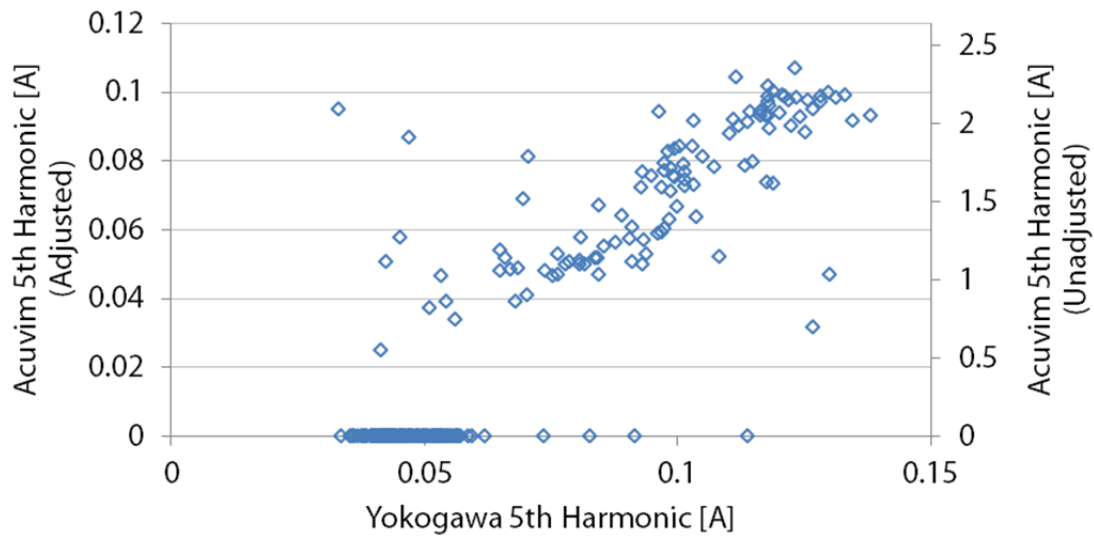
**Figure B.5:** The 5<sup>th</sup> order harmonic current measurement of the Acuvim IIW is notably attenuated from the Yokogawa WT1800 when the unadjusted harmonic current is between 0.5 and 2.5 A.
