# Anionic Polyacrylamide Hydraulic Dredging with On-site Disposal

## CASE STUDY

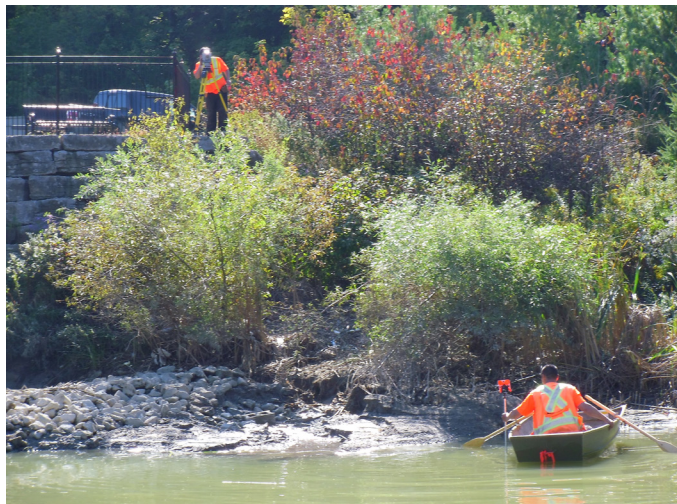
Figure 2. Field crew conducting a bathymetric survey of Pond 91 using a standard disk, rod and total station method.

An as-built survey was conducted in 2010 to establish a baseline bathymetry of the pond. Once the pond cleanout planning was underway, a bathymetric survey was conducted in 2013 utilizing sonar technology. It was determined that the sonar survey overestimated the volume of sediment that had accumulated in the pond, and thus the pond was re-surveyed using the disk and rod method (Figure 2). In this method, a flat disk is attached to a long metal rod, which is submerged in the water until the bottom of the disk is positioned relatively flat on the pond bottom. A GPS total station survey was utilized to obtain high resolution vertical and horizontal measurements of the disk through a reflector attached at the top of the disk. Based on the survey, it was determined that the total volume of sediment accumulated in the pond was 750 m<sup>3</sup>, which is equivalent to 48% of the permanent pool volume.

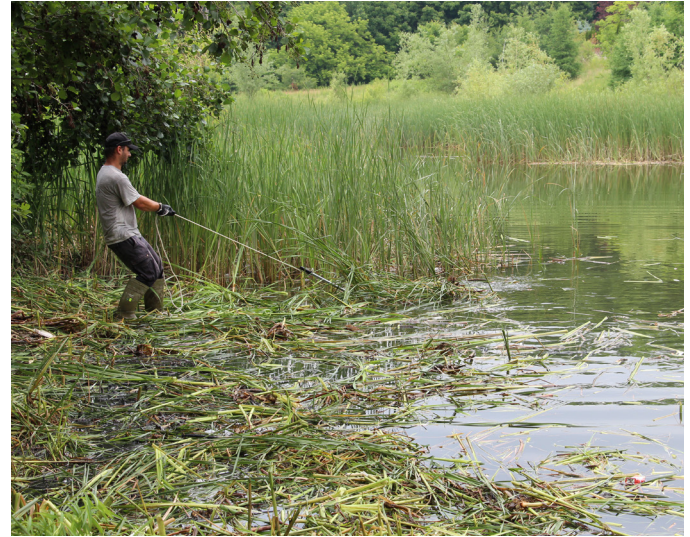
Figure 4. Shoreline cattail removal.

removal and the necessary erosion and sediment control measures were minimal. However, cattail removal was necessary to maximize the dredge's accessibility to the shores (Figure 4). The site has two access roads, which were both utilized during the site mobilization and set-up. The primary activities associated with preparing the site for sediment removal were:

Although cattails serve biological, erosion prevention and hydraulic functions within the facility, their excessive growth in the pond fringe areas hindered access to the open water area. Because hydraulic dredges operate from the surface of open water, while cattails reduce the area of open water, they need to be removed in order to allow the dredge to access the fringe areas of the pond.

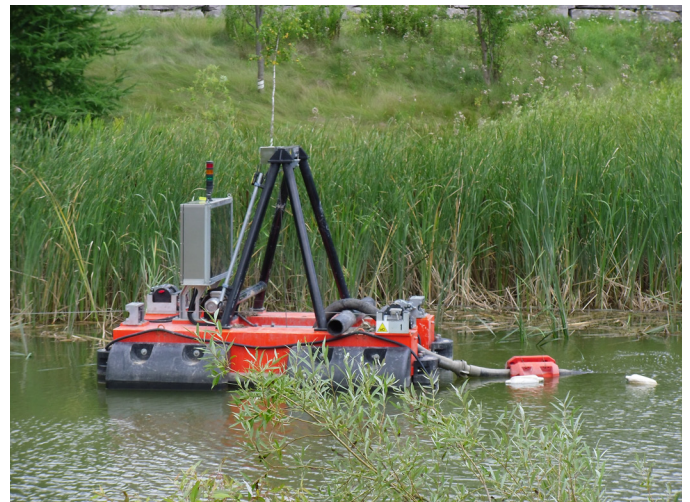
Figure 5. Hydraulic mini dredge.

The remote controlled Dragflow® Mini Dredge with an electric submersible pump (Model EL12.5 SS) was deployed in the pond during the dredging operation (Figure 5). This hydraulic dredge operates in a grid-like pattern with the help of a cable system connecting opposite sides of the pond. A diesel generator provided power to the dredge. Water pumped by the dredge is directed to trailers set up for dosing with polymer and mixing of the dosed sediment slurry. The slurry was then directed to the dewatering bags in the sediment management area, where water was drained and conveyed back to the pond.

**HYDRAULIC DREDGE FUNCTION.** Hydraulic dredging operates through a substantial amount of pumping and water conveyance. The dredge is operated with a remote control to guide the speed of the dredge and depth of the submerged pump. The hydraulic dredge uses high and low pressure fields at the pond bottom created by the pump.

The pump creates a high pressure at the top of the sediment, which results in a low pressure at the suction point of the pump. As such, the slurry moves from the high pressure to the low pressure and into the pump, which creates a circulation. The pump functions at a rate of 80 m<sup>3</sup>/hour.

The movement of the dredge was guided by steel cables attached at either end of the pond, while a remote control was used to move the dredge forward and backward, control its speed and determine the depth of the submersible electric pump. The colour of the slurry being pumped into the dosing and mixing trailer was monitored in real time as a means of determining when the pump should be moved. If the slurry appeared to be relatively clear with low solids content, the pump would be lowered in order to capture the dark sediment at the pond bottom. A lighter coloured slurry with high solids content was indicative that the pump had reached the clay pond liner and thus the pump could be advanced forward to clean the next section.

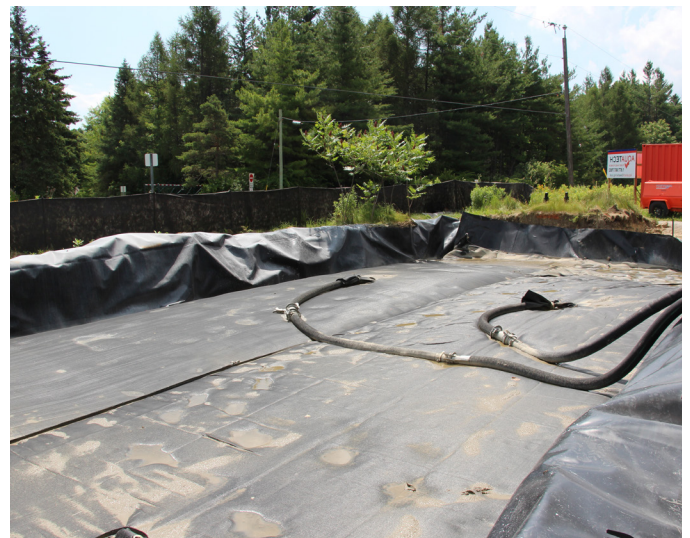
Figure 6. Sediment dewatering bags.

**DEWATERING.** The chemical reaction between the injected polymer and suctioned slurry begins its reaction while in the polymer and effluent mixing tanks while being conveyed through hoses into the sediment dewatering bags for further consolidation and dewatering (Figure 6). The PAM dosed slurry was pumped through a mixing zone that created turbulent flow conditions allowing for the polymer to react more fully with the sediment. After this mixing occurred, the slurry was pumped into the dewatering bags, which filtered out

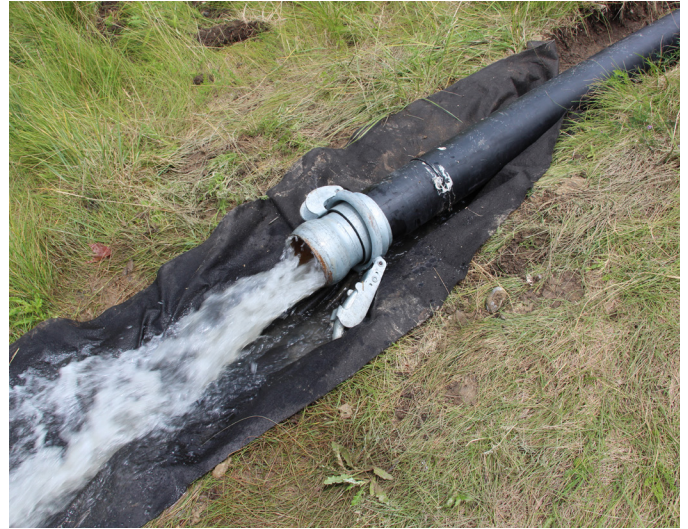
Figure 7. Clear water exiting the sediment dewatering bags.

any particles larger than 425 µm. In addition to filtration, the bags also provide an opportunity for gravitational settling of suspended sediment particles. There were two entry points in each dewatering bag so that as one side became filled with sediment, the hose could be removed and re-attached at the adjacent entry point. The water that drained from the bags was conveyed from the dewatering area and back into the pond via three 4-inch pipes (Figure 7). The flow path from the pipe to the pond was stabilized with geotextile fabric to prevent erosion.

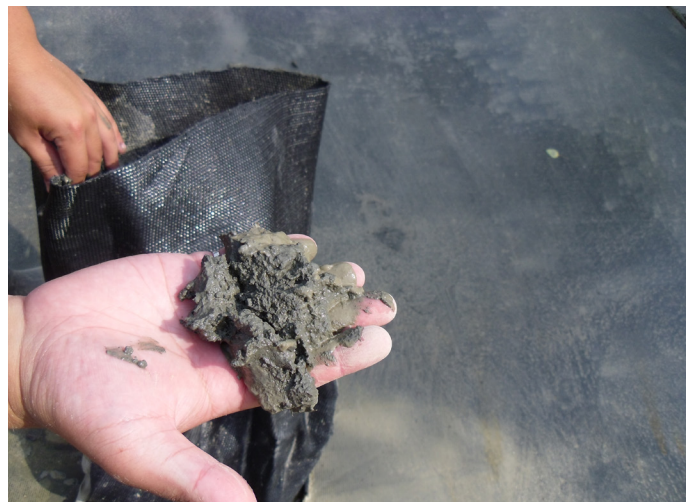
Figure 8. Level of sediment consolidation from within the dewatering bags.

The sediment contained in the dewatering bags was left within the excavated containment area, avoiding the need to haul and dispose of sediment off site (Figure 8-9). The top of the bags was cut open to allow the dredged consolidated sediment to integrate with the soil used to backfill the sediment containment area. The area was back-filled, leveled and hydroseeded. On sites where sediment contains higher contaminant levels than on this site, it is possible that this method of onsite reuse and integration with existing site soils could result in reduced contaminant levels over time. The churning of the soil by microbes could potentially help to mix the dredged sediment with the backfilled soil, and also help reduce contaminant levels through biological breakdown and uptake. While this has not been proven through a field study specifically looking at dredged storm-water facility sediment, the soil remediation power of microbes is a widely accepted phenomenon.

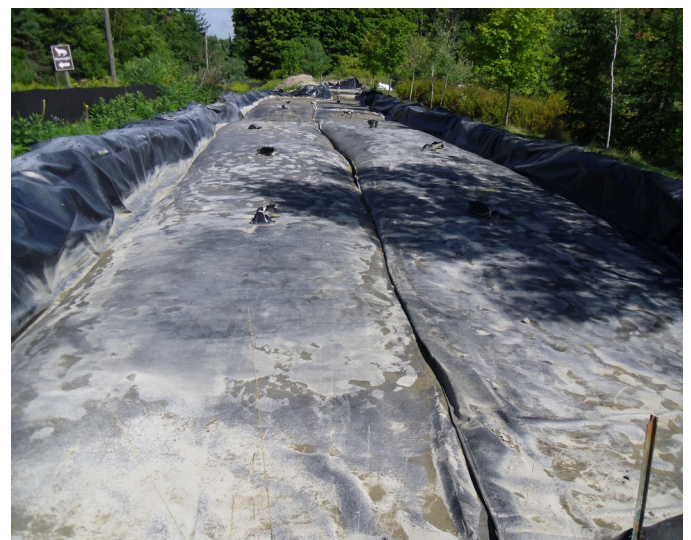
Figure 9. Sediment dewatering bags at the end of dredging.
