# Polymer Assisted Hydraulic Dredging of a Stormwater Pond

## CASE STUDY

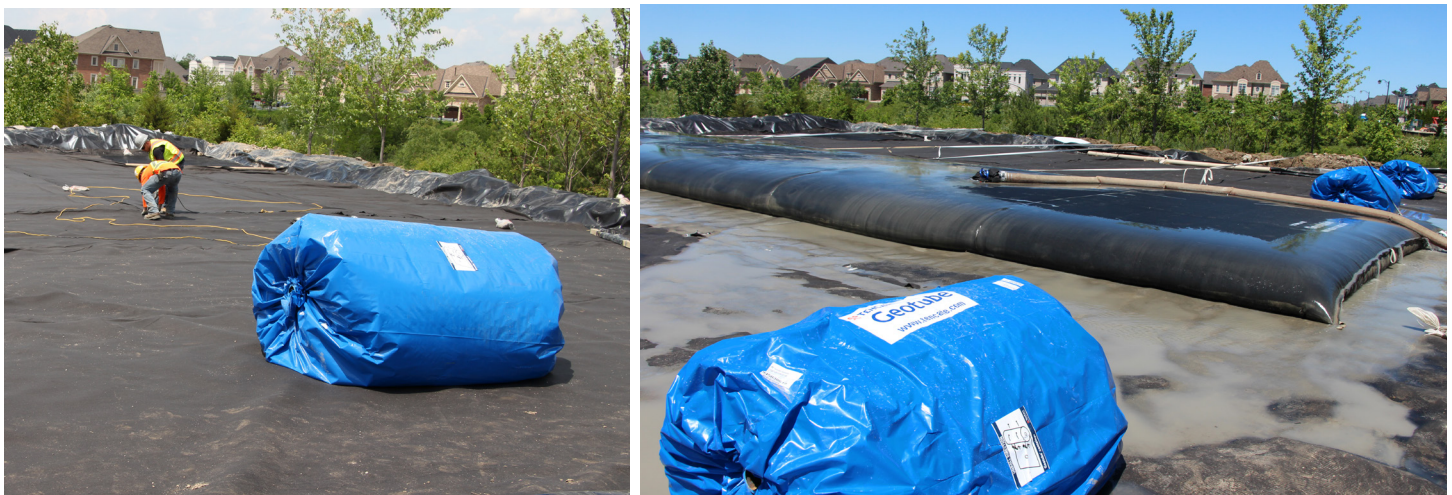
Figure 2. Preparation of laydown area for sediment dewatering Geotubes® (left). The same area with the Geotubes® in place and filtering water (right).

The area designated for the placement of the Geotubes® (measuring 45 by 100 feet) was a vacant gravel parking lot immediately south of the pond (Figure 3). The first step in preparing the area was leveling the ground with a backhoe and creating earthen berms around the perimeter. These measures ensured that the Geotubes® would not shift or roll once they were filled. Following this grading, the area was covered with a plastic liner, plastic netting for drainage, and a nonwoven geotextile fabric (Figure 2).

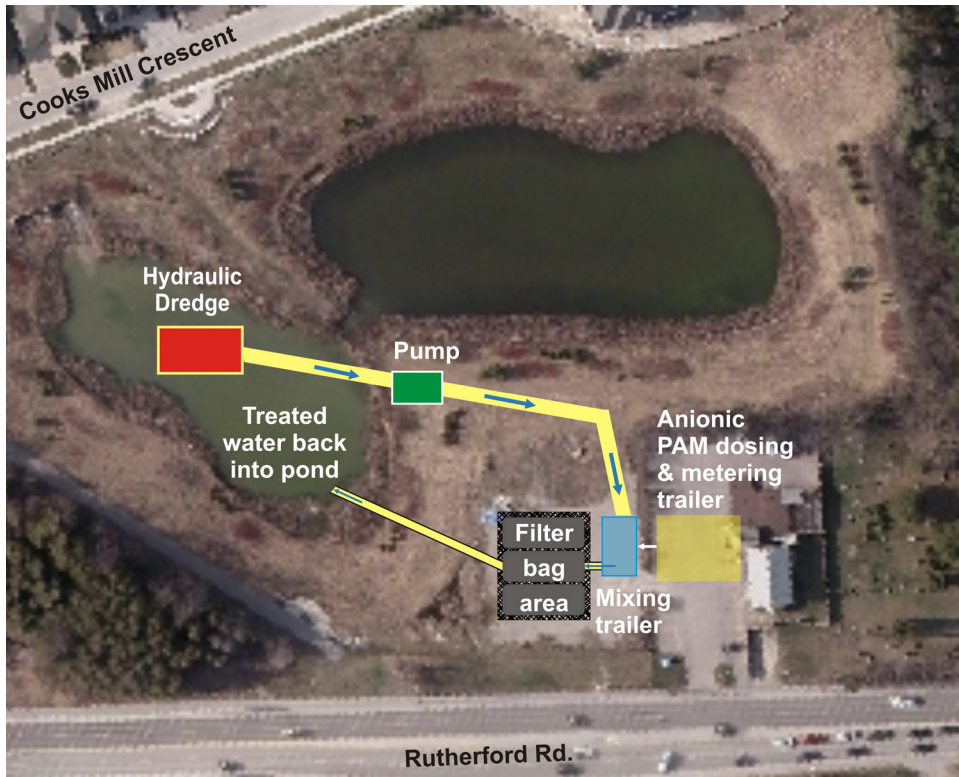
Figure 3. Schematic aerial view of the Pond 4 site during polymer-assisted hydraulic dredging.

Figure 3 illustrates the overall site set up for the dredging of Pond 4. The remote controlled, floating, auger-type dredge used – a Pit Hog™ – was lifted into the pond and removed at the conclusion of dredging with the use of a crane (Figure 4). A diesel generator

As depicted in Figure 3, the sediment slurry was suctioned by the dredge, pumped to the trailer for inline polymer injection and mixing, and then pumped to a Geotube® for dewatering (Figure 5). Water drained from the Geotubes® was conveyed back into the forebay part of the pond.

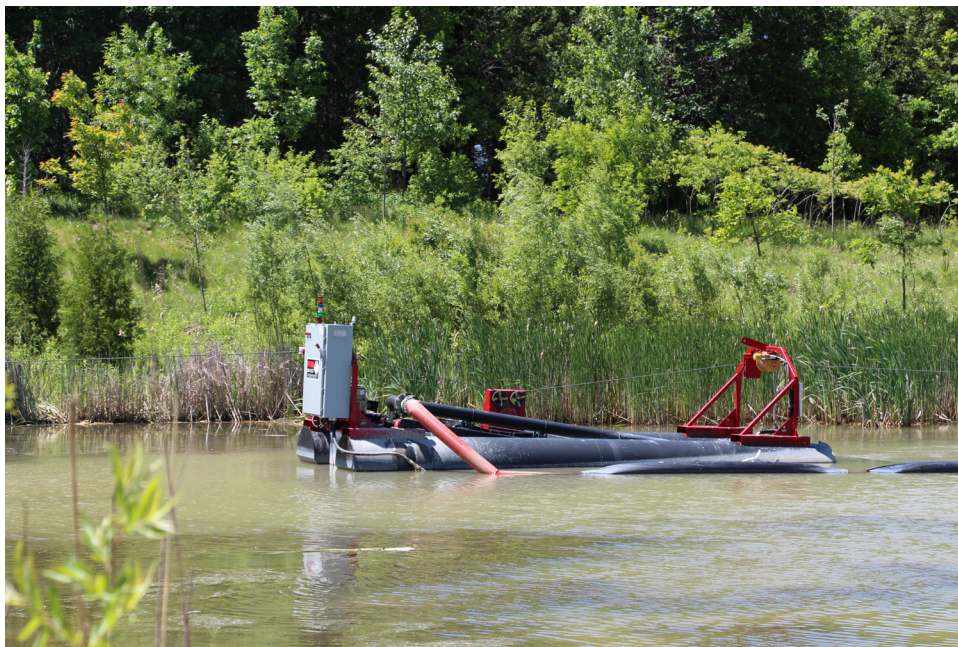
Figure 4. Pit Hog™ dredge operating in Pond 4.

The operation of the dredge (Figure 4) was done by remote control, with the dredge's forward, reverse and lateral movements guided by a steel rail system installed at the ends of the pond. The movement of the dredge was determined based on real time measurement of solids levels in the material being suctioned. The concentration of solids in the slurry being pumped through the dredge was measured by a density meter in the polymer metering and dosing trailer. These real time measurements were observed by an individual in the trailer who remained in constant radio contact with the person remotely operating the dredge. The percent solids level indicated whether or not that part of the pond bottom had been cleared of sediment. When the percent solids decreased at a specific spot, it served as a cue to the operator

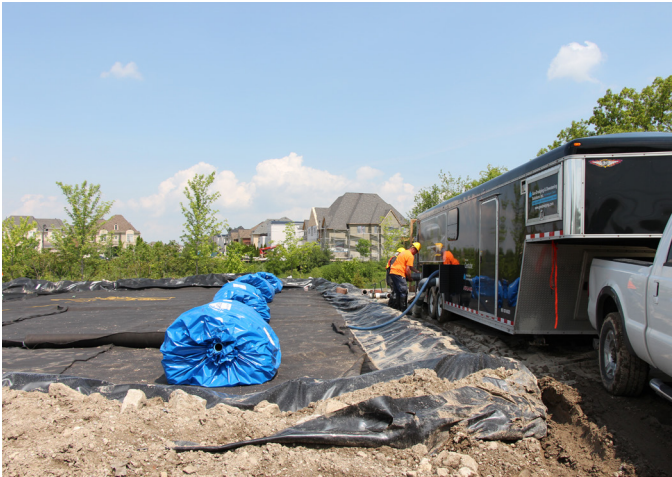
Figure 5. Sediment dewatering bag laydown area.

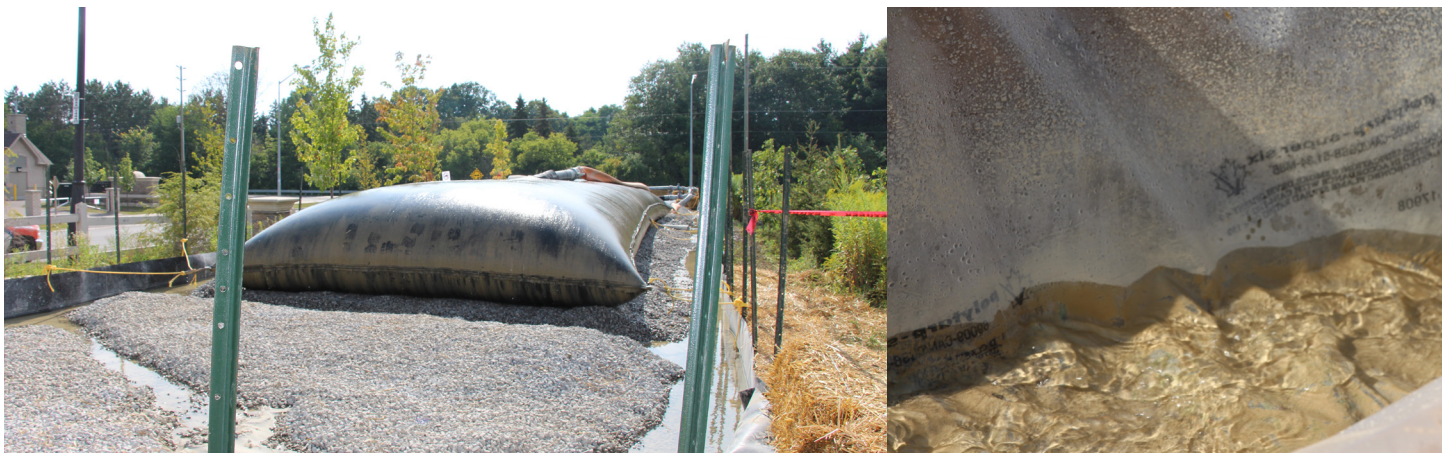
Figure 6. Filled sediment dewatering bag (left) and clarity of effluent water after it drains from the sediment dewatering area (right).

The final step in the dredging/dewatering process was the pumping of the dosed and mixed slurry into the Geotube™. Here, much of the sediment either settles or is filtered out of suspension (Figure 6). Water draining from the Geotube™ pools slightly in the containment area, where there is some additional sediment settling. The effluent was discharged back into the pond forebay area via two 6" pipes, with a plastic liner installed on the ground at the discharge point to prevent erosion (Figure 6).

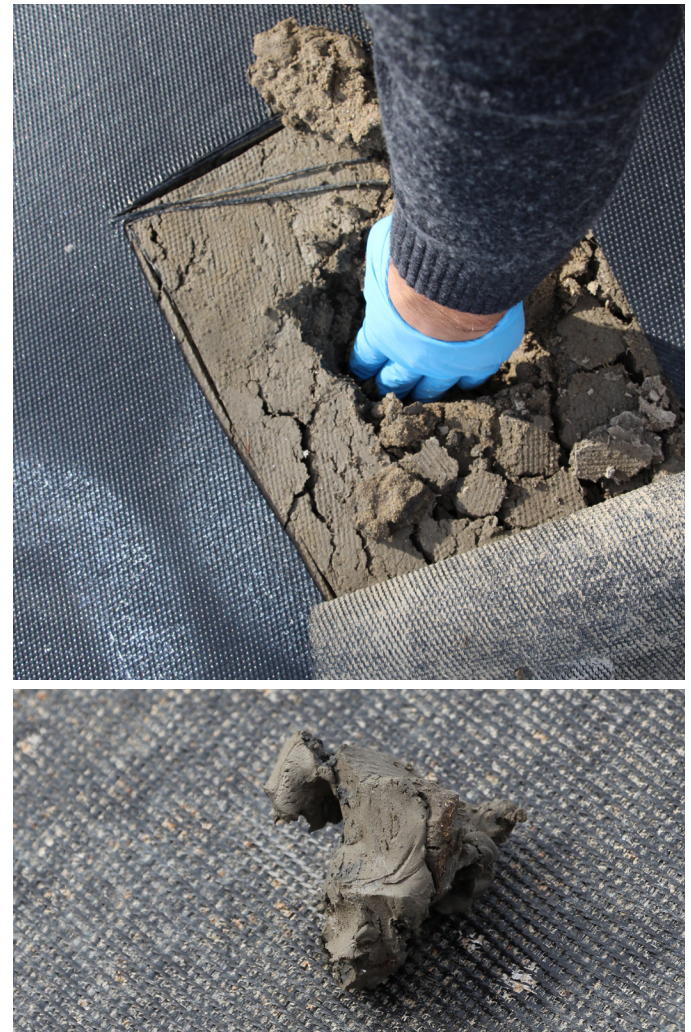
Figure 7. Consistency of Pond 4 sediment at the time of hauling, after two months in the Geotubes™.

The Geotubes™ used to contain the sediment were left to drain for a period of two months. This drying period was longer than what would normally be required, reflecting delays in scheduling of hauling rather than the actual time needed for sediment to be dry enough. Typically, a few weeks of drying time would be sufficient, but this can vary significantly according to the type of material being dewatered and weather conditions. For this project, the solids concentration was 56% at two weeks and roughly 60% at two months post dredging, demonstrating that the additional drying time resulted in a relatively marginal benefit.

sediment retained in the geotubes amounted to approximately 215 m<sup>3</sup> (Figure 7).

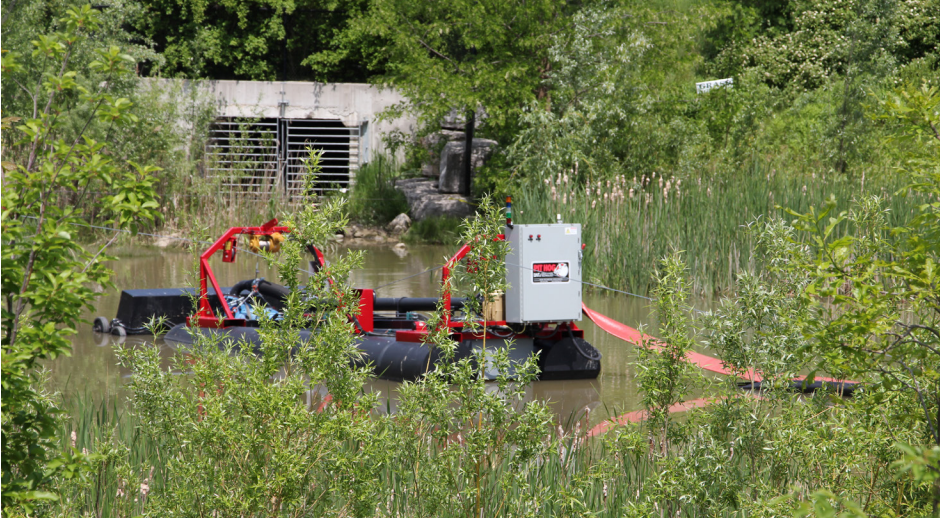
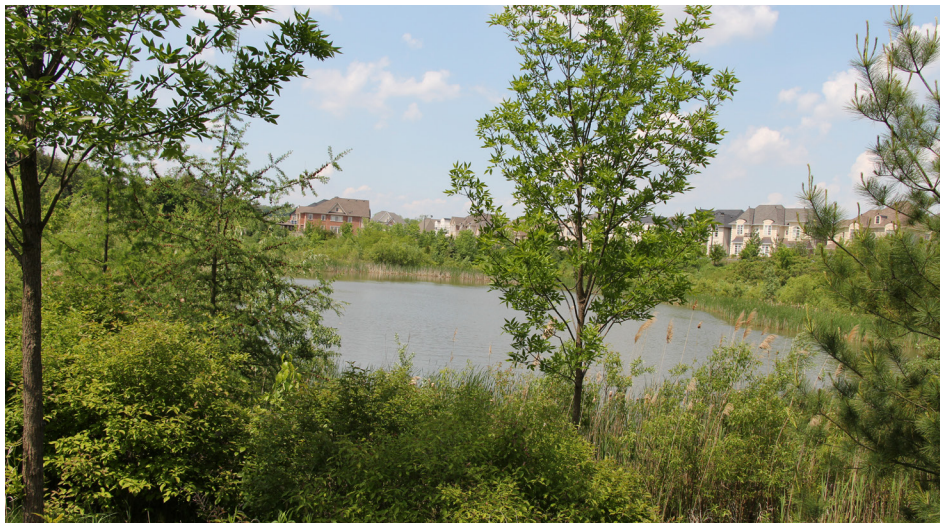
Figure 8. The well-established plantings surrounding Pond 4 that remained undisturbed during dredging.

The dredging method used was largely non-invasive, with no excavators requiring access to the pond and only a crane used to lift the dredge into and out of the pond. As such, no significant vegetation removal was necessary to facilitate pond access, and the established vegetation stabilizing pond embankments was also preserved (Figure 8). As a result, the only site restoration activities necessary were the removal of the materials lining the containment area and the re-grading of the parking lot to its original condition. Because there were few construction vehicles required on site, walking trails around the pond area remained accessible to local residents throughout the dredging process.
