Water-Absorbing Polymer Assisted Mechanical Dredging

CASE STUDY

Within the City of Toronto there are several ponds that have been identified as being at capacity and in need of maintenance, including the Sisters of St. Joseph (SOSJ) and Lansing ponds described in the current case study. Based on sediment surveys of both ponds carried out in the summer of 2013 by the Toronto and Region Conservation Authority (TRCA, retained by the City to complete the pond clean outs), the SOSJ Pond was 58% full and Lansing Pond was 42% full relative to their original designs. The corresponding volumes of sediment to be removed were estimated to be up to 1320 m³ for SOSJ and 1200 m³ for Lansing. Over and above the primary objective of removing this accumulated sediment, these pond clean out projects were also undertaken to meet the following secondary objectives.

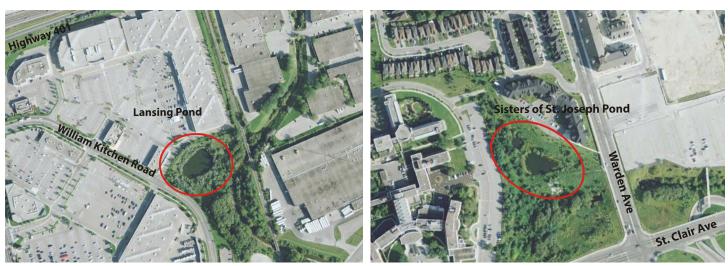
Figure 1. Locations of the Lansing (left) and SOSJ (right) ponds in the east end of Toronto.

The ponds, SOSJ and Lansing, are located in the east end of the City of Toronto, Ontario. The former is immediately northwest of the intersection of St. Clair Avenue East and Warden Avenue, and the latter is just off of William Kitchen Road, located southeast of Kennedy Road and Hwy 401 (Figure 1). Both ponds were constructed in 1997 and prior to 2013 neither had been dredged.

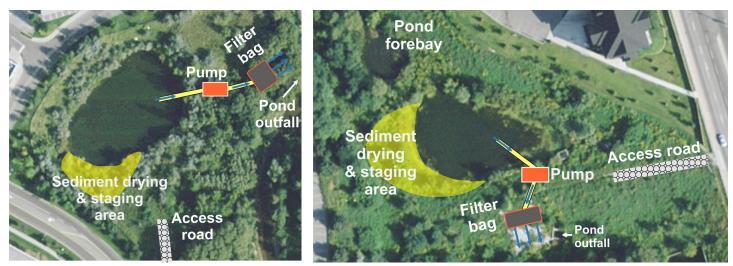
Figure 2. Preparation of laydown areas for Lansing (left) ad SOSJ (right) ponds.

The preparation of both sites began in October 2013 (Figure 2). In

order to make the sites accessible for construction vehicles, it was necessary to create a clear path to the pond by removing several of the established trees and shrubs at both sites. The trees removed from the site were later chipped to make the mulch used to aid sediment drying.

Site preparation also involved the installation of erosion and sediment controls, including silt fencing and geotextile filter bags to be used during pond dewatering, and the installation or placement of equipment required for the project such as the pumps, hoses, super absorbent polymer bags, and heavy machinery.

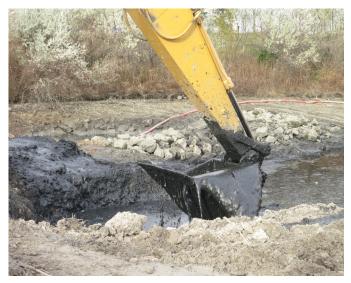
Figure 4. Sediment consistency after dewatering and prior to polymer application.

Prior to the addition of the polymer, wet sediment samples were collected and used to determine the quantity of polymer that should be applied to the excavated sediment. Due to the high moisture content of the sediment (Figure 4), a small depression was created within the sediment drying/staging area to contain the sediment dredgeate during the polymer application and mixing process. Once the appropriate dosage rate was determined, the LiquiSorb 2000[®] powder was sprinkled over the surface of the wet sediment. This was achieved by suspending a large bag of polymer from an excavator and cutting the bag open while suspended in the air above the sediment holding area (Figure 5). Dust masks were worn by onsite construction staff during this application and mixing process to avoid inhalation of wind-blown polymer dust. Once the polymer was applied, it was thoroughly mixed with the wet sediment using an excavator. It was then left to sit for up to 24 hours, giving the polymer the opportunity to absorb the water within the sediment dredgeate (Figure 6). The amount of time required for this process depends primarily on the water content in the dredgeate and the amount of polymer applied.

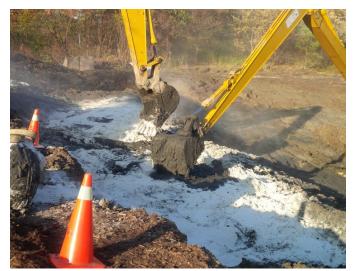
Figure 5. Polymer application using long reach excavators for spreading.

Once dewatering was largely complete, the dredging process was initiated. A long reach excavator was used to scoop the wet sediment out of the pond, place it on the sediment drying/staging area on the pond banks, and mix the sediment with the super absorbent polymer. A skilled operator was retained to ensure that as much sediment as possible was removed from the pond without damaging the clay pond liner. Pond liners are installed during pond construction to minimize the exchange of water between the pond and the groundwater. This ensures that the appropriate permanent pool level is maintained and also that contaminants are not migrating out of the pond and into the groundwater.

POLYMER APPLICATION. The polymer product used at both sites to absorb water and improve the manageability of the wet sediment is LiquiSorb 2000[®]. The product contains both bentonite clay and polyacrylate superabsorbent polymer, and is specifically designed to absorb water from, and aid in solidification of, dredgeates or any industrial wastewater with high solids content. The polymer used in this product differs substantially from other polymers used for erosion control and water clarification (e.g. linear anionic polyacrylamide). While anionic polyacrylamide (PAM) binds sediment particles to one another so that the sediment becomes consolidated, the superabsorbent polymer simply absorbs water in the sediment mixture. Polyacrylate superabsorbent polymers are capable of absorbing a very large amount of water relative to their own mass, and as a result are very useful in personal hygiene products like baby diapers and as a soil additive to improve water retention for plants. They are also approved by the U.S. Food

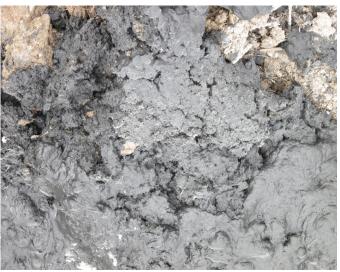
Figure 7. Consistency of sediment after polymer addition.

Once the polymer treated sediment was mixed and allowed to sit, slump tests were performed in order to determine whether the sediment had solidified enough to be hauled away (Figure 7). When the material was ready for hauling, it was transported to conservation lands in the City of Pickering, roughly 35 and 40 km away from the SOSJ and Lansing ponds, respectively. The sediment was used to fill an excavation from which contaminated soils had previously been removed. The lands are slated for development of recreational multi-use trails in the future.
