Central Maintenance Garage

369 kW_t Solar Wall Air Heating System

Final Report – January 2012

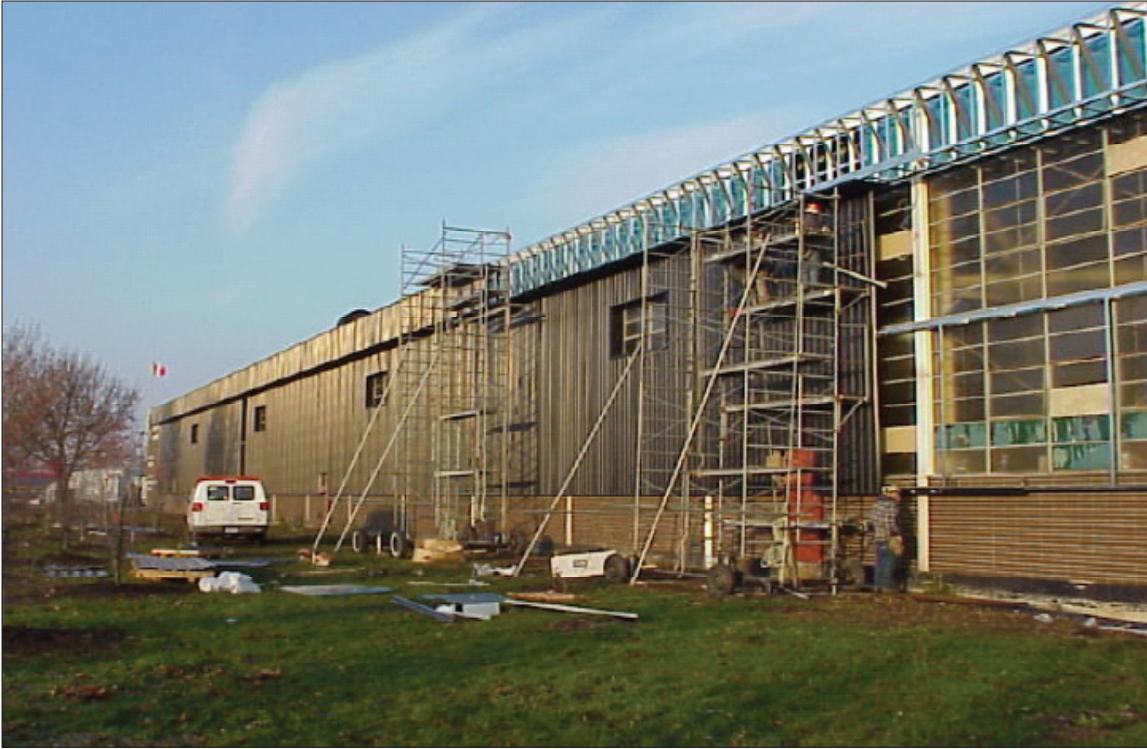
The City decided to install a Solar Wall to replace the south-facing glass wall. The Solar Wall consists of over 600 square meters of solar air heating perforated-plate collectors mounted on the south wall of the Maintenance Garage. Ventilation fans draw in outside air, which then circulates through the collectors and is heated by the metal panels. The warm air passes through ducts to fans and warm, fresh air is distributed throughout the building.

Figure 1. Installation of solar wall.
