## Low Impact Development

## Evaluation of Retrofitted Lot Level Stormwater Source Control Practices – Calstone Inc., Toronto

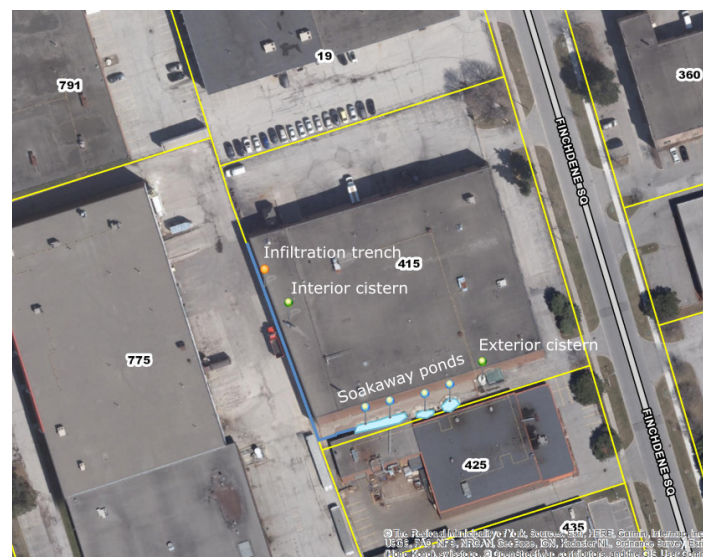
Figure 1. Calstone Inc. property and stormwater source control practice locations

With supportive grants from Earth Day Canada and Ontario Ministry of the Environment and Climate Change, the scale of the project was expanded to include a 9,300 L rainwater cistern and irrigation system to provide a source of water for landscaping, a rear lot infiltration trench, three soakaway ponds and a lined, decorative pond and fountain, to reach a total value of \$97,920. Combined these features disconnect 4 of 6 roof drains (2,600 m<sup>2</sup> roof area) from municipal storm sewers, which produces approximately 1.8 million L (1,800 m<sup>3</sup>) of runoff in an average year. Selection of LID practices implemented was influenced by the relatively small pervious area available, which favored practices with small surface footprints, and the desire to create attractive landscape and water features for aesthetic value, in addition to stormwater management benefits. Locations and configurations of stormwater practices on the Calstone Inc. lot are illustrated in Figures 1 and 2. Characteristics of the lot and source control practices are described in Table 1 and Table 2.

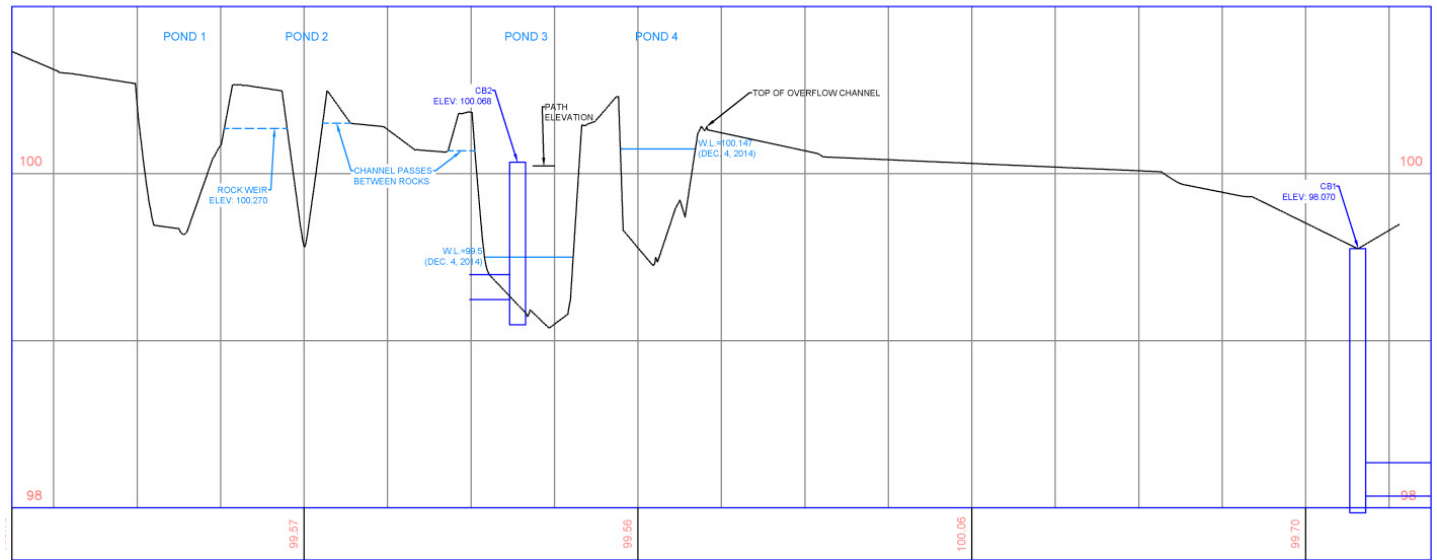
Figure 2. As-built drawing of Calstone rainwater harvesting and landscape renovation project

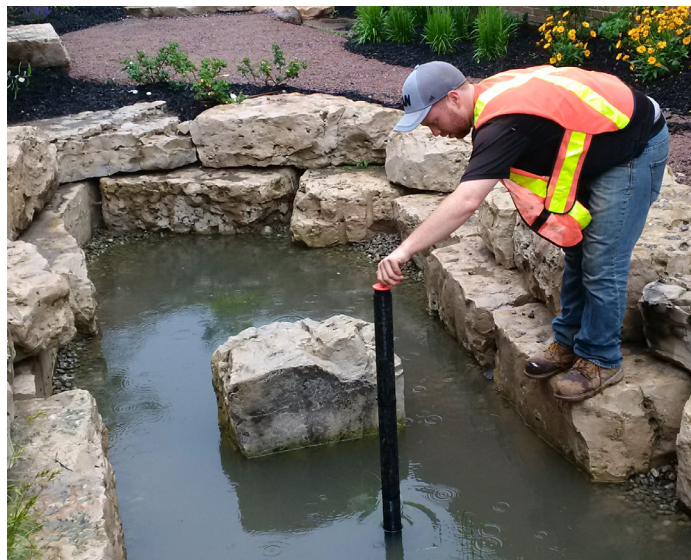
Figure 3. Water level monitoring well being checked

installed on the roof and pressure transducer water level loggers were installed in the cistern and three soakaway ponds and all were set to record readings on 5 minute intervals. Monitoring data was used to assess runoff volume reduced, rainwater used/municipal water conserved, soakaway pond drainage rates and frequency and causes of overflows.

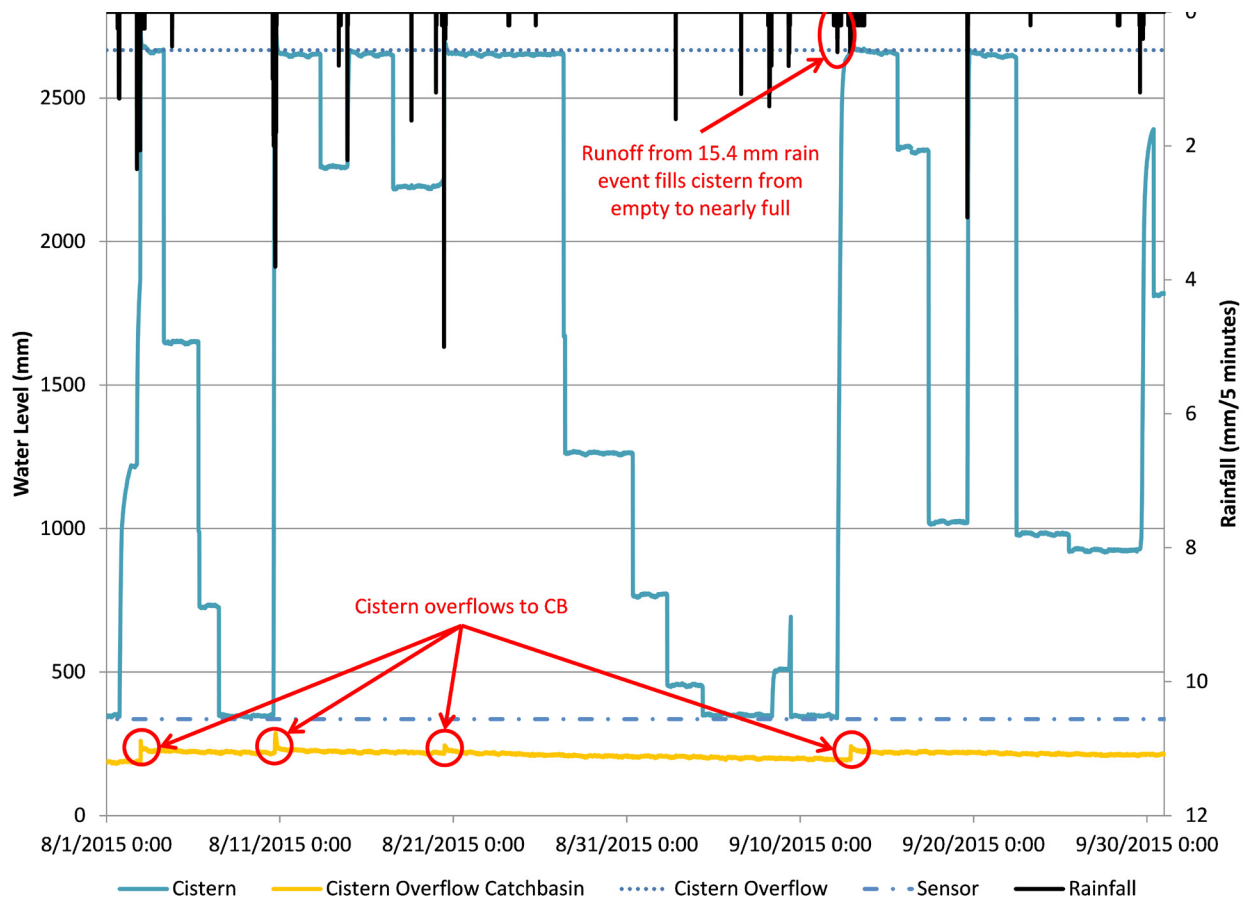
Figure 4. Hydrograph showing rainfall depth and cistern water level during August and September 2015

**The rainwater cistern and irrigation system reduced runoff volume from the 650 m<sup>2</sup> roof drainage area by approximately 64% over the 2015 growing season. A total of 56,331 L (56.3 m<sup>3</sup>) of rainwater was harvested and used to irrigate the planting beds over the July 1 to October 26, 2015 cistern operating period, resulting in a municipal water cost savings of \$180.** Drainage of cistern overflow water via infiltration below its gravel base accounted for around 25% of roof runoff, which contributed substantially to overall system performance. Weather during July and September was much drier than normal, while October was much wetter. Despite these deviations from climate normals, monthly quantities of rainwater used for landscape irrigation remained relatively consistent (Table 3), indicating that the irrigation system was being routinely operated by Calstone staff. The cistern overflowed on 9 occasions when roof runoff exceeded available storage capacity. When fully drained, the cistern has the capacity to fully capture runoff from a 15.7 mm rain event without overflowing, which was evident on September 11, 2015 when a 15.4 mm storm filled the cistern from empty to just below the overflow outlet elevation (Figure 4).

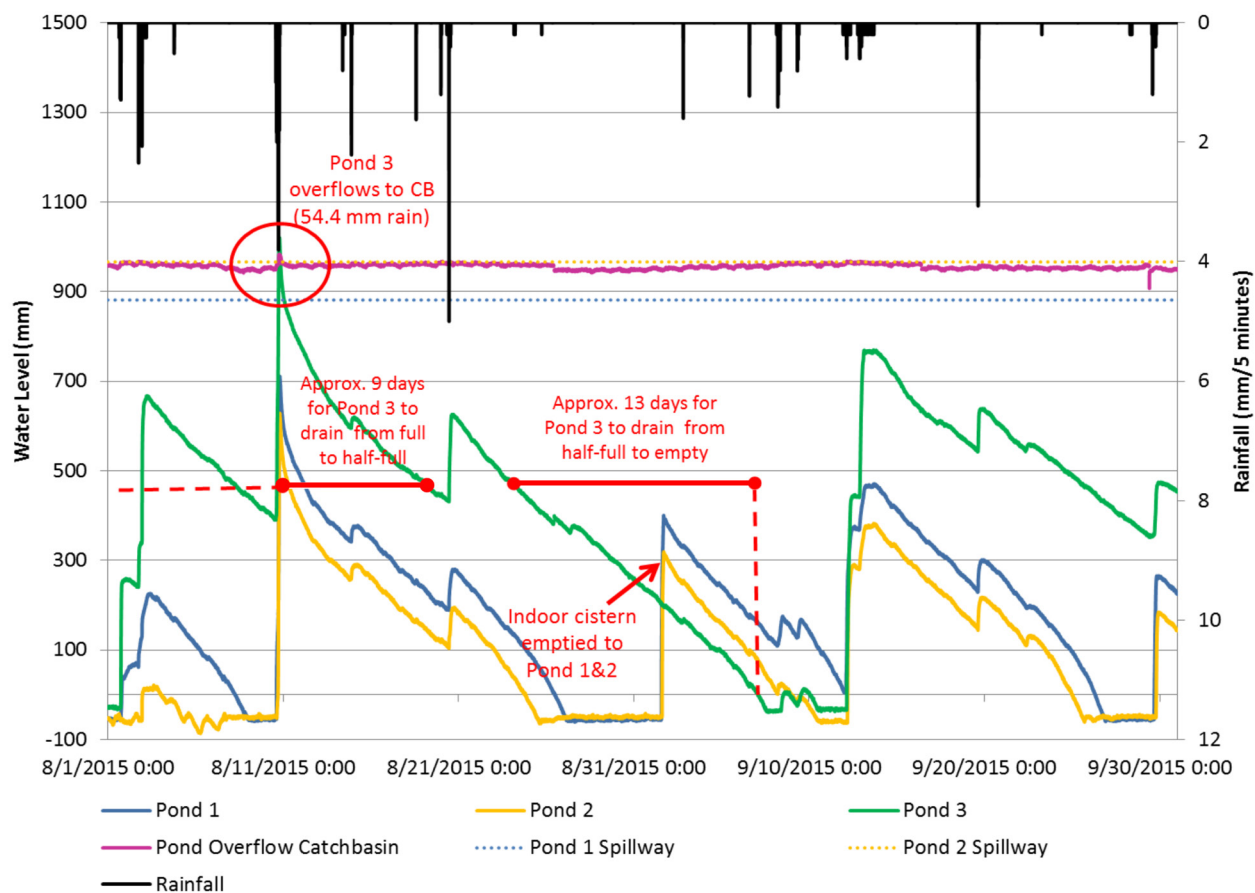
Figure 5. Hydrograph showing rainfall depth and soakaway pond water levels during August and September 2015

to greater pressure head at the pond bottom helping to force the water into the underlying soil. Pond 3 was observed to drain from full to half full in approximately 9 days, while it took 13 days to drain from half-full to empty (Figure 5). The ratio of impervious area to infiltration practice footprint area for the three soakaway ponds combined is 29:1, which is similar to ratios applied to the design of roof runoff infiltration practices examined previously by STEP (TRCA, 2013).

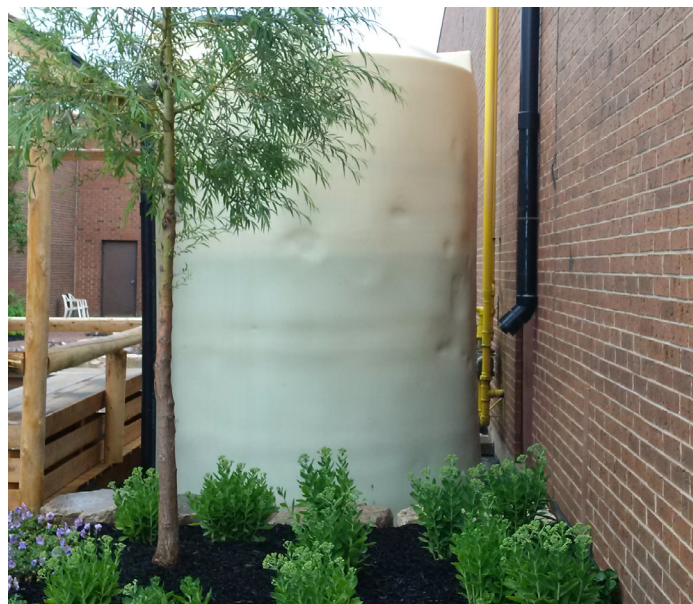
Figure 6. Cistern and disconnected downspout at Calstone
