# Design and Performance of Retrofitted Roadside Biofilter Swales, County Court Blvd., Brampton

**Dean Young M.E.S., B.Sc.**  
**Toronto and Region Conservation Authority**

# County Court Blvd. Biofilter Swales

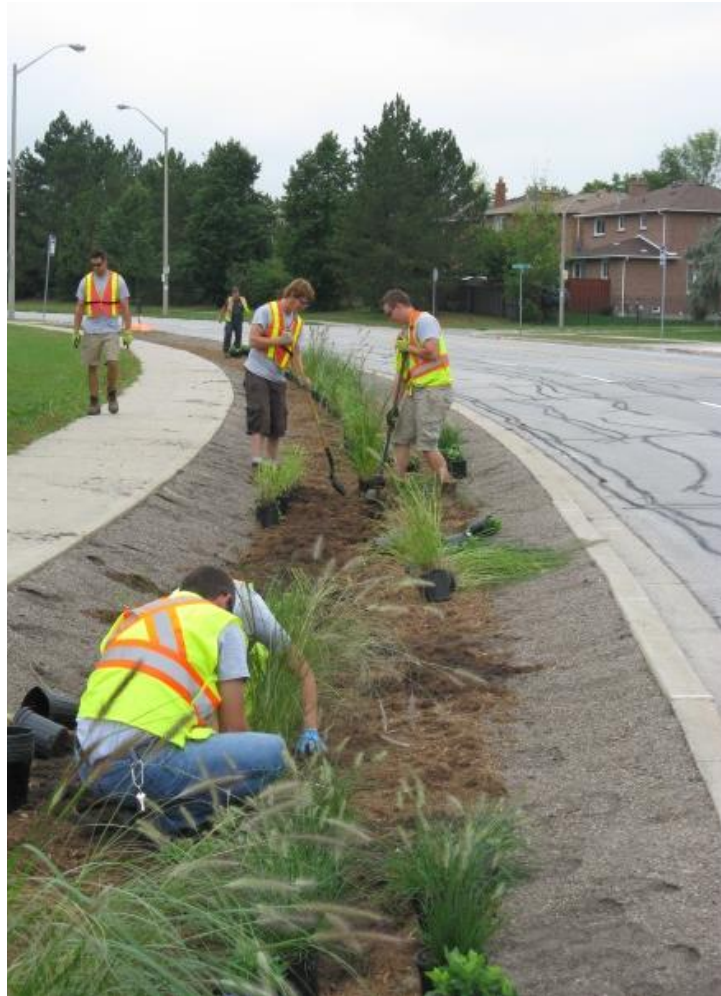
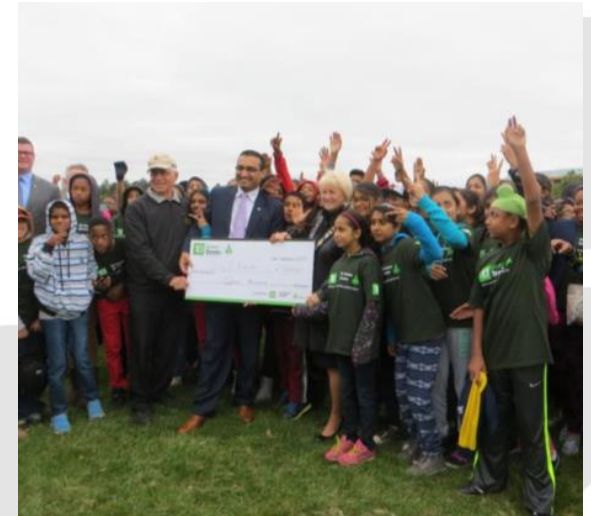
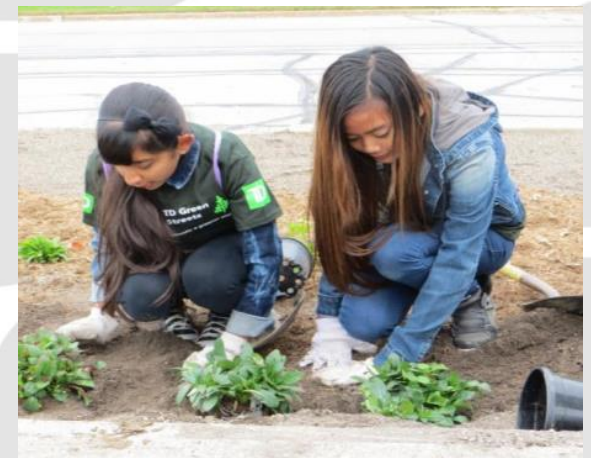
- Two lined bioretention (biofilter) swales, 70 m (West) and 85 m (East) length x 3 m width, constructed in 2014/15 that receives runoff from 1,904 m<sup>2</sup> portion of County Court Blvd.;
- Impervious liner and perforated sub-drain pipe to limit risk of damage to watermain located below swale footprints;
- Construction and routine inspections and 18 mo. performance monitoring by STEP.

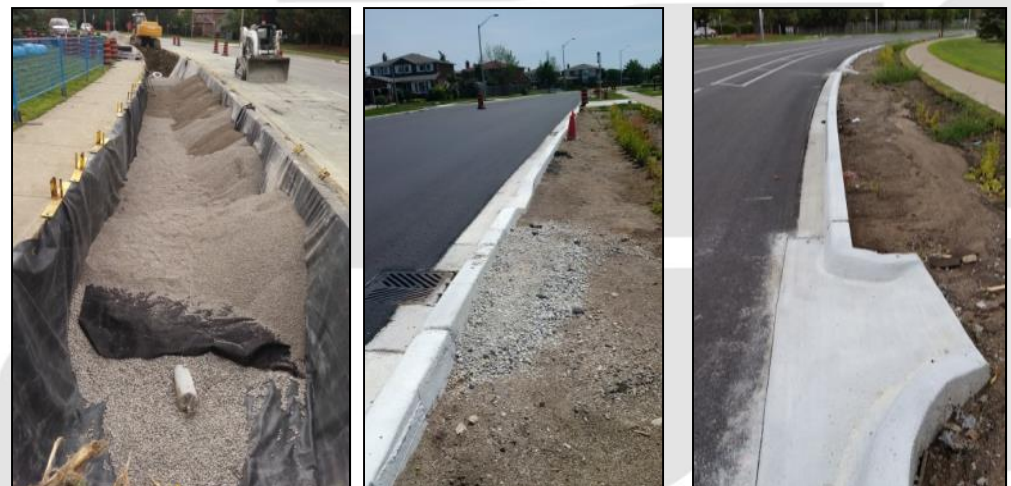
# County Court Blvd. Biofilter Swales – Design

- Impervious to pervious area (I:P) ratio of 4:1;
- ~ 1 m deep, vertical walled excavation lined with EPDM (rubber) geomembrane;
- 150 mm dia. perforated pipe sub-drain with filter sock and standpipes;
- 15 cm coarse sand transition layer sandwiched between geotextile;
- 50 to 75 cm depth of filter media (85% sand-sized, 4% O.M.);
- OPSD 605.040 concrete asphalt spillways (2 per bioswale) and simple curb cuts as inlets (5 to 6).

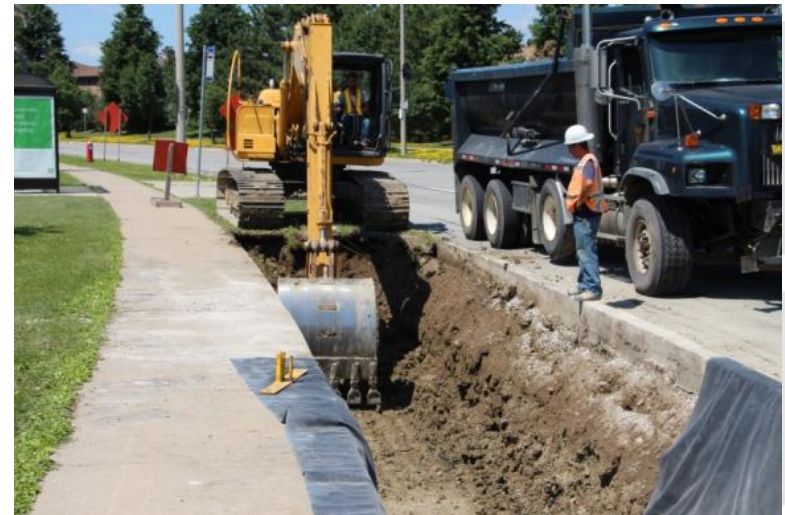
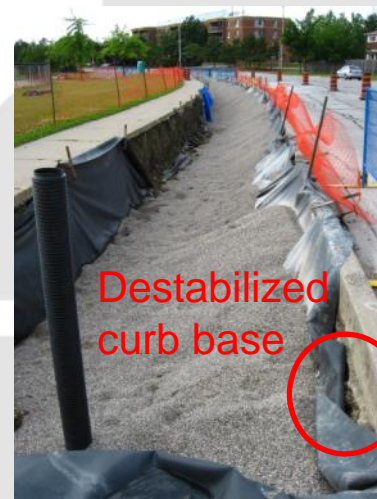
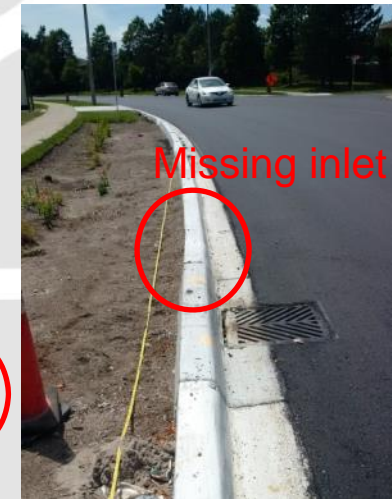
# County Court Blvd. Biofilter Swales – Construction

- Vertical excavation destabilized the gravel base of the existing curb, necessitating replacement with wider curb and delaying construction;
- Lab testing of biomedial prior to delivery delayed installation;
- Modified curbs not constructed to OPSD specifications – needed to replace 4 of 15 with OPSD 605.040 concrete asphalt spillways;
- Missing curb cut inlet u/s of one road catchbasin.

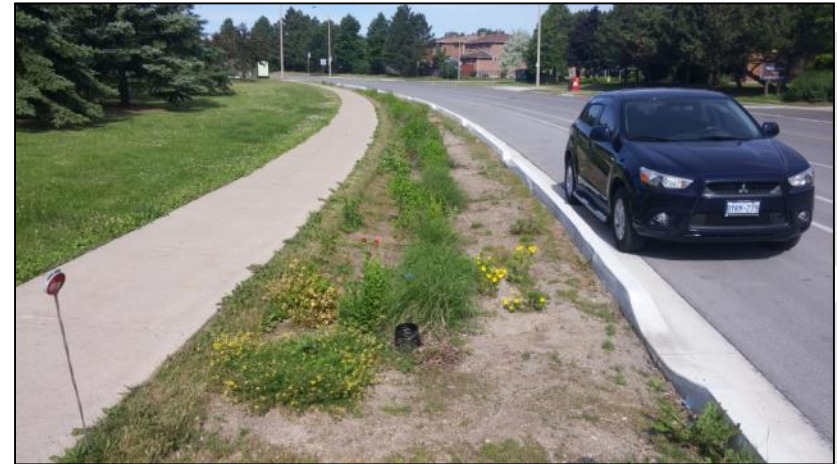
West Swale - June 2016

- Original planting plan: mix of flowers, herbs and ornamental grasses with shredded mulch cover to create attractive landscaped feature;
- Community planting event in fall 2014;
- Vegetation cover <80% after 2 years – too few plants, lack of watering and mulch, dry spring 2015, road reconstruction in summer 2016 were contributing factors;
- Grass/herb seed mix spread on biomedial in fall 2015 - poor results;
- Added river-run stone cover around surviving plants in 2016.

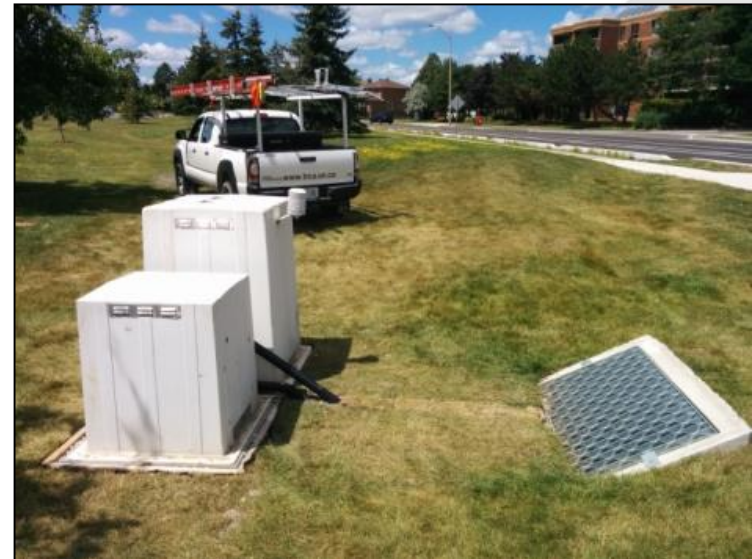
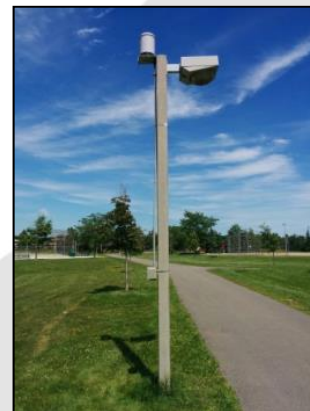
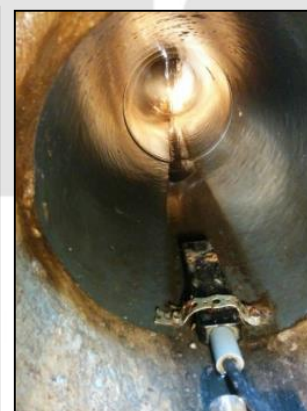
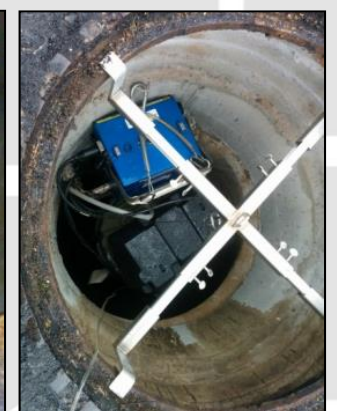
# County Court Blvd. Biofilter Swales – Performance Evaluation

- Conducted inspections using visual indicators and test methods recommended in LID I&M Guide (TRCA, 2016);
- Continuous field monitoring to evaluate runoff volume and pollutant load reduction and examine effects on effluent temperature;
- Examine effects of winter operation on treatment performance and maintenance needs;
- Compared bioswale flow volumes, rates & water quality to runoff from an untreated portion of County Court Blvd. (Control catchment);

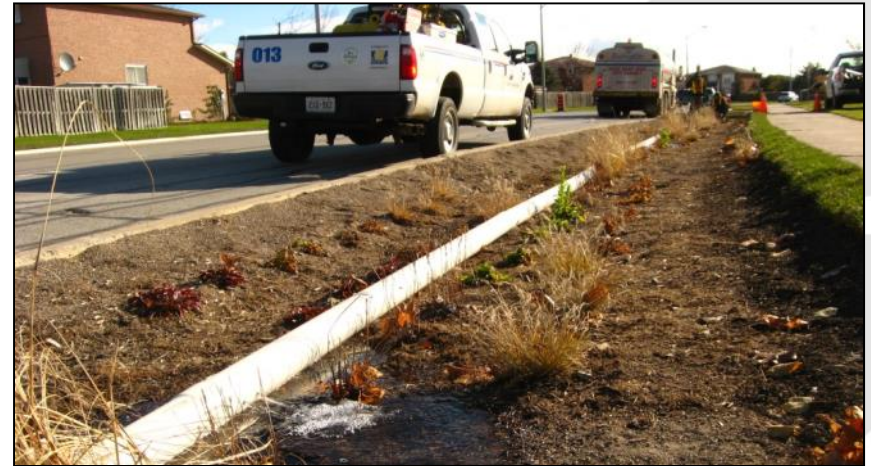
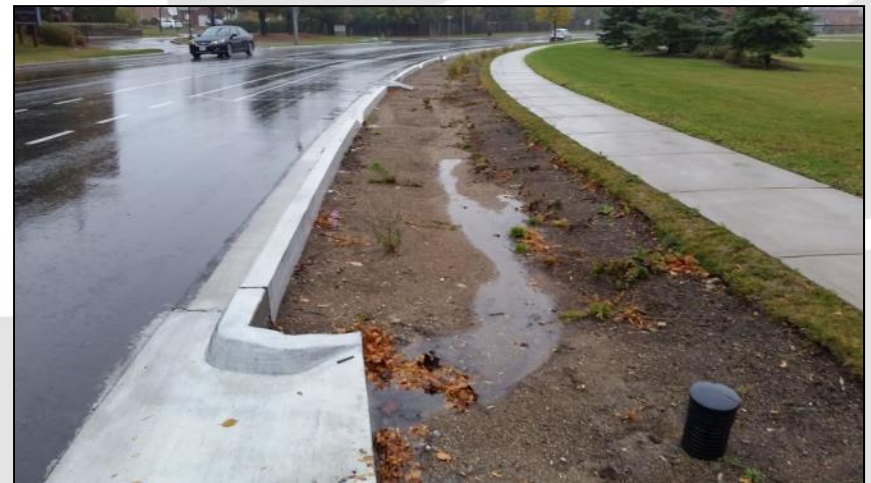
# County Court Blvd. Biofilter Swales – Performance Evaluation

- Evaluated runoff reduction through continuous flow monitoring during simulated and natural storm events;
- Simulated storm event testing (Nov. 2014) indicated potential to reduce runoff in order of 30% for a 12 mm simulated event on dry soil;
- Biofilter swales with 4:1 I:P ratio can retain all runoff from rainfall events up to 3.0 mm in depth;
- Runoff reduction (2015/16 rain events, n = 80):
  - East Bioswale: 17%
  - West Bioswale: 34%

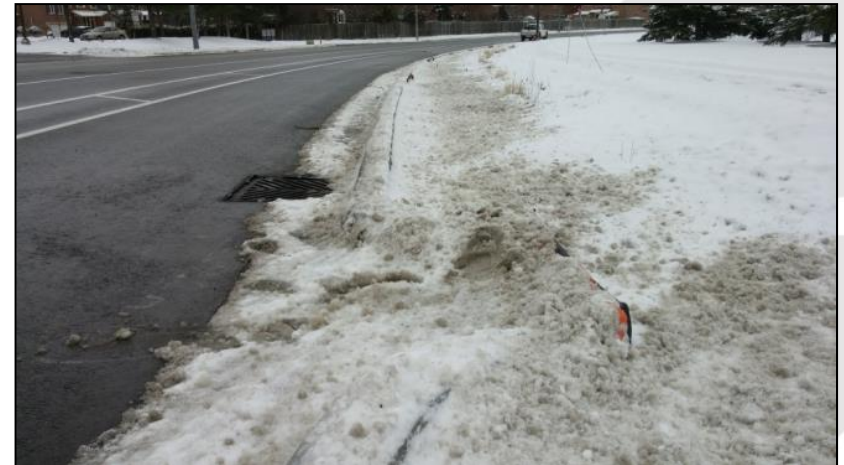
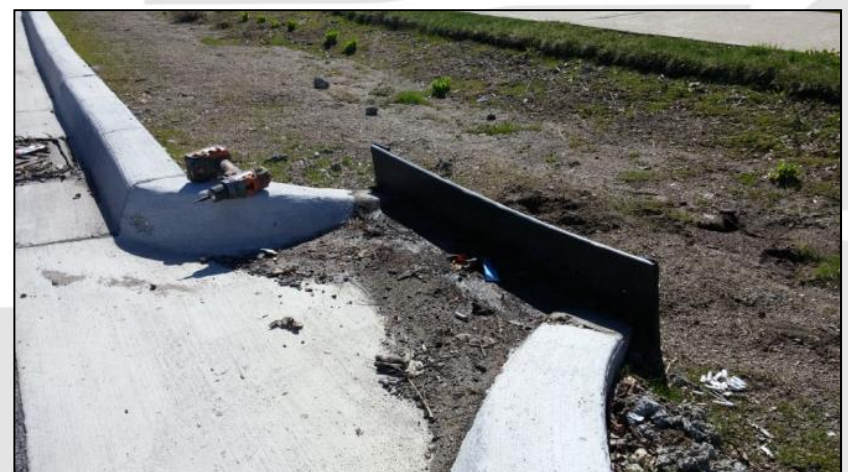
# County Court Blvd. Biofilter Swales – Winter Operation

- West Biowale inlets blocked over winter 2016 while East remained on-line;
- Some snowmelt and plowed snow still able to enter West Bioswale;
- Sediment accumulation at inlets  $\geq 5$  cm – sediment removal needed annually in early spring;
- Bioswales affected by ingress of salty interflow from surrounding landscapes;
- Biomedia samples at inlets and along centreline showed sodium (SAR) contamination during winter, but back below guideline by end of April.

- Operation during winter 2016 had no significant effects on biofilter swale treatment performance;
- Biomedia showed sodium contamination within the top 10 cm at inlets during winter months; SAR declined to below Ontario parkland/residential guideline of 5 by end of April.
- Despite efforts to dam inlets, monitoring results show that substantial quantities of snowmelt and plowed snow enters the bioswales over the curb (and past dams/sandbags?);
- In contexts where BMPs are to be taken out of service during winter, inlets should be designed with sluice gates or other flow diversion devices.

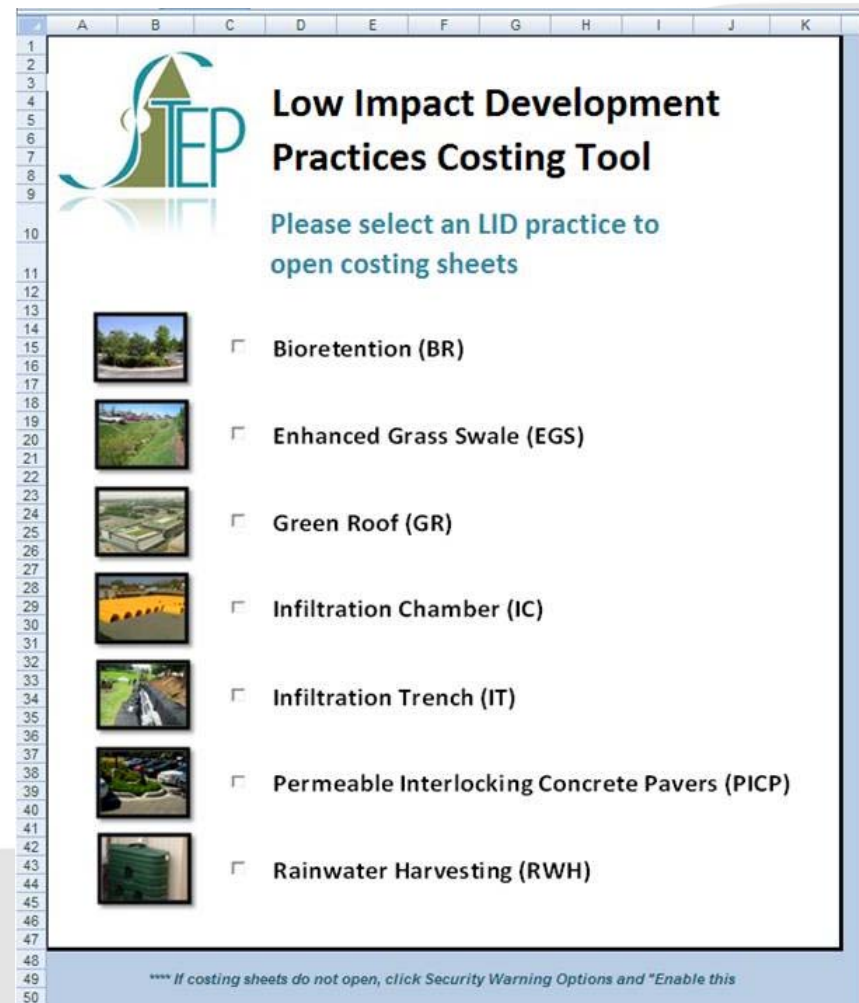
# LID BMP Life Cycle Costing Tool

- User enters site characteristics, and can modify default design and maintenance parameters;
- Tool provides capital, maintenance, inspection and rehabilitation cost estimates;
- Inflation factor can be applied to update costs to current year;
- Version 1.1 free to download;
- Version 2.0 coming soon!
