Wychwood Subdivision, City of Brampton

Low Impact Development Infrastructure Performance and Risk Assessment

Technical Report Monitoring Results (2016-2017)

Prepared by:
Credit Valley Conservation

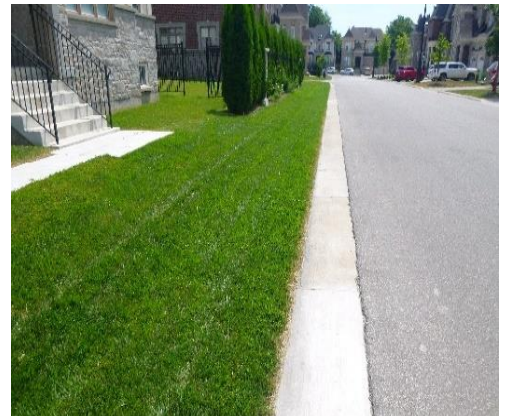
Figure 1: Wychwood grass swale. Source: CVC

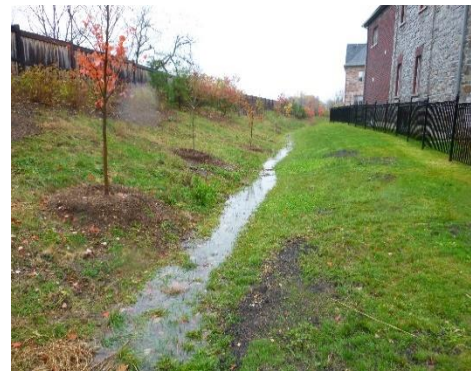
Figure 2: Wychwood bioswale. Source: CVC

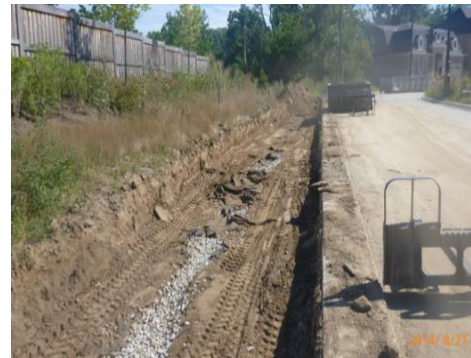
Figure 3: Rehabilitation of bioswale. Source: CVC

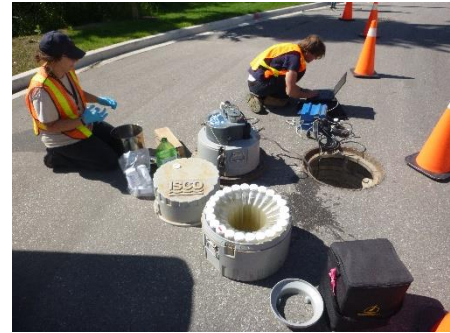
Figure 4: Performance monitoring data collection. Source: CVC

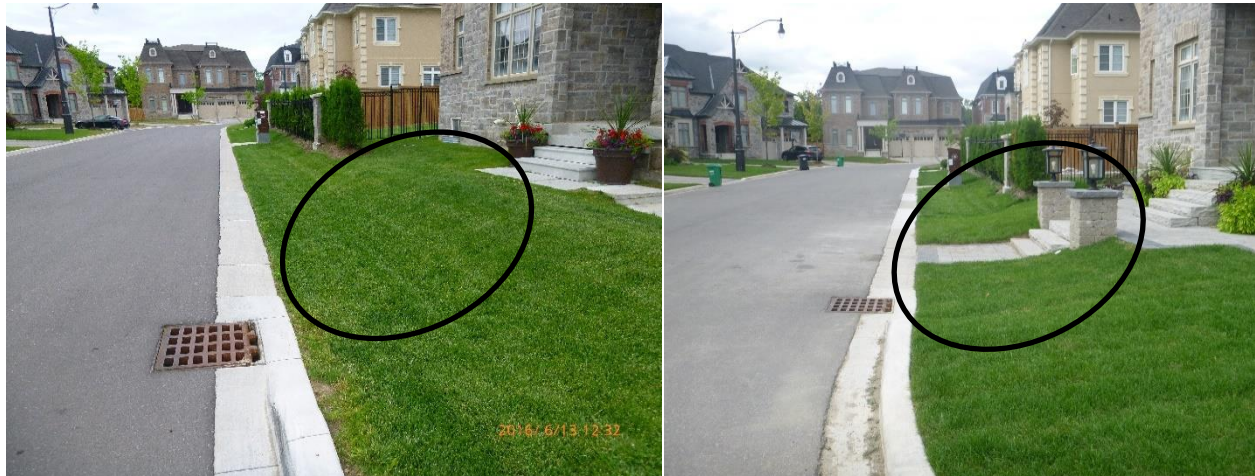
Figure 5: Resident walkway constructed through grass swale. Source: CVC

It is essential for municipal authorities to properly regulate impervious landscaping within stormwater features on municipal property and enforce by-laws to protect the feature from being included in lot-level landscaping. Figure 5 represents a case from Wychwood where a resident has extended a private walkway through the enhanced swale, potentially impacting the underlining infrastructure and the feature's infiltration and storage capacity.

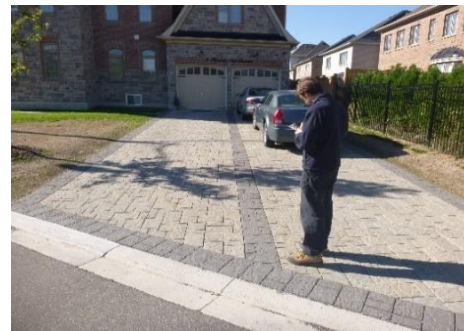
Figure 6: Site Maintenance Inspections. Source: CVC

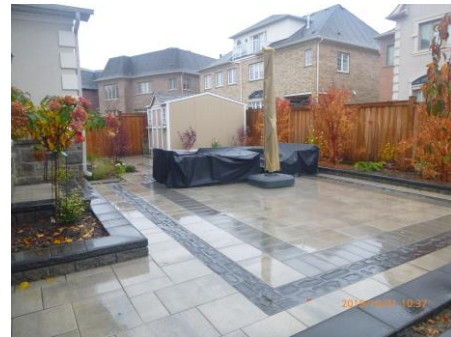
Figure 7: Residential yard with added impervious cover. Source: CVC

Nearly half of the 70 lots at Wychwood have either added impervious landscape features to their property or have modified lot-level drainage, increasing runoff volumes directed towards the LID features. (CVC, 2020)

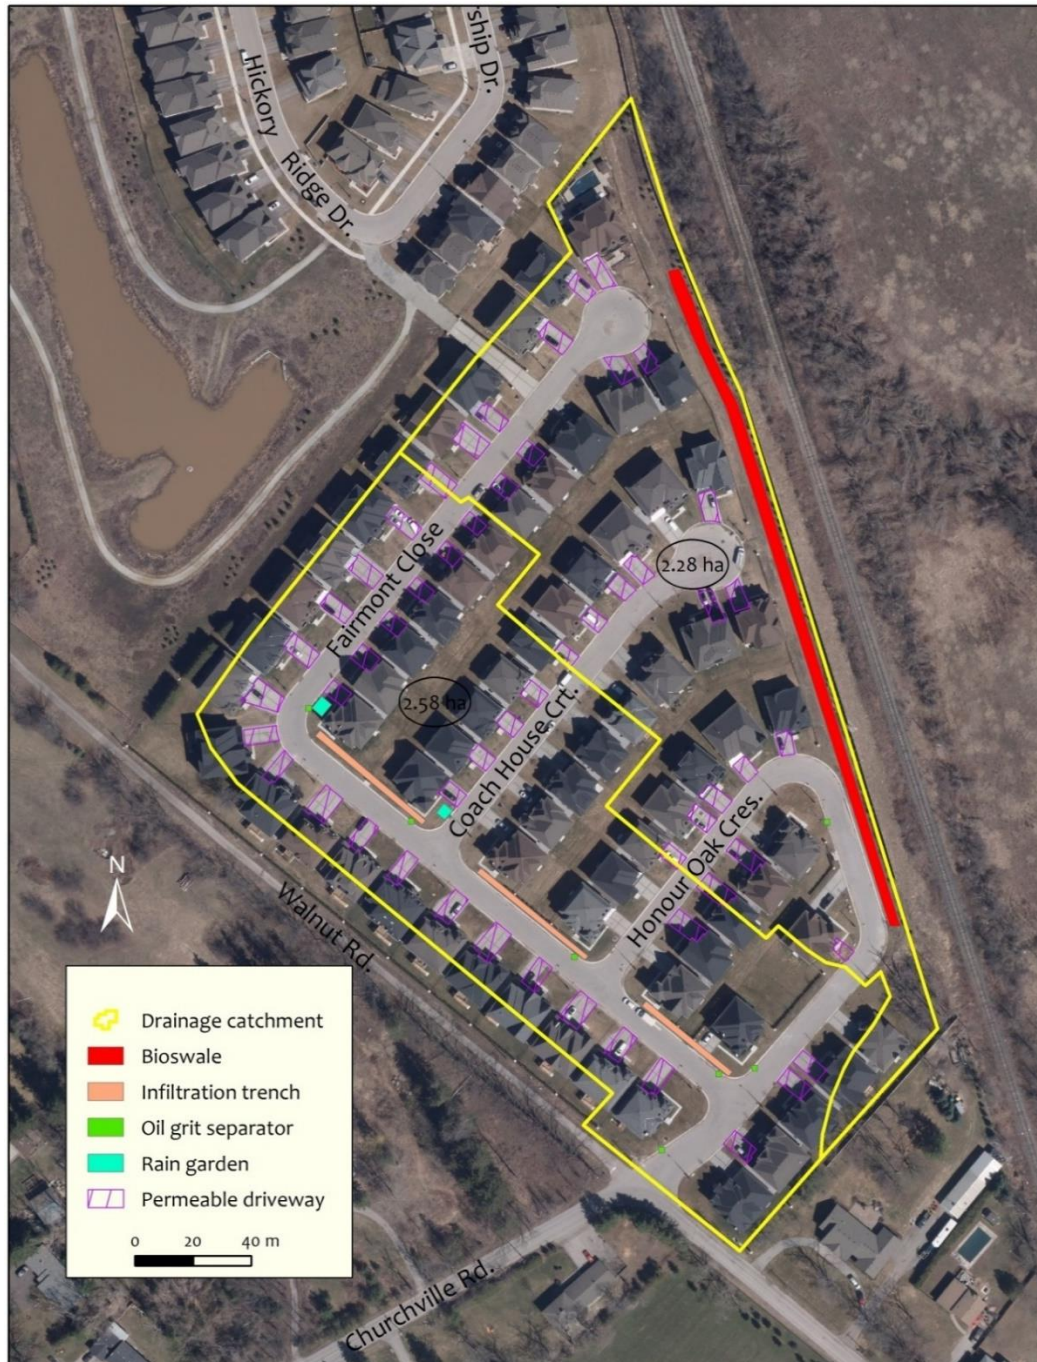
Figure 3-3: Western and Eastern Catchment Area

The site is divided up into two separate drainage areas, each with its own LID features. Figure 3-3 shows both drainage areas and the stormwater features within each catchment.

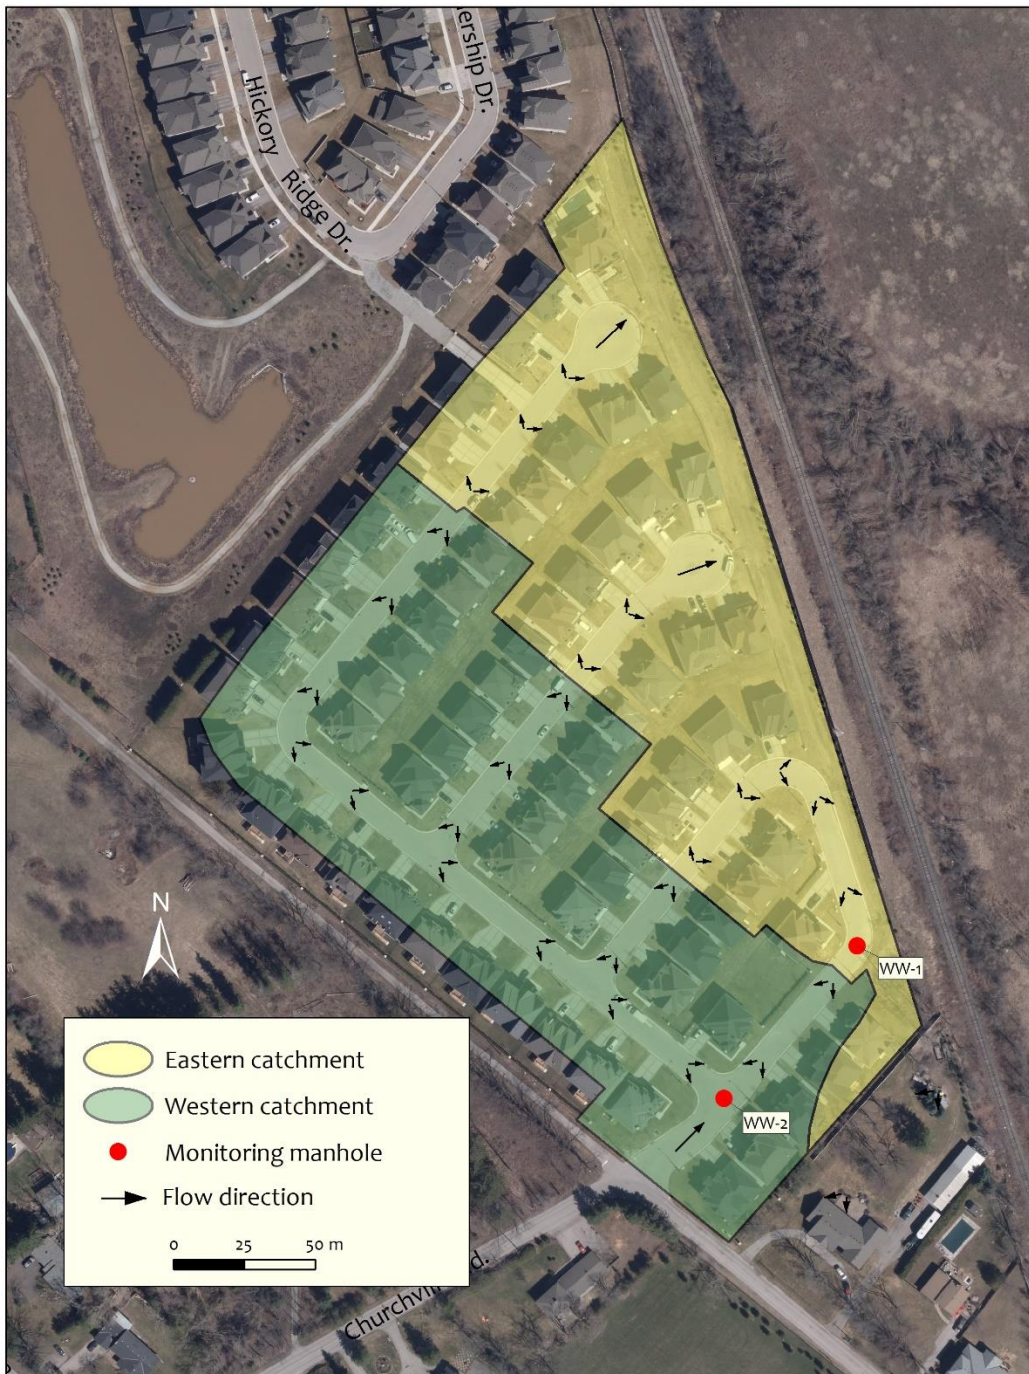
Within the eastern portion of the subdivision all minor and major runoff flows are controlled by a bioswale, which provides water quantity and quality control as well as erosion controls through the bioswale itself and the infiltration trench component beneath. The first flush portion of runoff events from impervious surfaces is treated by filtering through the bioswale and allowing for some fines to settle. Additionally, a single catch basin located on Honour Oak Crescent will provide runoff pre-treatment through the installed Stormceptor® for a small portion of the impervious surface. Similar to the infiltration trench in the western drainage system, there is a perforated pipe wrapped in geotextile fabric with a downstream orifice designed to allow a controlled release of stormwater so that the storage capacity of the bioswale may be fully utilized. The perforated pipe is located at the bottom of the feature invert of the infiltration trench and is sloped towards the downstream section of the trench to provide positive drainage towards the bioswale outlet. Figure 3-4 presents the flow path through the subdivision and identifies the sewer monitoring locations.

Figure 3-4: Flow Direction and Monitoring Locations

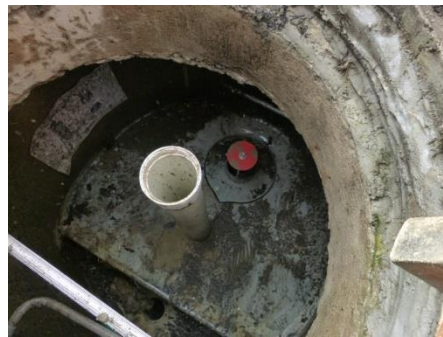
Figure 3-5: Stormceptor

Oil and Grit Separator (OGS): Stormceptor® STC 300 OGS units (Figure 3-5) are installed in all but two catch basins within the subdivision and are used to remove oil, grease and sediments from runoff. Stormwater flows treated by the OGS system are then conveyed to the perforated pipe within the infiltration trenches (TMIG, 2012).

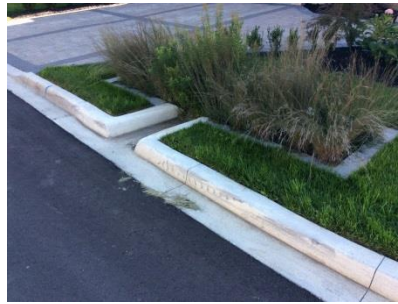
Enhanced Dry Grass Swales and Rain Gardens: The western drainage area that does not drain into the OGS units is pre-treated via enhanced swales and rain gardens. Curb inlets to the swales and the rain gardens are located at low points within the western ROW. Runoff will filter through the media in the swales/rain gardens and enter into the infiltration trenches below. Surface ponding within the grass swales and rain gardens over periods greater than 24 hours is not expected because stormwater should infiltrate into the infiltration trench. Overflow catch basins have been installed downstream of each rain garden inlet but not within the infiltration swale within the ROW (TMIG, 2012).

Figure 3-6: Rain Garden

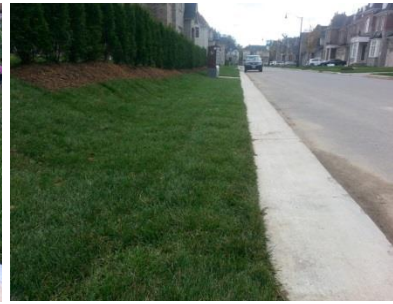
Figure 3-7: Infiltration Grass Swale

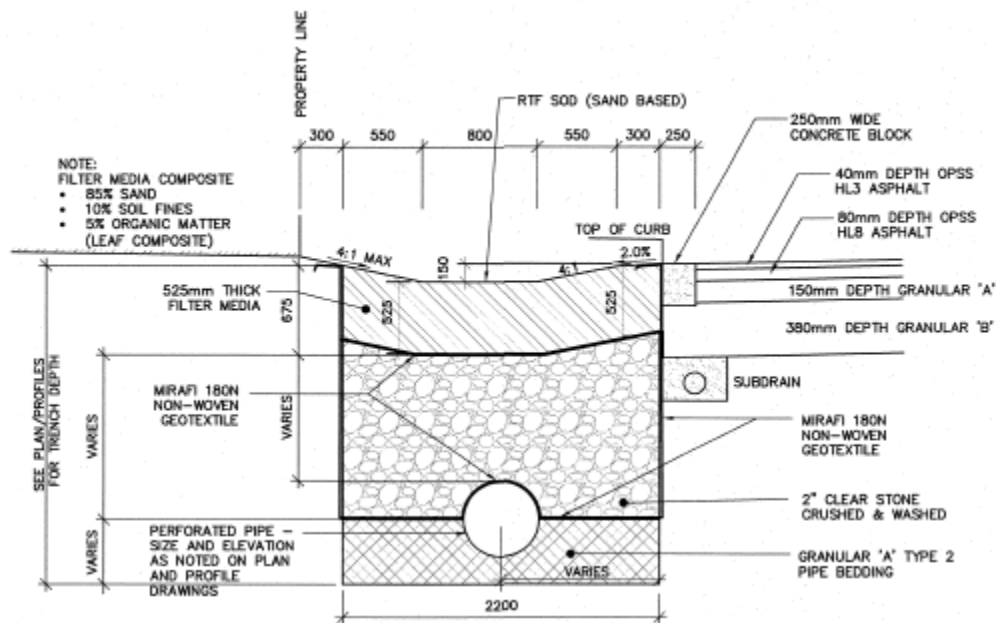
Figure 3-8: Cross section of Infiltration Trench System (TMIG, 2010)

The infiltration trench serves multiple functions: it serves as storage for erosion control and provides opportunities for infiltration to satisfy the water balance and water quality requirements. It also provides detention of runoff through the controlled flow outlet structures at the end of the system. The infiltration trench system has an estimated total storage volume of 191 m³ (Figure 3-8: Cross section of Infiltration Trench System (TMIG, 2010)

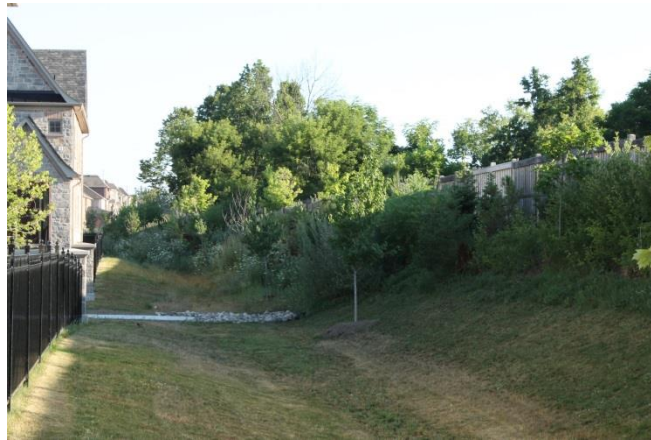
Figure 3-9: Bioswale

Bioswale and Perforated Pipe Infiltration System: A linear bioswale is installed within the buffer area adjacent to the rail line (Figure 3-9). The bioswale has an engineered soil media largely made of fine and course sand material. Underneath the bioswale is a layer of high-performance pipe bedding clear stone with an infiltration trench and perforated pipe system (Figure 3-10). The perforated pipe increases in size from 375 mm to 450 mm to 525 mm as cumulative flows infiltrate through the bioswale and ultimately flow through the outlet. The bioswale has an estimated total storage volume of 703 m³ (TMIG, 2012).

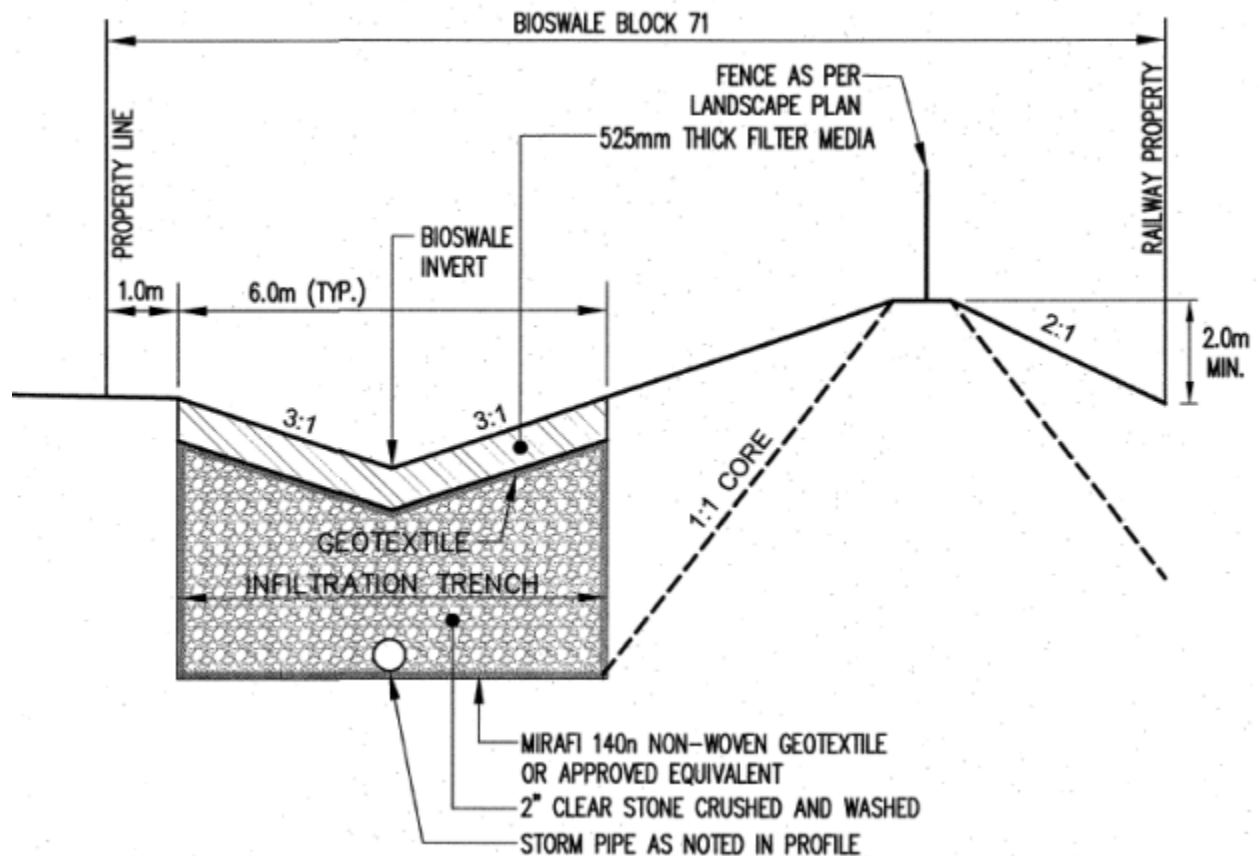
Figure 3-10: Cross section of Bioswale (TMIG, 2010)

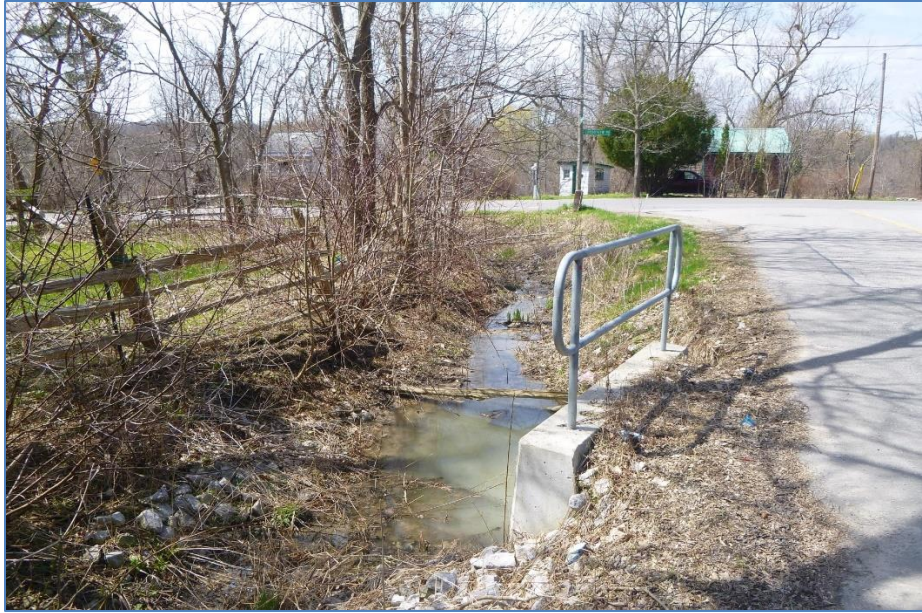
Figure 3-12: Outfall headwall and downstream receiver

The design consultant completed an analysis of the receiving ditch and determined the capacity of the ditch could manage peak flows from the 100yr design storm of $1.13\text{m}^3/\text{s}$ (TMIG, 2012). Additionally, the vegetation within the ditch will provide an added water quality benefit prior to discharging flows into the Credit River.

A summary of selected events where approximately 15 mm of rainfall had accumulated at Wychwood is provided in Table 4-13. Outflow and lag time results from the total site monitoring station (WW-2) for selected events indicates the site does not completely meet the erosion control criteria to manage, detain or reuse all runoff from a 15 mm event. For erosion control measures to be effective, a reduction in peak flows and runoff flow lag-time are necessary to limit erosion and stress on downstream infrastructure. However, during monitoring site visits and maintenance inspections no evidence of extensive erosion was observed within the site or in the downstream receiver within the roadside ditch on Churchville road (Figure 3-12).

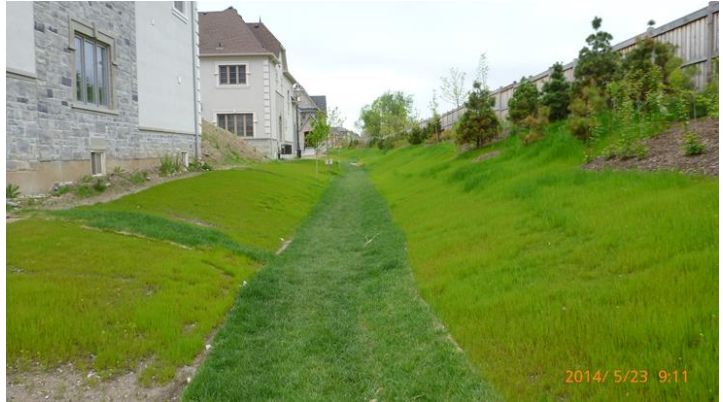
4) Staging Area

- Staging area should be determined pre-construction for material storage away from infiltration features to avoid compaction

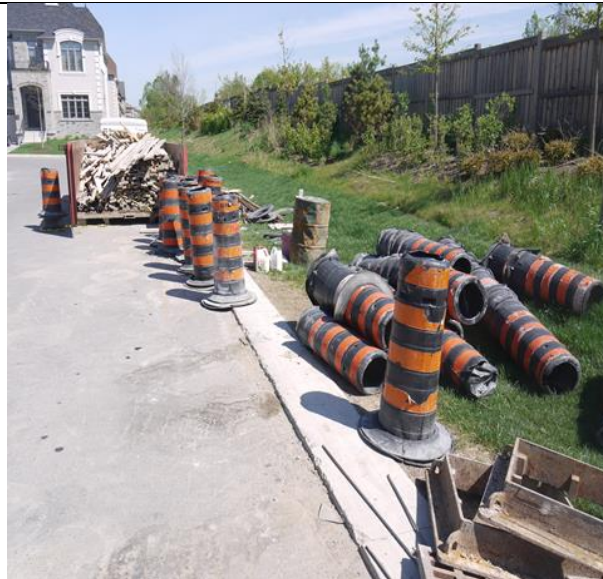
5) Finished Inlet Grades

- Recommended re-grading to design grades to allow runoff to enter the LID feature
- Grade drop will ensure positive drainage into the LID features. If there is insufficient grade drop, runoff bypassing or blockage could occur.

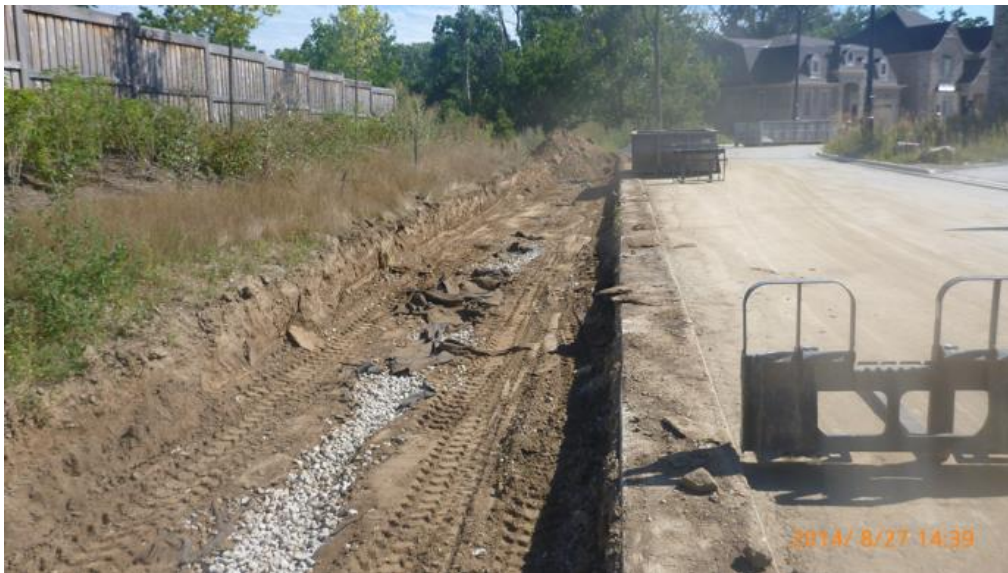
Figure 4-2: Remediation of Downstream Bioswale

Due in part to CVC's construction observations, testing, and partnership with the developer Sequoia Grove Homes, the bioswale was remediated to improve infiltration throughout the bioswale post-construction (Figure 4-2 and 4-3).

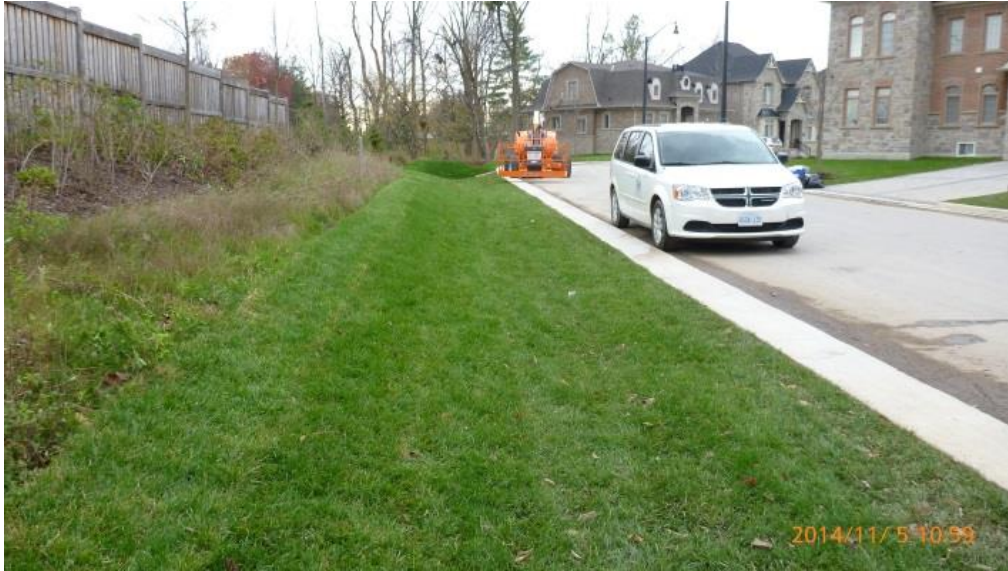
Figure 4-3: Bioswale feature remediated post-construction

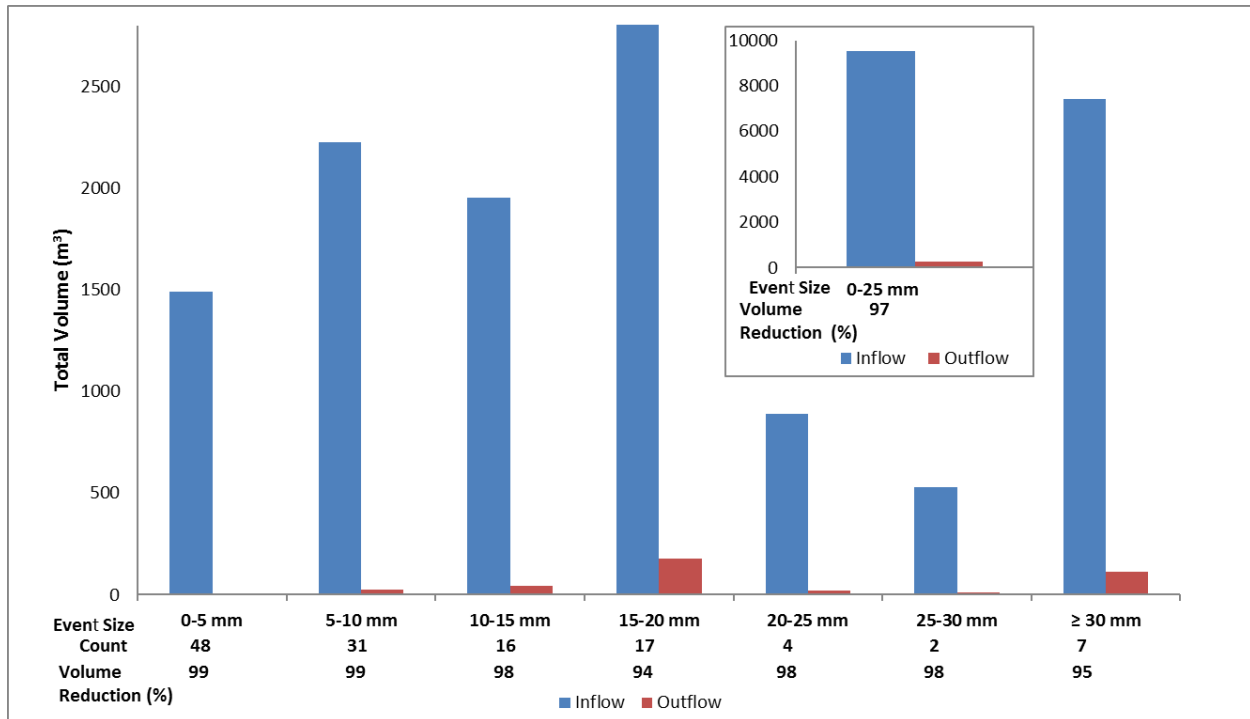
Figure 4-6: Runoff Volume Reductions measured at WW-1

Volume reductions for different precipitation event size bins for WW-1 and WW-2 are presented in Figure 4-6 and Figure 4-7. The total volume reduction from all measured events at WW-2, which represents outflow from 85 per cent of the subdivision catchment, was 73 per cent. For events under 25 mm, WW-2 detains 77 per cent of all runoff. The total volume reduction at WW-1, which measures outflow of the bioswale managing the eastern catchment is 97 per cent, and the volume reduction for events under 25 mm is also 97 per cent. Furthermore, result statistics summarized in Table 4-4 and Table 4-5 present high mean and median volume reduction results for both WW-1 and WW-2, demonstrating volume reductions the LID features have provided across a wide range of event flows.

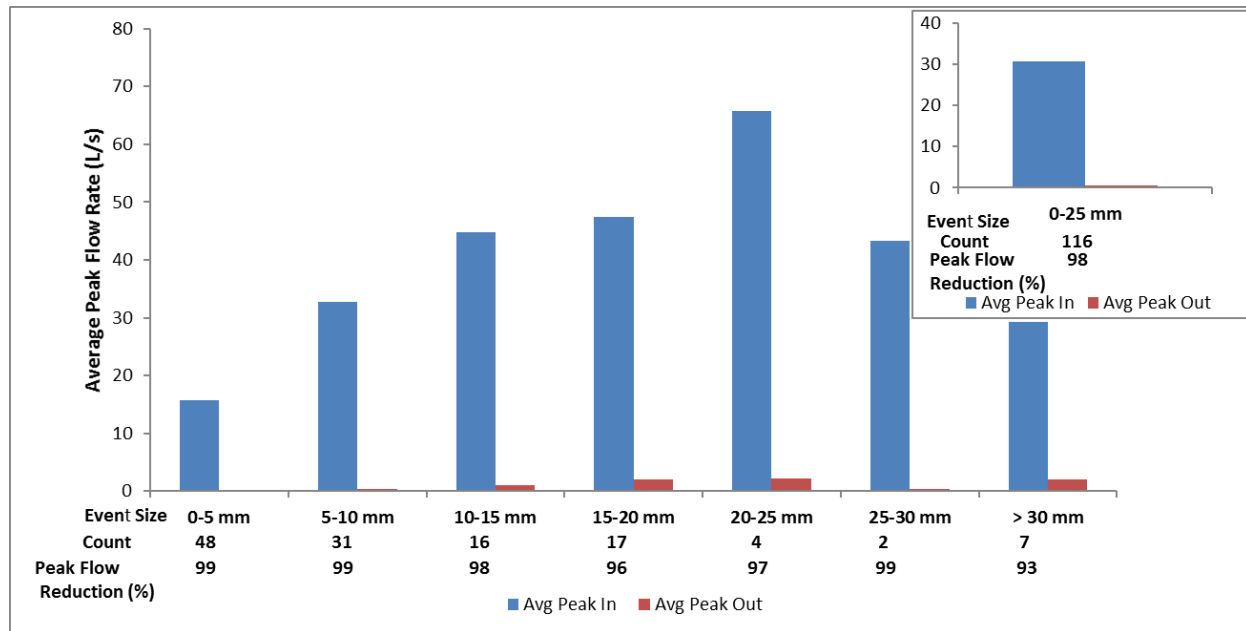
Figure 4-8: Mean peak flow reductions measured at WW-1

The volume storage provided by the LID features can help to reduce peak flows during less frequent events or high intensity events, which helps to prevent surcharging of downstream pipe infrastructure. The cumulative storage that can be provided by extensive LID implementation may contribute to the reduction of watercourse flooding as well. Median peak flow reductions presented in Table 4-4 and Table 4-5 for WW-1 and WW-2 monitoring locations are 100 per cent and 87 per cent respectively. Average peak flow reductions for both monitoring locations are presented in Figure 4-8 and Figure 4-9. During the monitoring period, 85 events measured at WW-2 (summarized in Figure 4-9) had magnitudes of 25 mm or less. For these events, an average peak flow reduction of 82 per cent was provided by the LID features. For large events greater than 30 mm, peak flows were reduced by at least 74 per cent. A comparison of peak flows observed at the WW-1 station against those calculated from the Simple Method (summarized in Figure 4-8) indicate a peak flow reduction of 98 per cent provided by the bioswale for 116 events within the 25 mm or less range and 93 per cent for events greater than 30 mm.

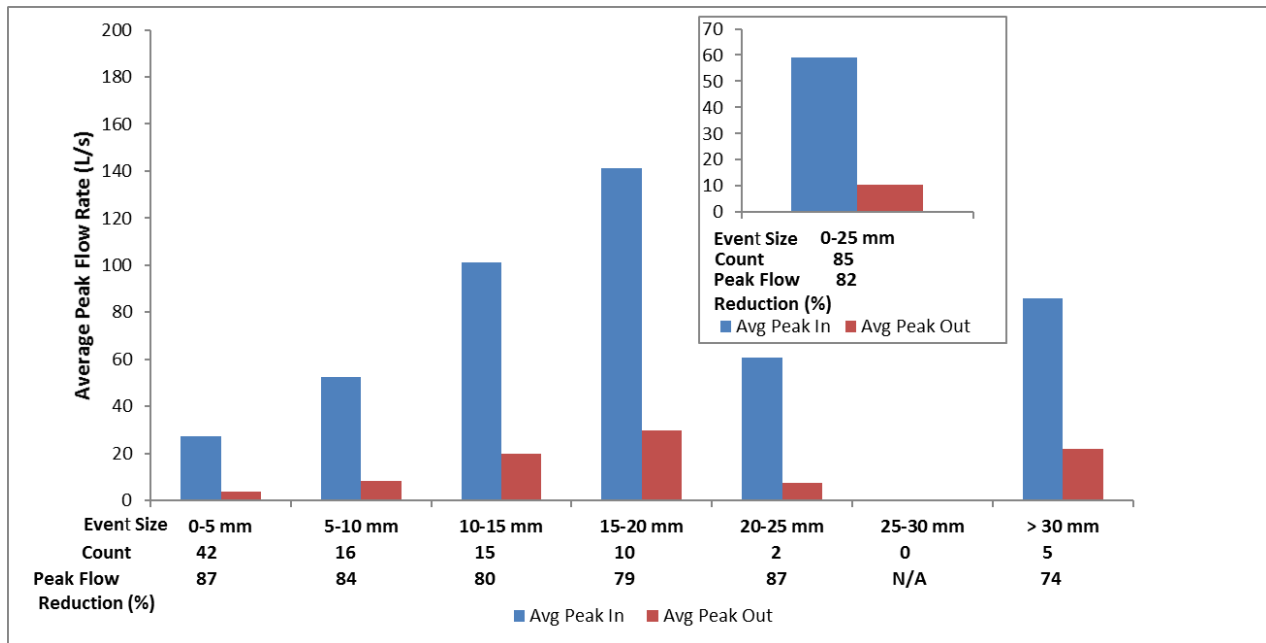
Figure 4-9: Mean peak flow reductions measured at WW-2

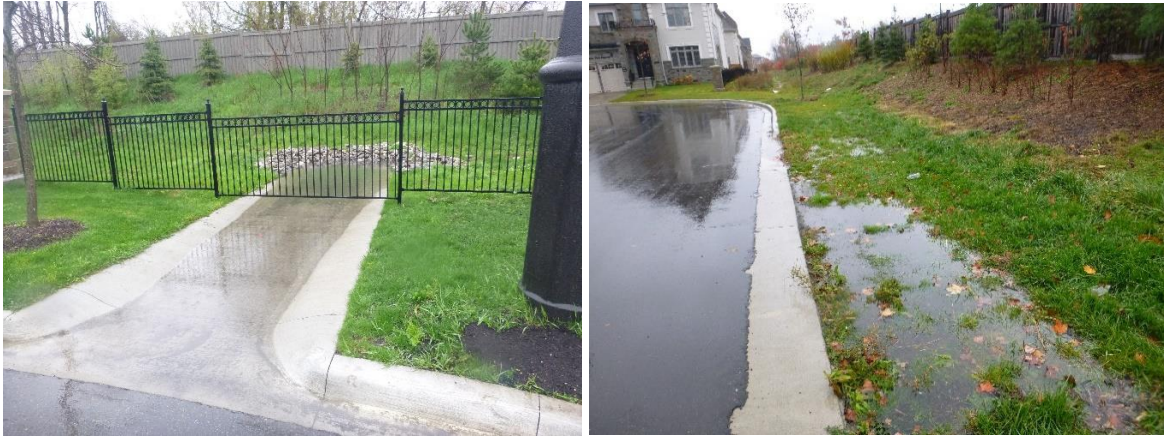
Figure 4-12: Curb-cut and Rolled Curb Inlets to Bioswale

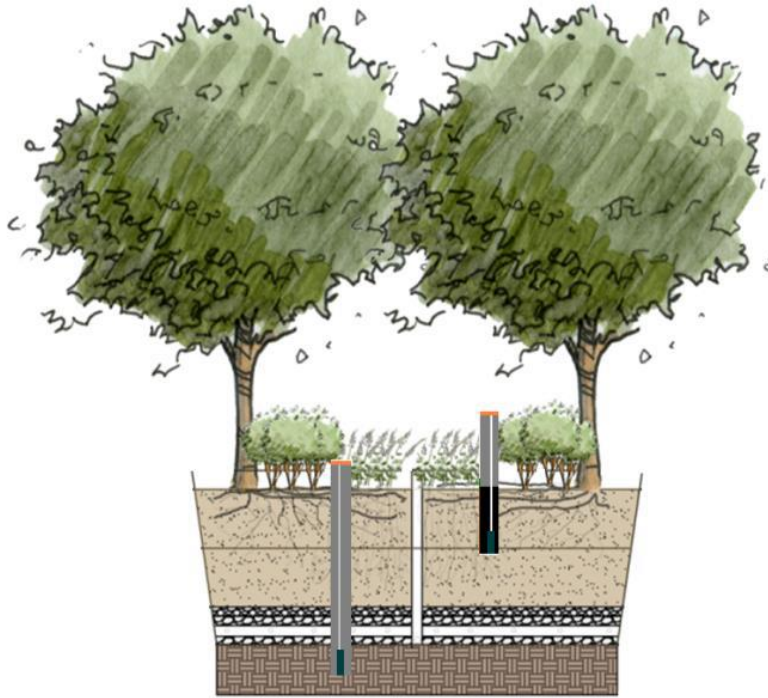
Figure 4-16: Example bioretention cell cross section with monitoring wells

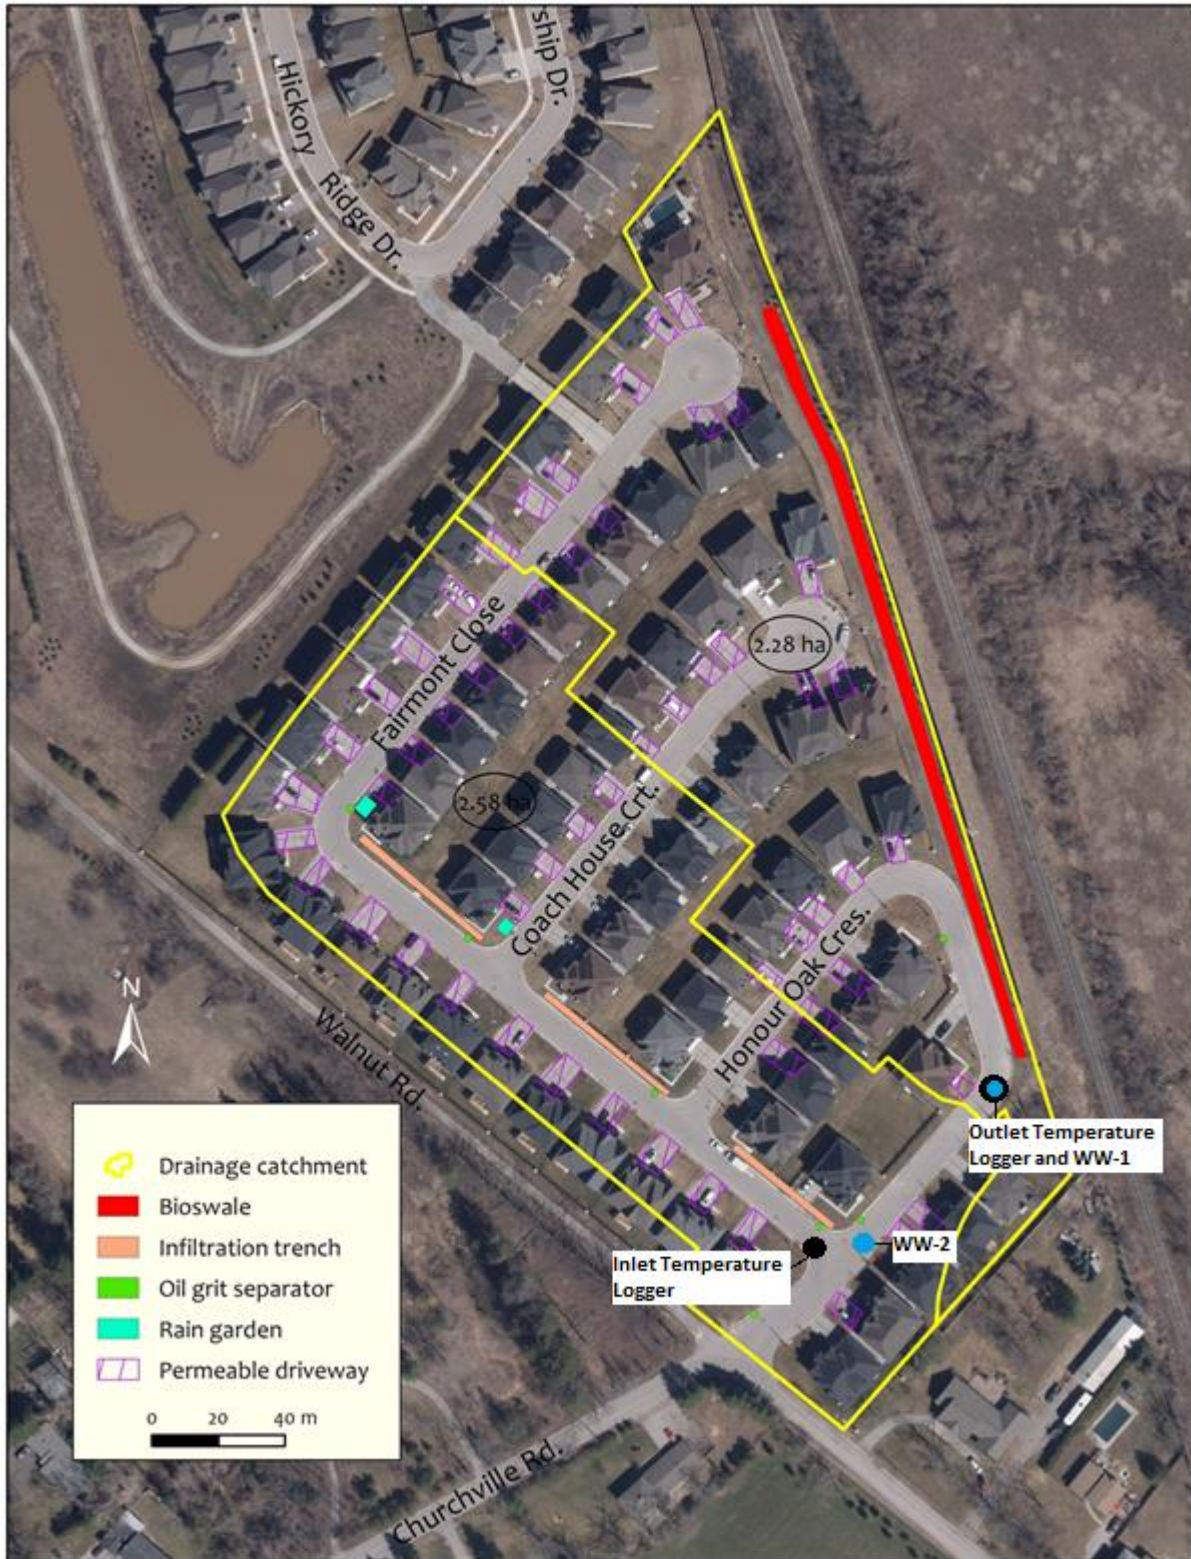
temperature of water flowing in and out of the LID facility during an event, whereas thermal load is the amount of energy introduced to the LID facility from heat transferred to stormwater from surface runoff. In order to assess thermal mitigation and calculate EMTs, HOBO pendant temperature loggers were deployed at the inflow catch basin at Fairmont Close and Honour Oak Crescent, and at the bioswale outflow manhole located at WW-1 as indicated in Figure 4-21. Both loggers are set to record temperatures at five-minute intervals. Refer to **Appendix G** for further details of the methodology and analyses used for determining thermal mitigation through the LID. It is important to note that monitoring station WW-1 was chosen for the thermal analysis as WW-2 has baseflow present, which would add complexities to the analysis. Thus, the results discussed in this section cannot be generalized for the entire subdivision.

Figure 4-21: Overview of the Wychwood LID subdivision and location of the inlet and outlet temperature loggers as well as the WW-1 and WW-2 monitoring manholes.

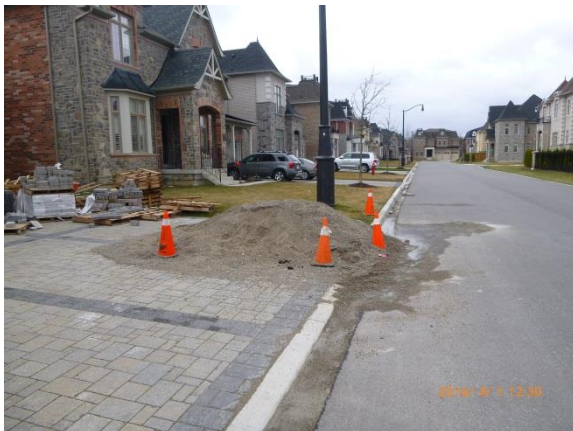
Figure 4-26: Improper material storage

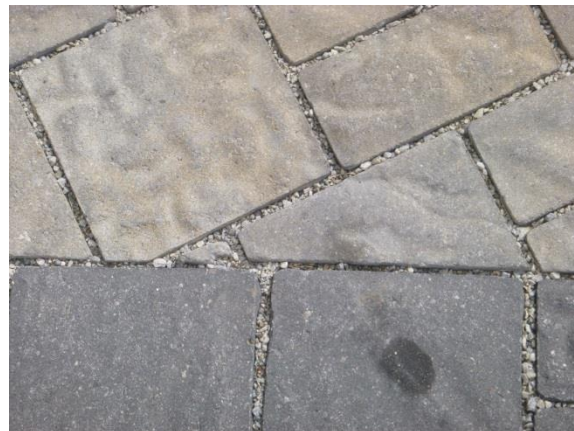
During the maintenance inspections it was observed that several properties had ongoing landscaping and construction projects. Construction materials (sand, flagstone, etc.) were observed to be staged on the permeable pavement during some of these projects (Figure 4-26). A close up of permeable pavement is shown in Figure 4-27 prior to being used for material storage. Staging these materials on the permeable pavement reduces the infiltration capacity as it blocks that surface area footprint from accepting infiltration. Construction materials such as sand can also run off these piles during rain events and clog the joints in-between the paving stones which further reduces the infiltration capacity of the permeable pavement (Figure 4-28). To prevent these issues in the future home owners can inform landscape and construction contractors of the permeable pavement function and they may be able to stage construction materials in a better location or at minimum lay down a surface cover such as plywood to prevent the pavement from becoming clogged (Figure 4-29). Vegetation growing through permeable pavement stones can be seen in Figure 4-30, which, can also reduce the infiltration provided by these LID features. Sunken paving stones were also observed during the maintenance inspections which may be due to contractors not compacting the granular bed material prior to the installation of the paving stones. These deficiencies reduce the water quality and quantity performance of these features.

Figure 4-27: Prior to material storage, free of Impediments

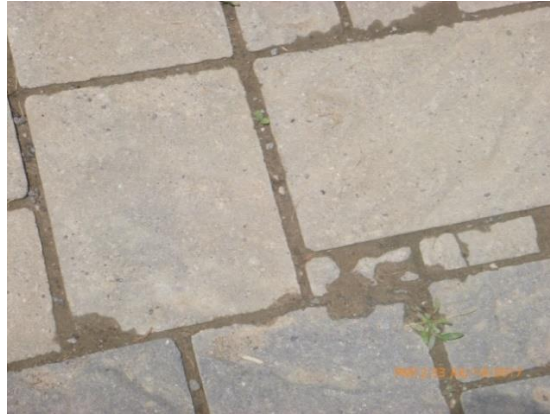
Figure 4-28: Close-up of Permeable Pavement Blockage, July 2017

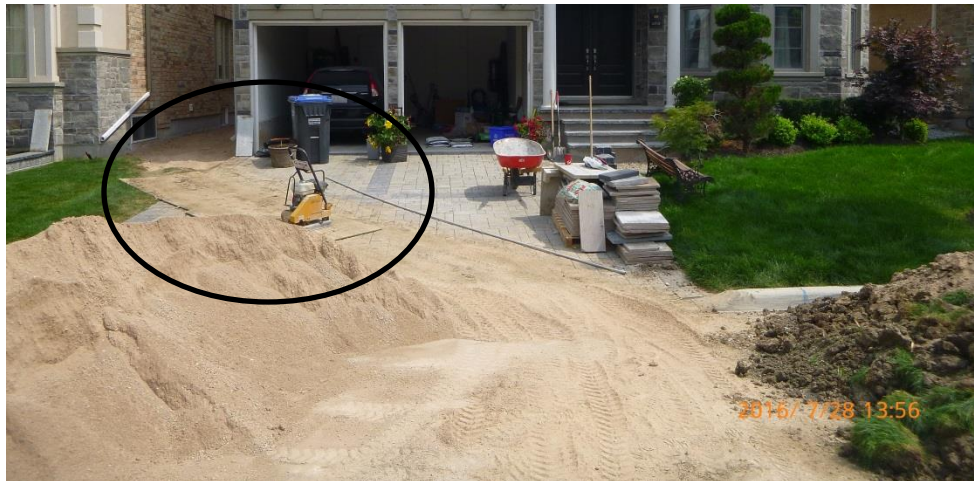
Figure 4-29: Permeable Pavement Blocked with Construction Materials in July 2016

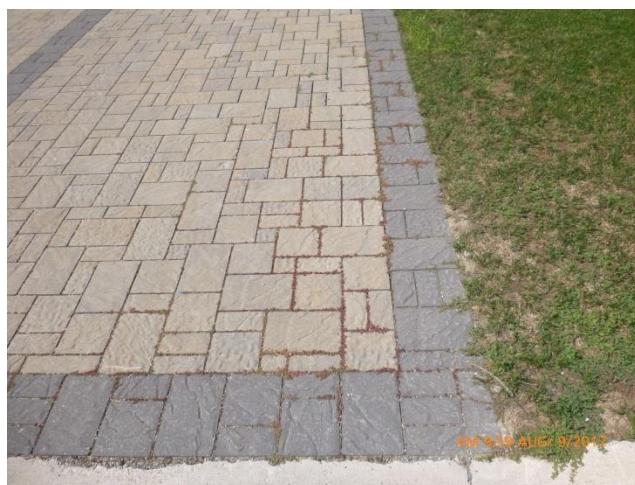
Figure 4-30: Permeable Pavement Partially Blocked with Weeds in August 2017

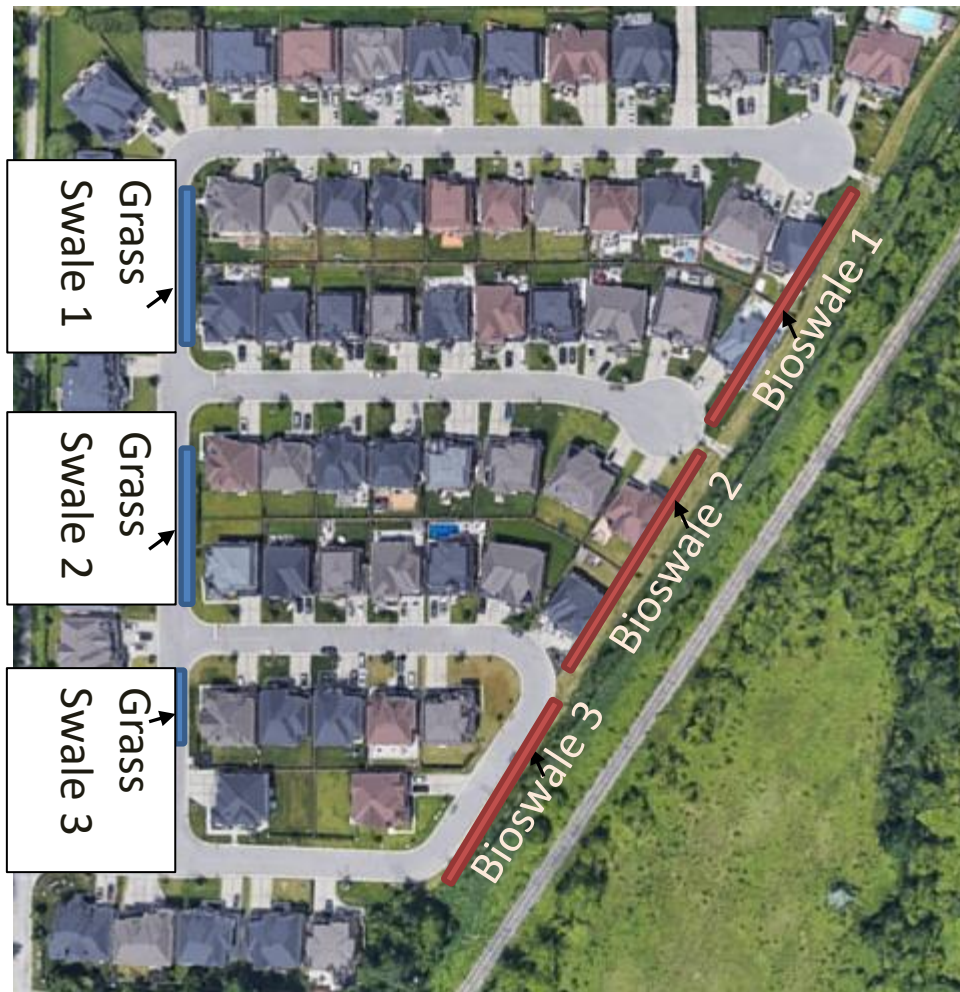
The difference between the bioswale and the grass swale may be due to the impact of the home owners. The bioswale is fenced off from the adjacent homeowner’s properties and is maintained by a City of Brampton subcontractor. The grass swales are located adjacent to the houses along Fairmont Close and there is no barrier so these home owners take responsibility for maintaining this feature (i.e. removing trash, cutting grass, etc.). The home owners are invested in maintaining the appearance of their property therefore the grass swale feature may be benefiting from this relationship. Figure 4-31 presents a location overview of each inspected section of the bioswale and grass swale.

Figure 4-31: Location of each section of the grass swale and bioswale features as inspected

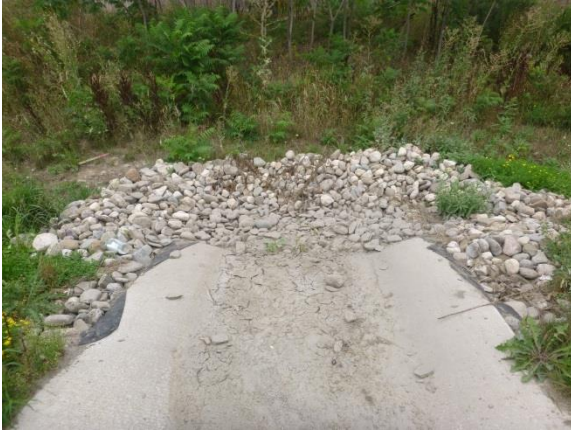
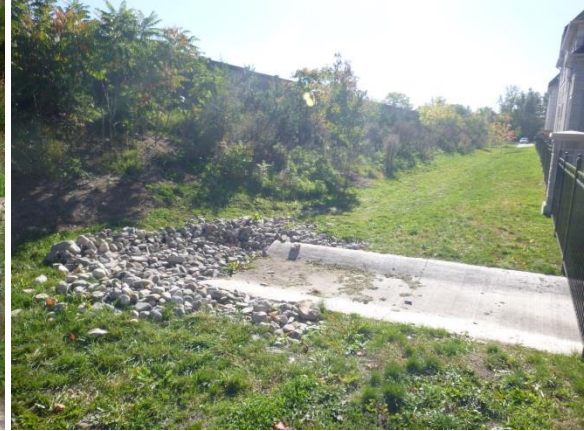
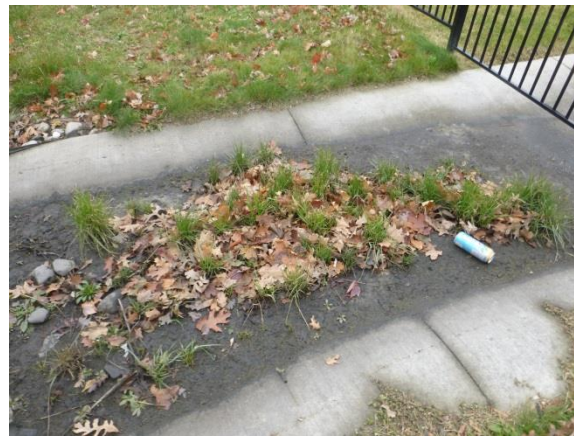
It was occasionally observed that the bioswale inlets were obstructed by sediment and debris accumulations (Figure 4-33 to Figure 4-32). Since the bioswale is located along the eastern property boundary and separated from the individual properties by a fence, this barrier may reduce the impact residents can have on the condition of the bioswale. The inlets to the bioswale (section 1 and 2) are curb cuts from Fairmont Close and Coach House Court which are prone to sediment accumulation and should be inspected seasonally to ensure runoff can freely flow into the feature. The inlet into the bioswale receiving runoff from Honour Oak Crescent is a rolled curb design and is not protected by a fence and as a result is accessible to residents and contractors. This design allows maintenance contractors to access the entire bioswale to mow the lawn and remove garbage and debris. However, during one maintenance inspection at Wychwood signs of truck washout were observed within the subdivision (see Figures 4-35 and 4-36). Truck washout may allow sediment to travel from the roadway into the bioswale which could reduce its efficiency by clogging the filter media. This activity should be avoided and could be eliminated if a designated washout and material storage station were provided during construction and landscaping activities. Street sweeping at least twice a year may help reduce the sediment and residual construction debris on the roadway making it less likely that it will be transported into the bioswale. During one occasion soil material was observed to be stored in one of the grass swales (see Figure 4-37).

Figure 4-33 to Figure 4-32: Bioswale Inlet (with sediment accumulation) in September 2016 and October 2016 and Bioswale Inlet (with sediment accumulation and vegetation growth) in December 2017.

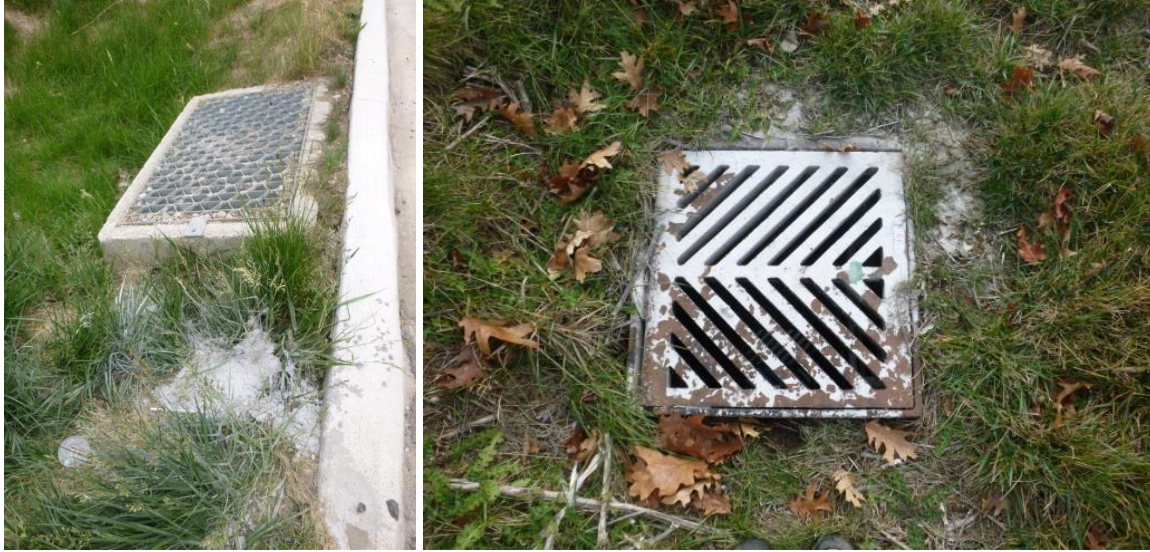
Figure 4-35 and Figure 4-36: Truck washout near rolled curb and overflow catch basin June, 2016 and signs of possible truck washout near catch basin in December 2017.

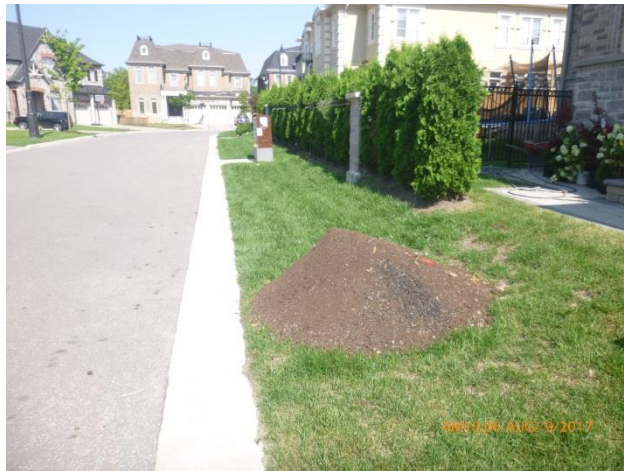
Figure 4-37: Excess soil material left in grass swale in August 2017
