Wychwood Subdivision, City of Brampton

Low Impact Development Infrastructure Performance and Risk Assessment

Technical Report Monitoring Results (2016-2017)

Prepared by:
Credit Valley Conservation

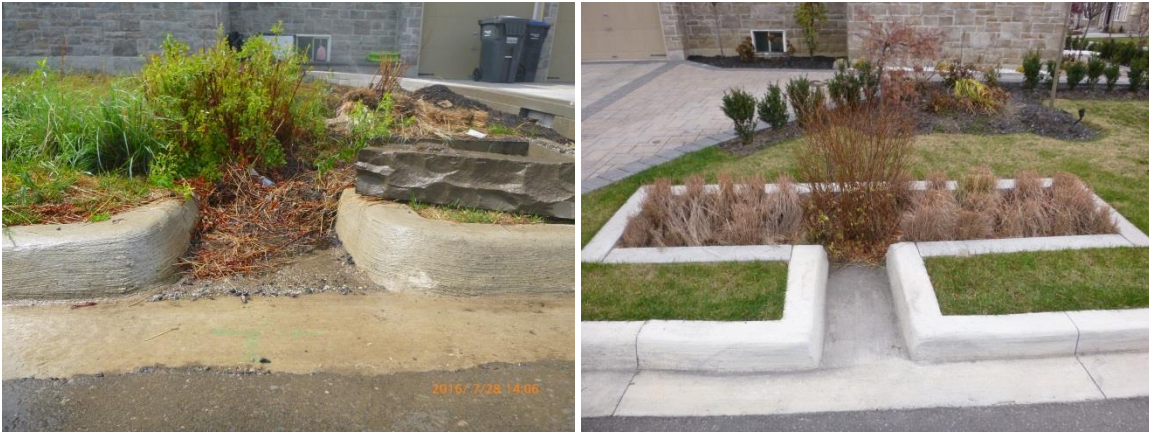
Figure 4-38 and Figure 4-39: Rain Garden Inlet (with debris and sediment accumulation and without impediments) in July 2016 and November 2016.

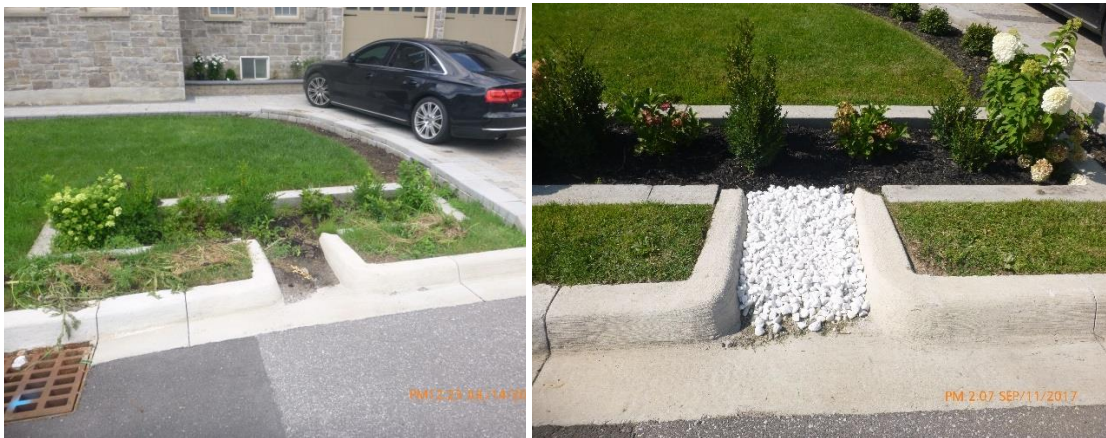
Figure 4-40 and Figure 4-41: Rain Garden Inlet (clogged with sediment prior to gravel installation and inlet modified by home owner) in July 2017 and September 2017.

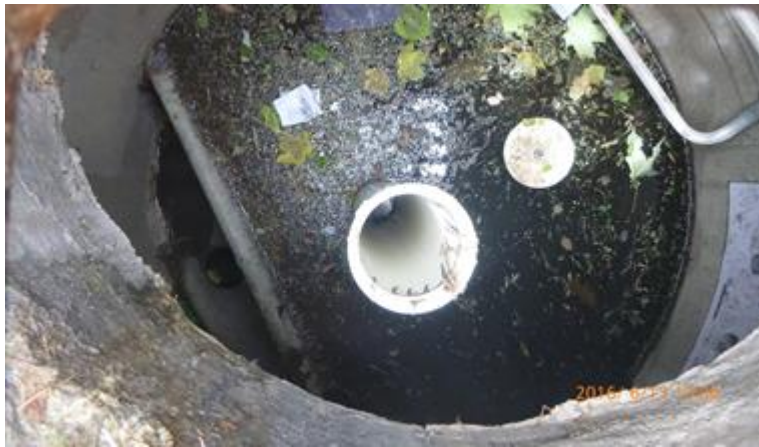
Figure 4-42: OGS clogged with sediment and grass clippings in June 2016

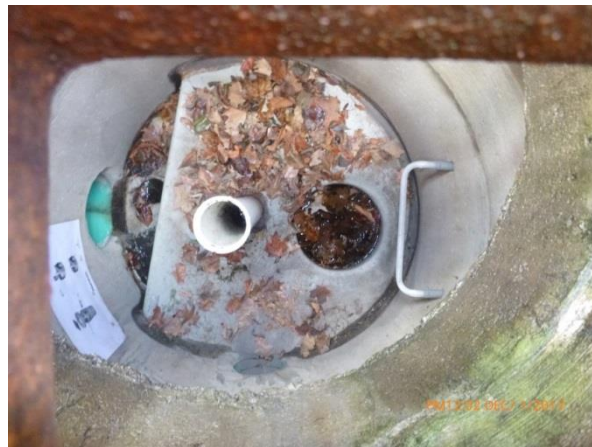
Figure 4-43: OGS with leaf litter in December 2017

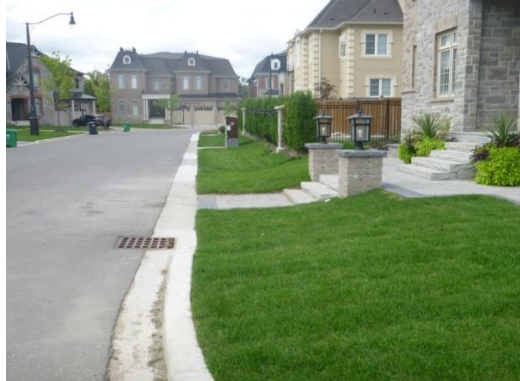
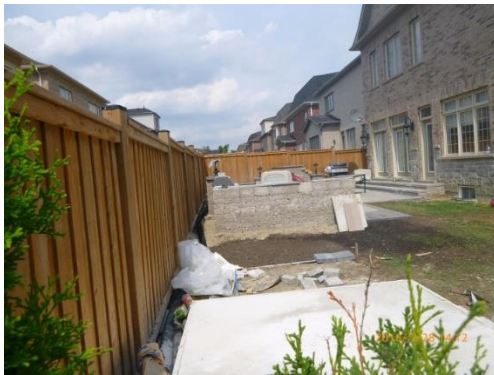
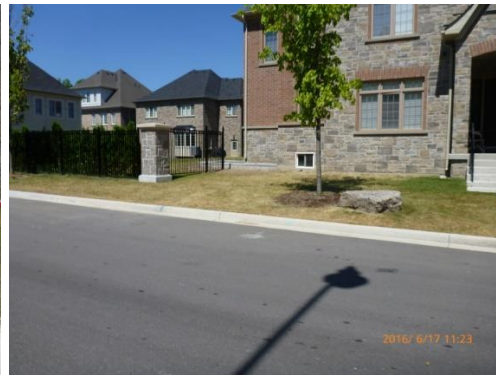
Another element related to the maintenance inspections is tracking, where possible, individual property owner's changes that affect the total impervious area of the subdivision (Figure 4-44 to Figure 4-46). Based on the maintenance inspections, over time, additional impervious areas were constructed (additional walkways or patio enlargements). These changes reduce the overall permeable area therefore increasing stormwater runoff. Individual home owners are allowed to modify their property (in accordance with applicable regulations) and since CVC only conducts the inspections on public land these changes in the drainage area may go unnoticed.

Figure 4-44 to Figure 4-46: Changes to the impervious area of individual homeowner's properties

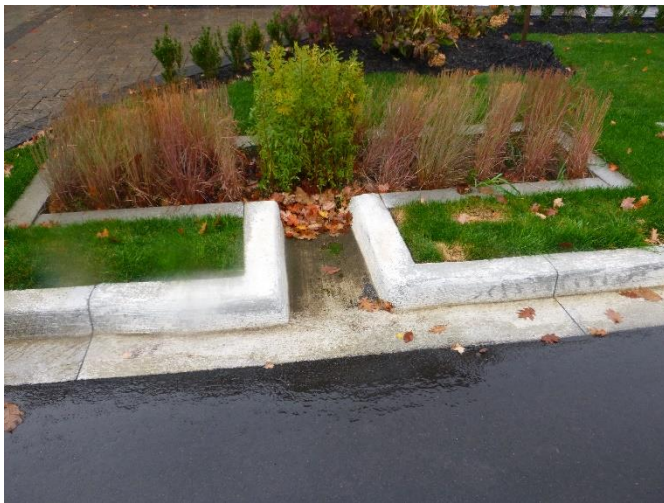
Figure 4-47: Rain Garden 90-degree inlet, bypass observed

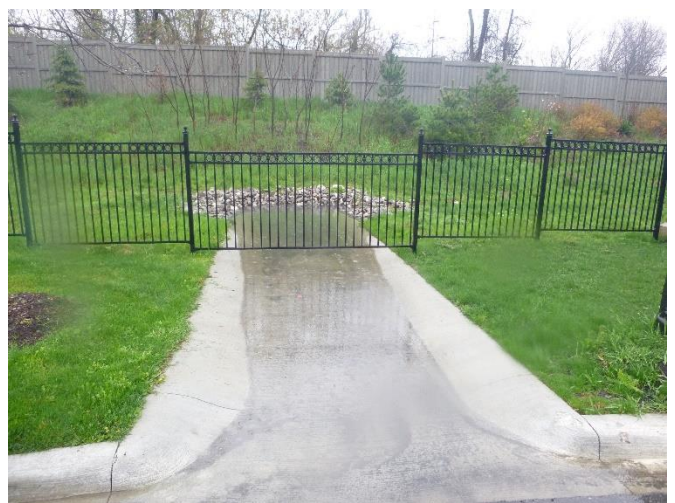
Figure 4-48: Example of wide curb cuts from bioswale

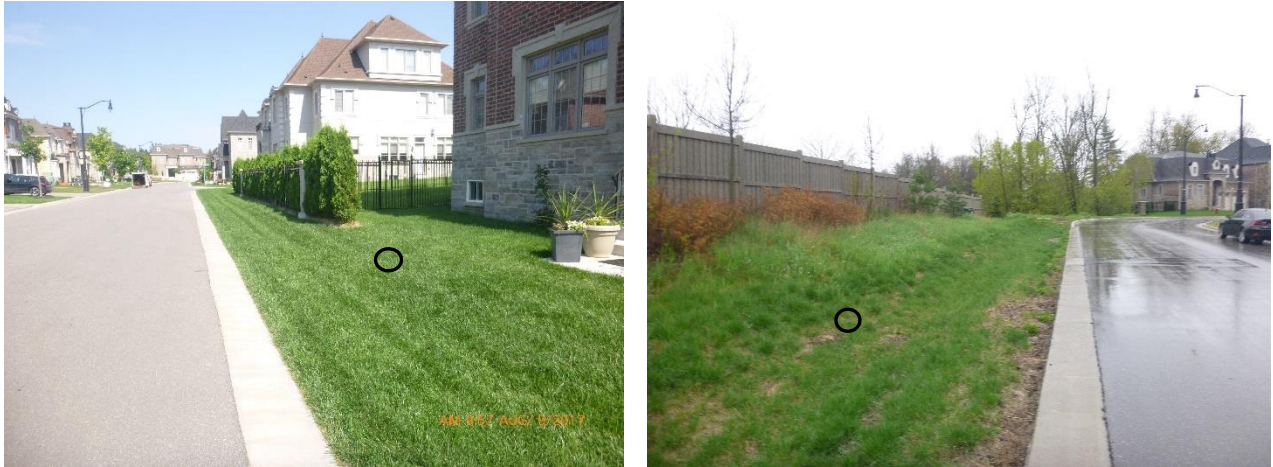
Figure 4-50 and Figure 4-51: Preferred Location for Shallow and Deep Well Installation
