Assessing the Health of Toronto Street Trees Irrigated by Stormwater

This study, conducted in partnership with the City of Toronto, assesses the health of street trees planted in 'soil cells' and conventional tree trenches. Three sets of the same two tree species (Freeman Maple and American Elm) planted in 2009 on Queensway Boulevard in Toronto were compared. The first two sets of trees were planted in supported soil cell systems (silva cell™). The others planted further west in tree trenches according to standard City of Toronto tree planting specifications were used as controls. One set of soil cell trees has been receiving stormwater runoff since the trees were planted. The other adjacent set of trees had the stormwater inlet pipe intentionally plugged by Toronto staff after 2 years to facilitate assessment of the effects of stormwater runoff on tree health. The standard control trees were not irrigated with stormwater runoff.

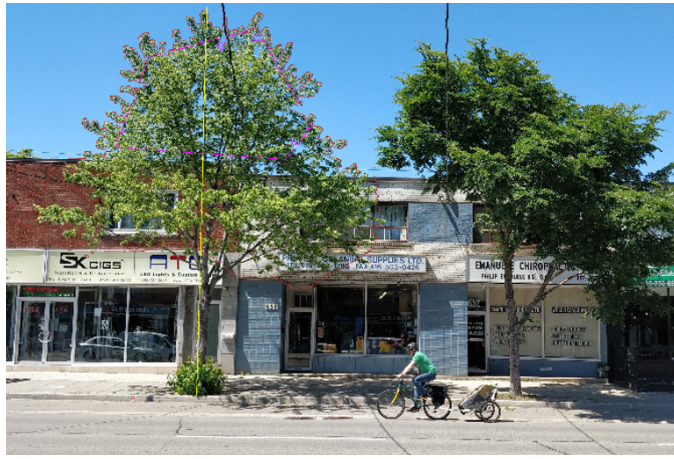
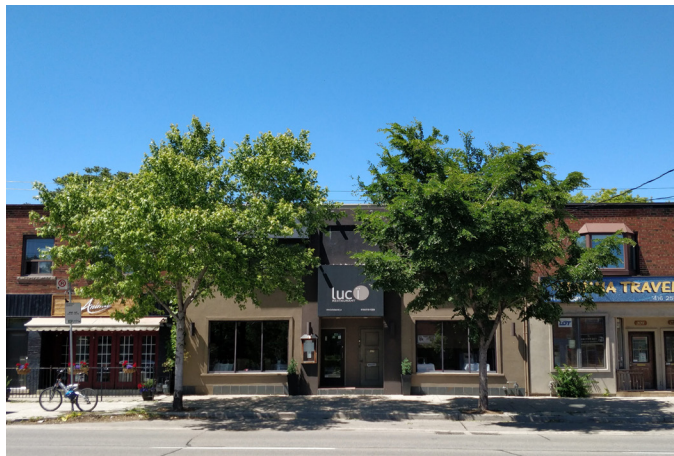
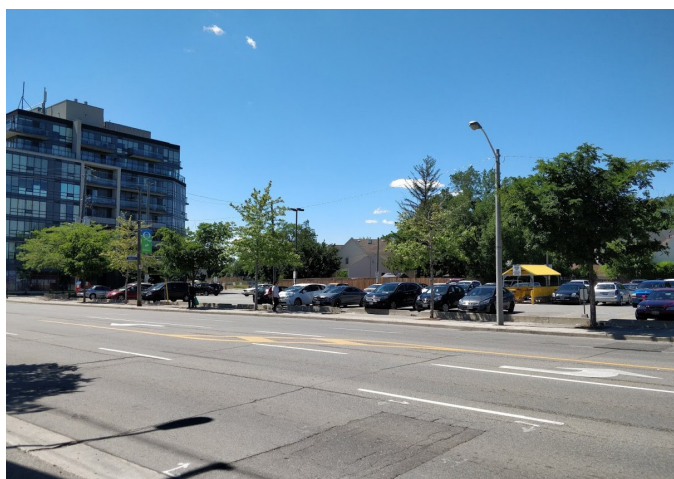
Figure 3. Stormwater trees (top) and dry cell trees (middle) and control trees (bottom) in June 2018

Unlike the other trees in this study, the stormwater cell Maple was surrounded by concrete slabs that caused damage to the base of the tree trunk as the tree matured. This caused suckers to spring up at the base. It is unknown how this scarring may have affected overall growth and health of the tree. Shoots developing from the tree base are often considered to be a sign of stress.

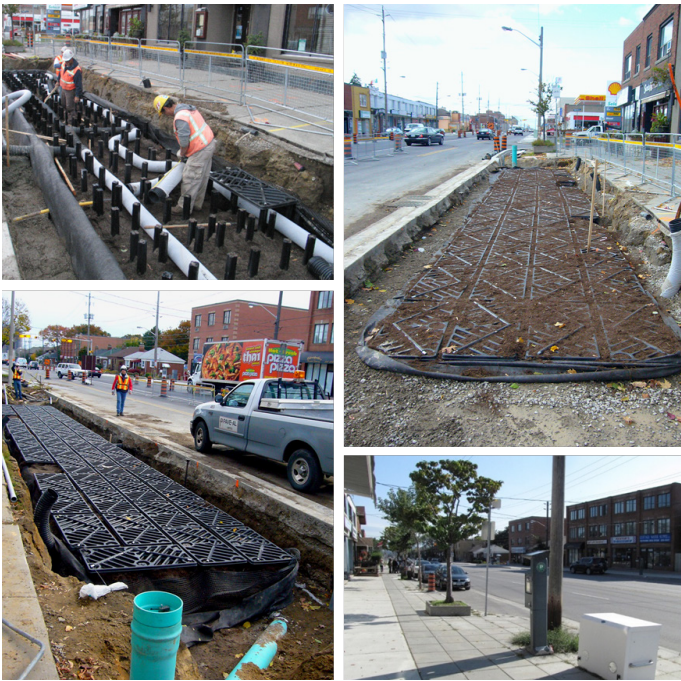
Figure 4. Soil cell construction and final planting (source: P. Cheung)

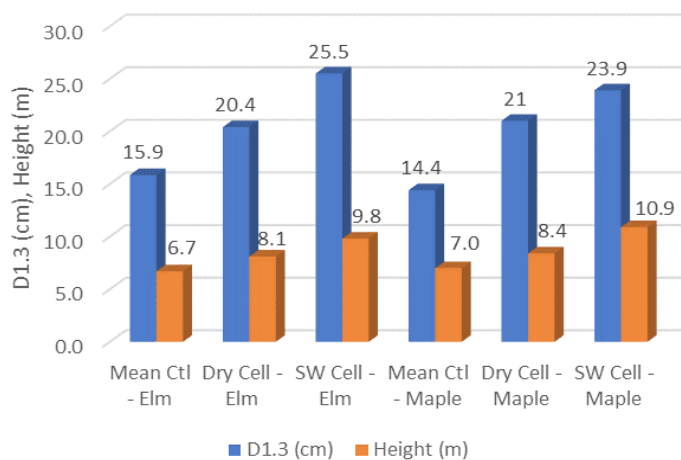
Figure 5. The height and diameter of the stormwater cell, dry cell and control trees

The study results showed that soil cells had larger trees than those in standard tree trenches. The breast height tree diameter and height of the Elm and Maple trees in soil cells were both greater than those in tree trenches (Figure 5). Among the two sets of soil cell trees, those with continuous stormwater irrigation had larger diameters and were taller than those with stormwater provided only during the first two years.
