## **Evaluation of a Thermal Mitigation System on the Heritage at Victoria Square Pond in Markham**

Toronto and Region Conservation Authority

City of Markham

January 2021

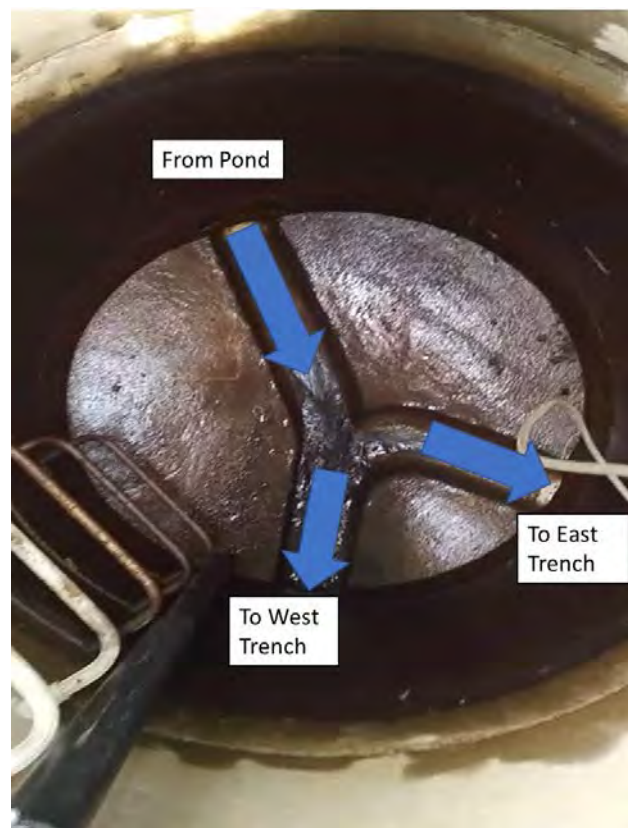
**Figure 3.5:** Photo of the control manhole looking down. Flows entering from the pond are directed to the east and west cooling trenches via a flow splitter.

The design of the cooling trench drainage system is presented in Figures 3.4 to 3.7. Flows were conveyed to a control manhole and then split (Figure 3.5) to an east and west cooling trench before discharging through catch basins at the downstream end of each trench. These trenches receive filtered water at a continuous discharge rate from the pond’s permanent pool through a 72.5 m long x 0.5 m wide perforated pipe embedded into a gravel/sand jacket within the pond bank 0.5 m below the permanent pool surface (see dashed line in Figure 3.2 and Figure 3.4). The cooling trench consists of two trenches that measure approximately 24 m long by 1 m wide by 1.5 m high. Each trench contains pea gravel and two sets of dual 24 m long 150 mm Ø perforated PVC pipes wrapped in filter fabric.

5. The flow splitter at the control manhole distributes water to each of the two trenches. Although not monitored in this study, very small grading differences and pipe angles can cause one trench to receive more flow than the other. A similar system in the West Cathedral subdivision in Markham had a flow splitter upstream of two parallel trenches. This system was shown to have flow discharging from only one of the two catchbasin outlets. Uneven flow distribution reduces system efficiency and should be avoided where possible. A single larger trench with a single inlet and outlet will provide more optimal conditions for cooling in most instances.

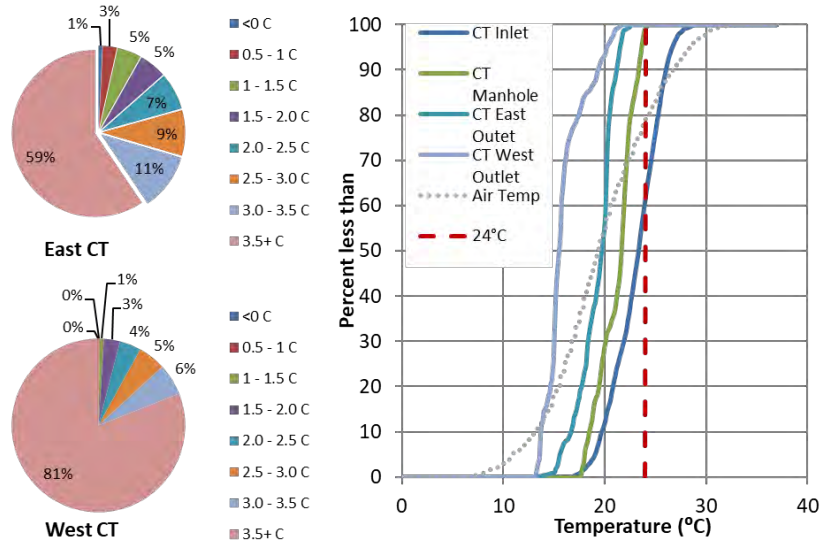
**Figure 5.1:** Secondary outlet cooling trench performance from June 21 to Sept 15, 2017, Heritage at Victoria Square Pond, Markham. The CT inlet in the pond discharges to a control manhole then to two cooling trenches. Left graph shows temperature changes from the inlet to outlet. Right graph shows inlet and outlet temperature frequency.

Results of monitoring in 2017, from June 21<sup>st</sup> to September 15<sup>th</sup>, showed temperatures from the cooling trench outlets fluctuating between 12.9 and 22.7°C, and 12.5 and 21.8 °C at the east and west catch basin outlets respectively. Ninety five percent of the east outlet temperatures were below 21.5°C, and 95% of the west outlet temperatures were below 20.3°C. The maximum temperature of pond water entering the east and west trenches during this period was 28.9°C (Figures 5.1 and 5.2).

The results shown in Figure 5.1 show inlet to outlet reductions in the warmest 5% of temperatures ranging between approximately 5 to 6°C. The west catchbasin was cooler than the east because of more groundwater interaction in this location, and the absence of ponded water at the cooling trench outlet, which heats up during the interevent period causing warmer outlet temperatures in the East trench. Water ponding occurred in this location because of poor surface drainage. As with the Majorwood trench system (see Van Seters and Graham, 2014), significant cooling occurred between the pond surface inlet and the manhole, and flows through the system were relatively slow.

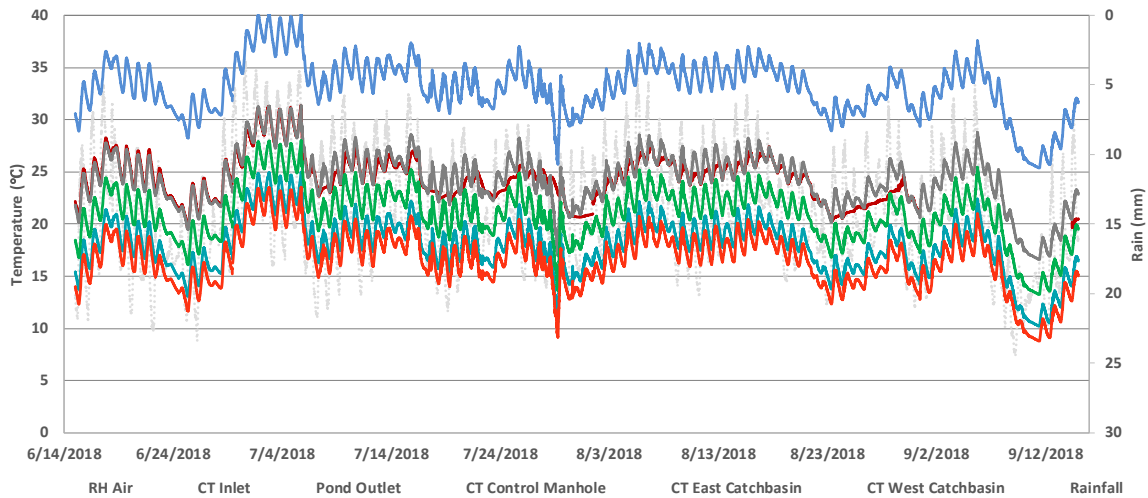
**Figure 5.4:** Temperature from June 15 to September 15, 2018. Water flows from a secondary inlet (CT inlet) to a control manhole and then into the east and west trenches and out to a surface catchbasin outlet (CT catchbasins). The pond outlet discharges through a separate pipe.

As mentioned previously, the much warmer east trench outlet temperatures are attributed to backflows at the outlet, which resulted in temporary ponding of water that warmed during the interevent period. Since the system was not designed to produce back-flows, it would stand to reason that the west trench performance data is more representative of how the system should operate with respect to cooling (albeit without flows from the east trench). In this trench, 95<sup>th</sup> percentile temperatures at the cooling trench outlet were 6.2°C lower than the pond inlet, but only 1.1°C cooler than the control manhole, suggesting that most of the cooling occurred as water was transferred from the pond to the control manhole. A possible explanation for the unexpectedly cool manhole temperatures may relate to observed backflows from the east trench. Temperature fluctuations in the manhole and east/west trenches were much more similar in 2018 than in 2017 (compare Figure.5.2 to Figure 5.4)

The cooler interevent temperature in the east trench (Figure 5.4) relative to 2017 may be attributed to the drier weather in 2018. Grading issues at the east outlet created ponded water on the east side that was exacerbated during wet weather. When this ponded water persists into the interevent period, the trench outlet temperatures are affected for longer time periods.
