A comparison of two approaches for winter maintenance of a large commercial property

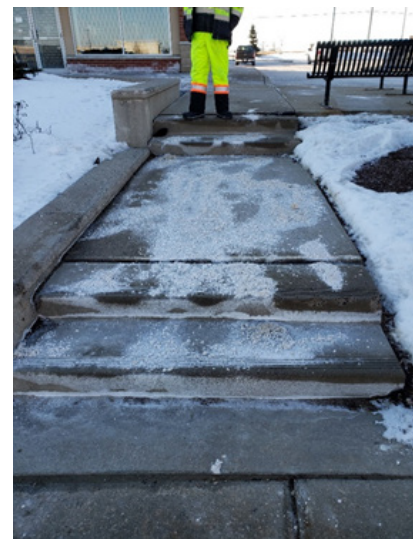
Figure: 1 Sources of salt in the Lake Simcoe watershed(2015).

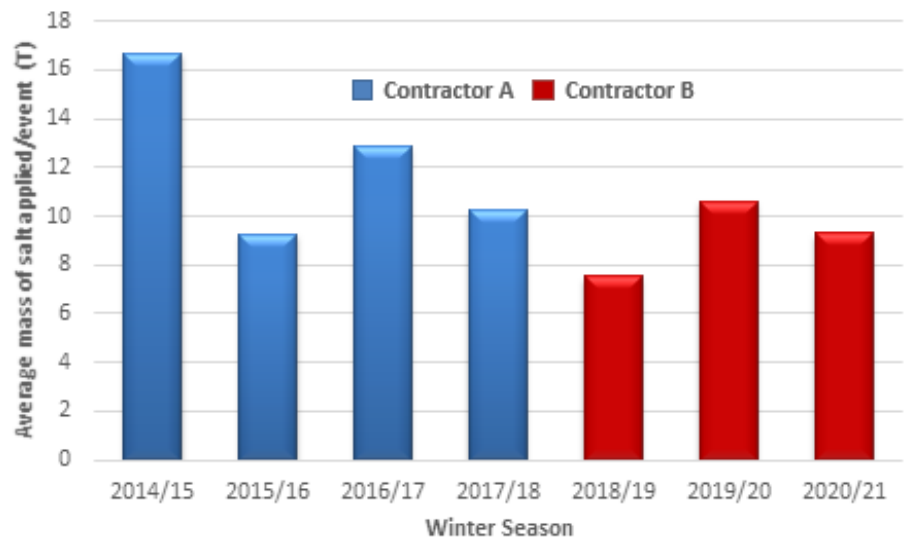
Figure 2 Average mass of salt applied per event (t) with Contractor A depicted in blue and Contractor B depicted in red.

As has been noted, the contractors each took a different approach to ensuring safe surfaces. The differences bear out in the data for the site over the years of the study. Figure 2 displays the average mass of salt applied per event over each season (as calculated by LSRCAs through its instrumentation at the outlet), with Contractor A depicted in blue, and Contractor B in red, and Figure 3 shows the salt application rates for the two contractors. Contractor A applied an average of 12 t per event across all seasons, with an application rate of 81 g/m², while Contractor B applied an average of 9 t per event at a slightly lower rate of 65 g/m². Contractor A noted that they applied using the same rate regardless of what the conditions were and what weather was expected, while Contractor B noted tailoring their application rates to the conditions, including noting the expected duration of the event and the amount and type of precipitation that was expected, which enabled them to apply less salt in most circumstances. Also of note was the mild winter in 2015-2016, which may explain why the amount of salt applied was lower in this season than the contractor typically used; it appears that the drivers used some discretion in determining how much salt should be applied.

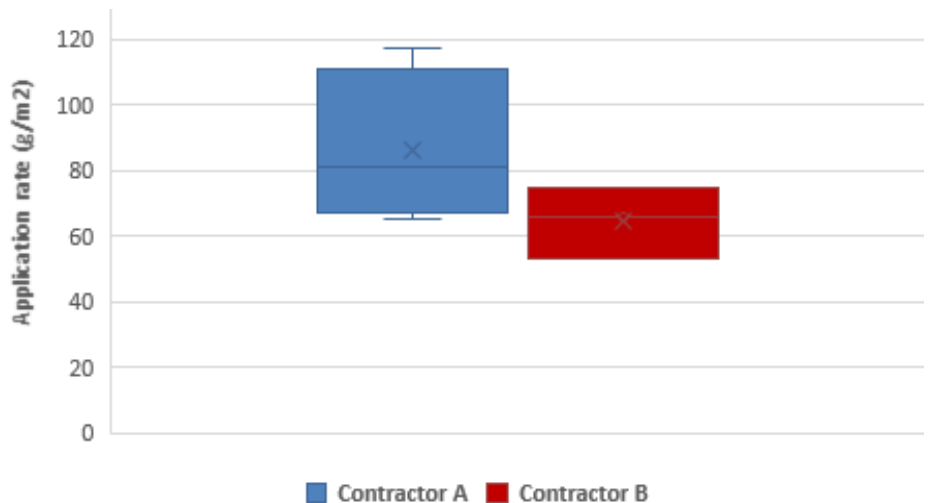
Figure 3 Box and whisker plot depicting the salt application rates (g/m²) for Contractors A and B.

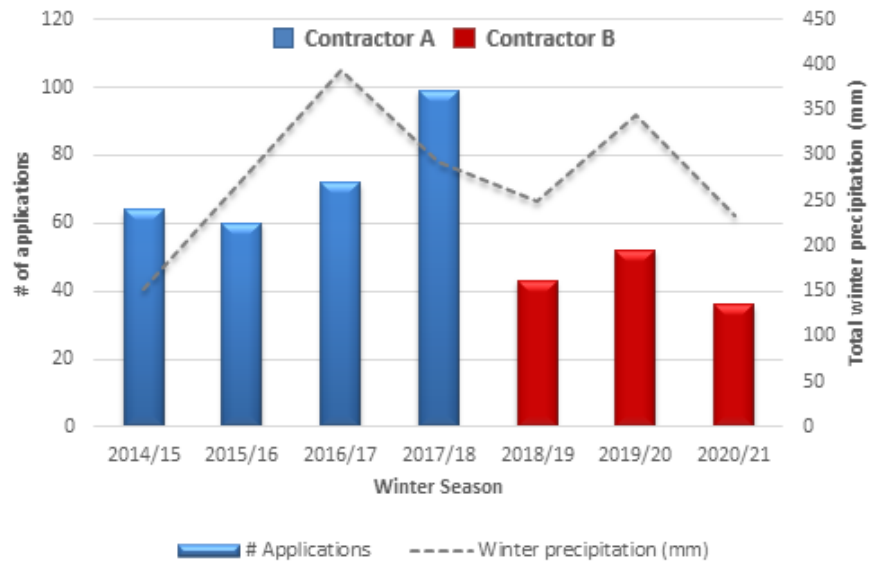
Figure 4 Number of applications undertaken during each winter season (Contractor A = blue, Contractor B = red). Total winter precipitation for each season, from November 15 to April 15 (mm) is shown on the secondary axis.

The most notable area of difference between how the two contractors treated the site can be seen in the number of events responded to in each season (Figure 4). Contractor A had more events responded to in every season than Contractor B. Contractor A had an average of 66 event responses each season, while Contractor B had significantly fewer, with approximately 43. As can be seen in Figure 4, seasonal precipitation was not notably lower for the period that Contractor B has been managing the site and does not appear to be the

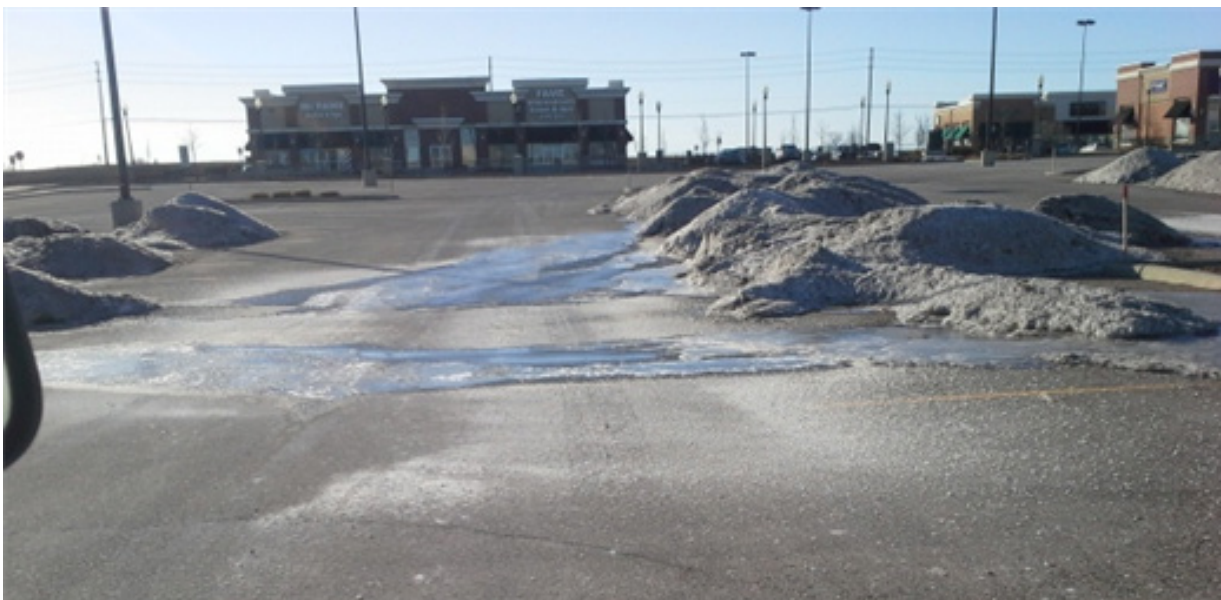
Figure 6 An example of a trouble spot due to freeze/thaw from improperly placed snow piles

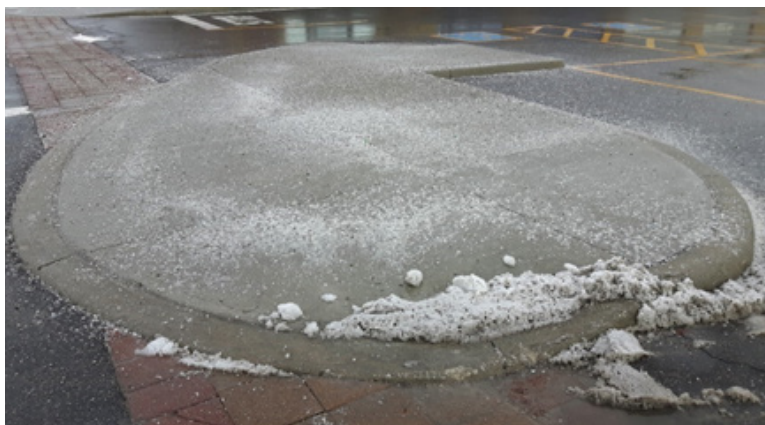
Figure 7 An example of an over-salted "orphaned" walkway

Other areas where salt is commonly over applied include at the entrance to a large, high traffic department store, and some low traffic walkways. Salt is often also applied to "orphaned" walkways (raised "sidewalk" areas in parking lots that don't lead to any of the businesses and therefore aren't typically used by pedestrians). Suggestions for seasonal closures of these surfaces, or improved design to eliminate this issue are included in LSRCA's [Parking Lot Design Guidelines to Promote Salt Reduction](#) (2017). Low traffic areas and orphaned walkways could be closed seasonally and not maintained to further reduce the amount of salt applied. Given that walkways are the areas of parking lots where slips and falls tend to
