# Vancouver's Green Infrastructure Maintenance and Rehabilitation Pilot Programs

June 9, 2022

Presented by Julie McManus and Sheri DeBoer

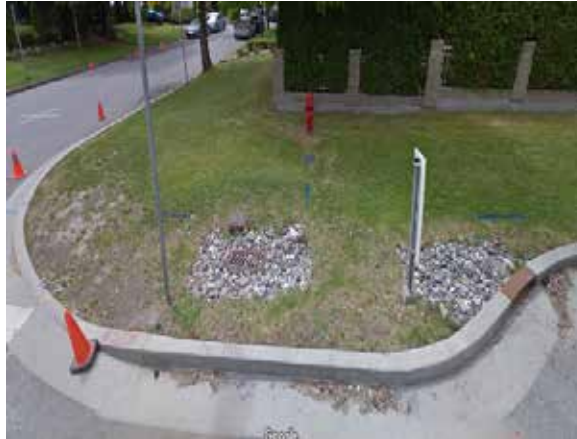
*Design lacking in stormwater function*

*Short-circuiting to catch basin*

*Undersized inlet*

*Inlet clogging, requires re-design of pre-treatment*

- Many of the City's existing bioretention bulges were designed and installed prior to the formation of the GI Branch (2016) and without consistent maintenance.
- GI's Vegetated Assets assessed for level of service in 2017 & 2019; **48% are found to be under performing or ineffective**
- Many lack infiltration function, have water by-pass and contain invasive weeds that must be managed.
- The underperforming assets require rehabilitation to bring them back provide adequate drainage and infiltration.

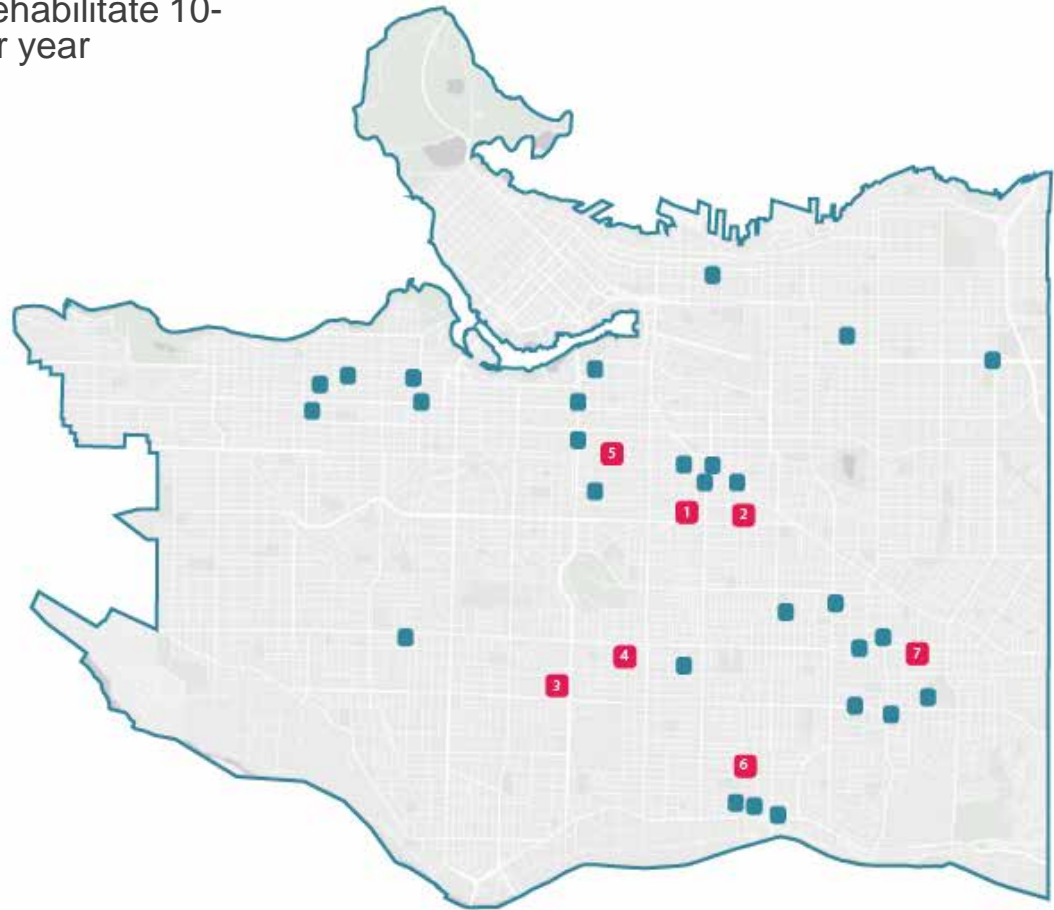
*Example map of the assets requiring rehab and the 7 locations chosen for the 2021 Rehabilitation Program*

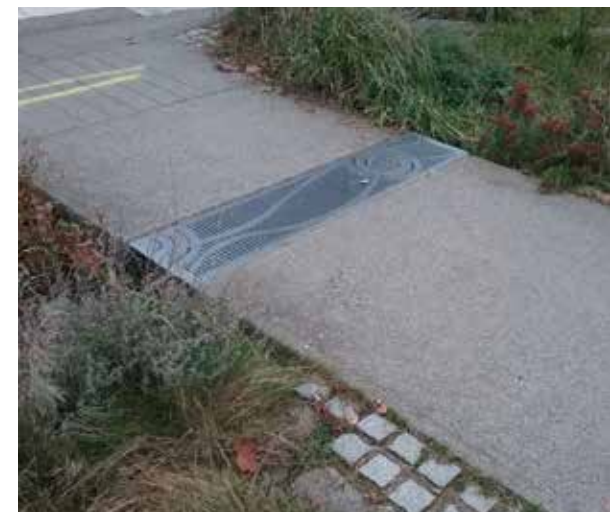
## Inlet types

An opening that allows water to enter into the bioretention facility.

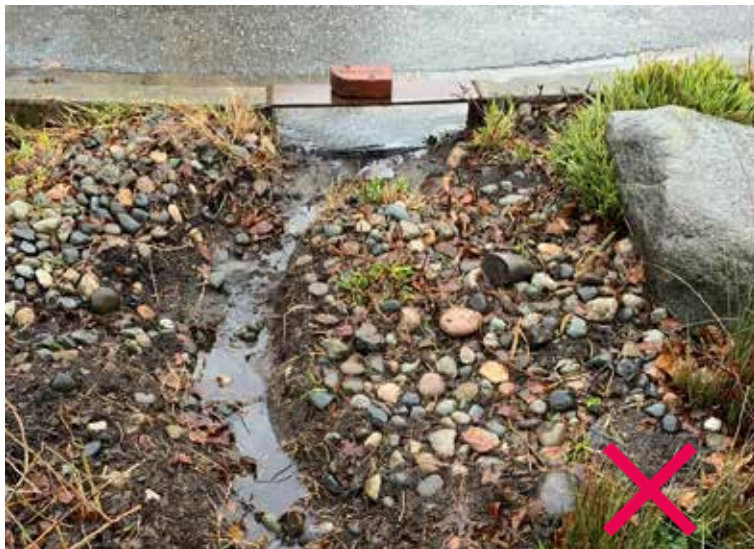
### Erosion

- Occurs regularly at all bioretention sites, typically around the inlet.
- Erosion can be caused by too steep of grading, high inflow of water, lack of sediment / splash pad, or overdue maintenance.
- Erosion can prevent proper infiltration, damage planting, and create a location for debris / litter collection and build-up.

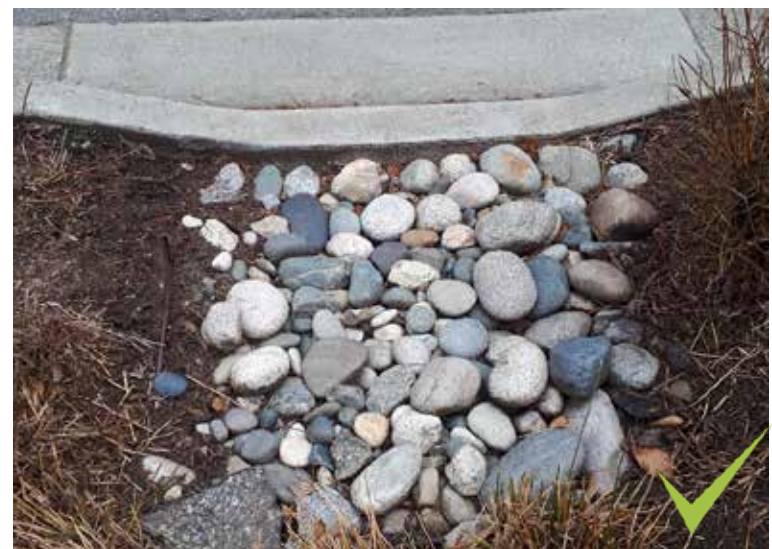
### Maintenance Needed

- Re-grade to remove erosion lines / reduce slope and infill with new soil as needed
- Adjust sediment pad / river rock if available to help slow inflow of water
- If erosion is a serious concern, recommend sediment pad or river rock on site

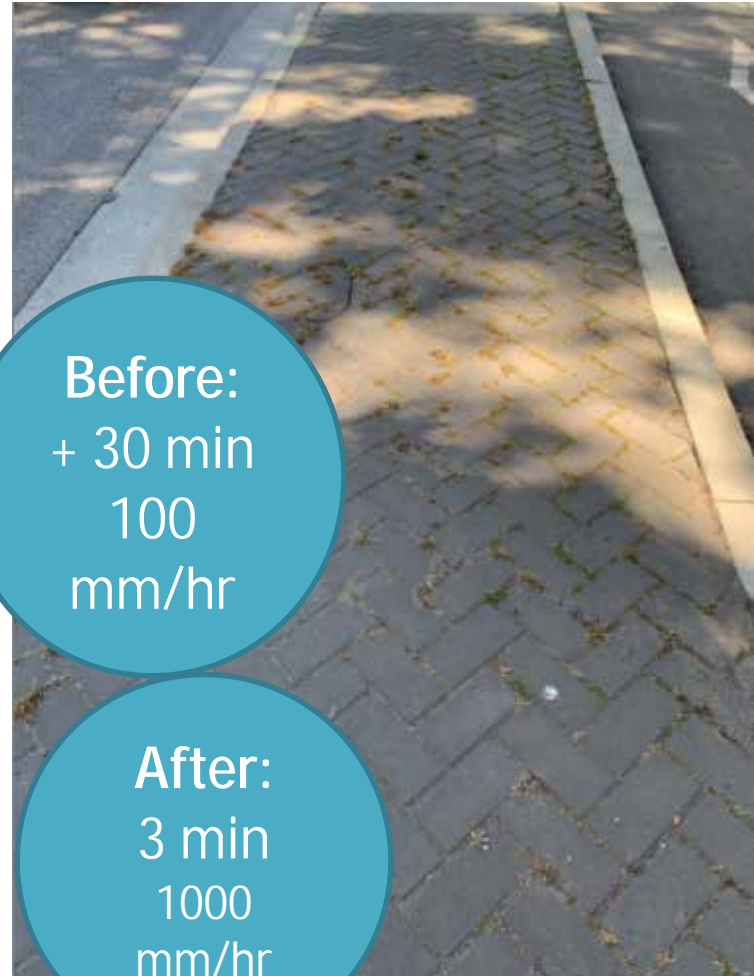
Nelson between Cambie and Beatie

Site	Pre-maintenance Infiltration	Post maintenance Infiltration
Nelson Street	> 100 mm/hr	1000 mm/hr
Expo Street	> 100 mm/hr	1200 mm/hr
Commercial Drive	> 100 mm/hr	120 mm/hr
Richards Street	> 100 mm/hr	1000-1200 mm/hr
Olympic Village	> 100 mm/hr	1200 mm/hr

Before:  
+ 30 min  
100  
mm/hr

After:  
3 min  
1000  
mm/hr

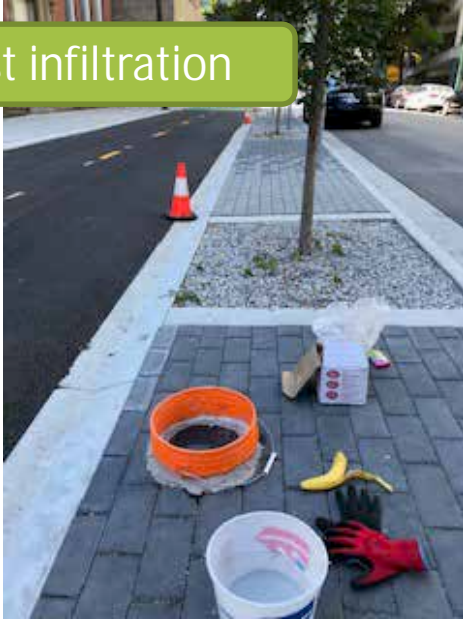
1. Test infiltration

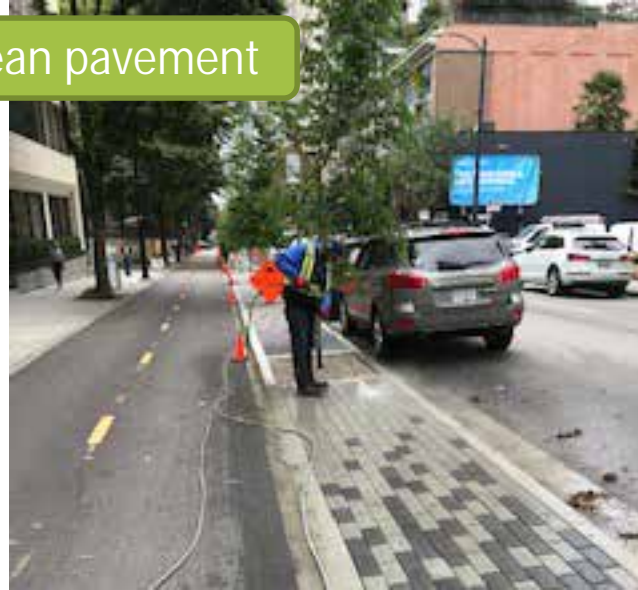
2. Clean pavement

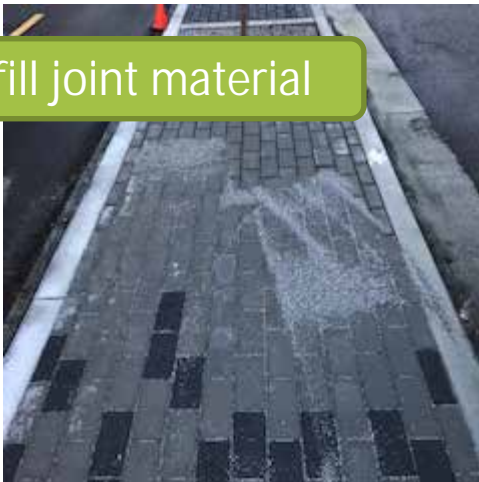
3. Refill joint material

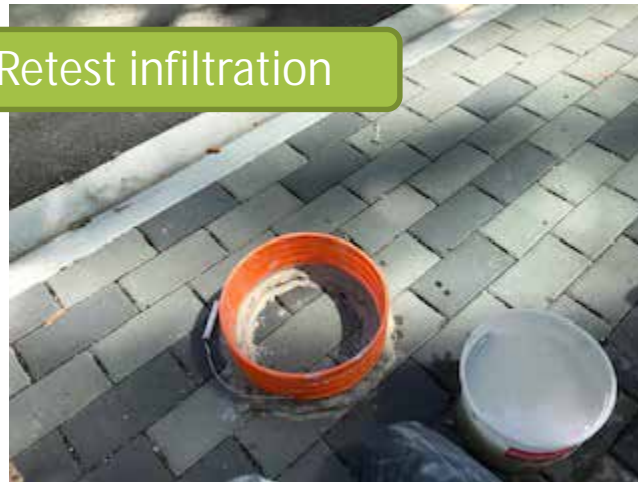
4. Retest infiltration

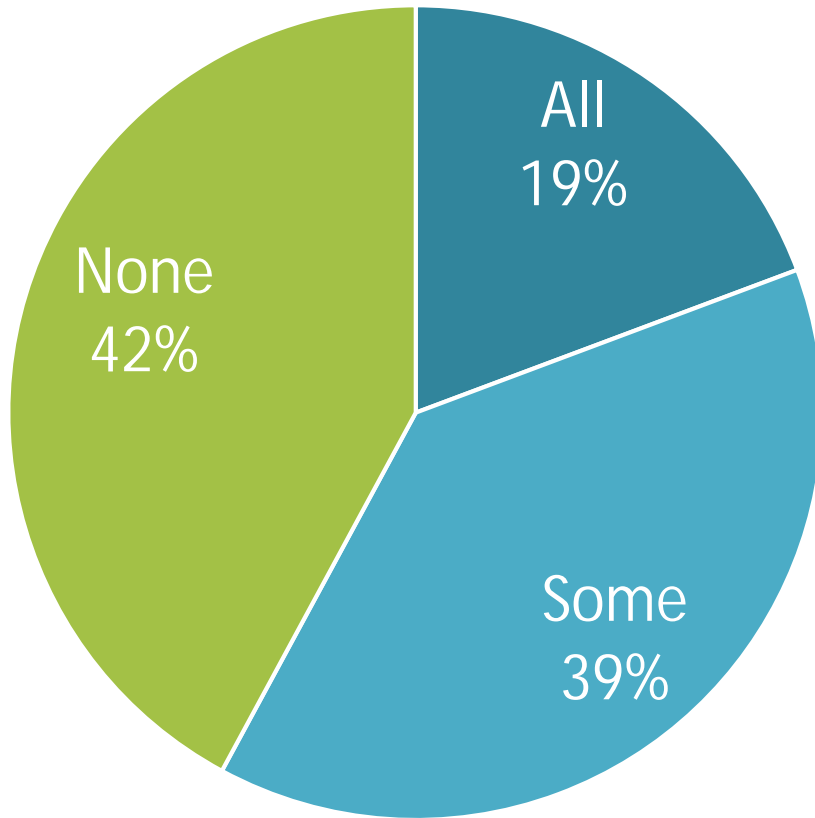
Bypass during rain event

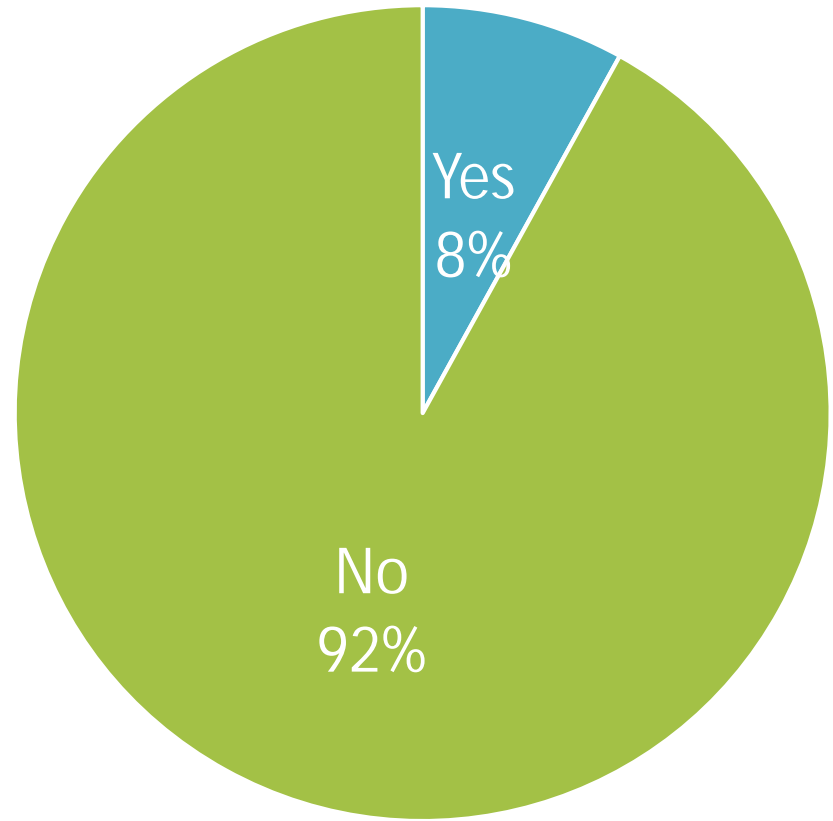
24 hour post-rain spot check
