Performance Evaluation of Catch Basin (CB) Shields

This study evaluates a proprietary stormwater pre-treatment system (CB Shields) that acts to reduce the velocity of stormwater runoff into the storm drain system via curb and gutter conveyance. The reduction in velocity is aimed to capture more sediment while preventing scour and transport of accumulated sediment out of the catch basin sump.

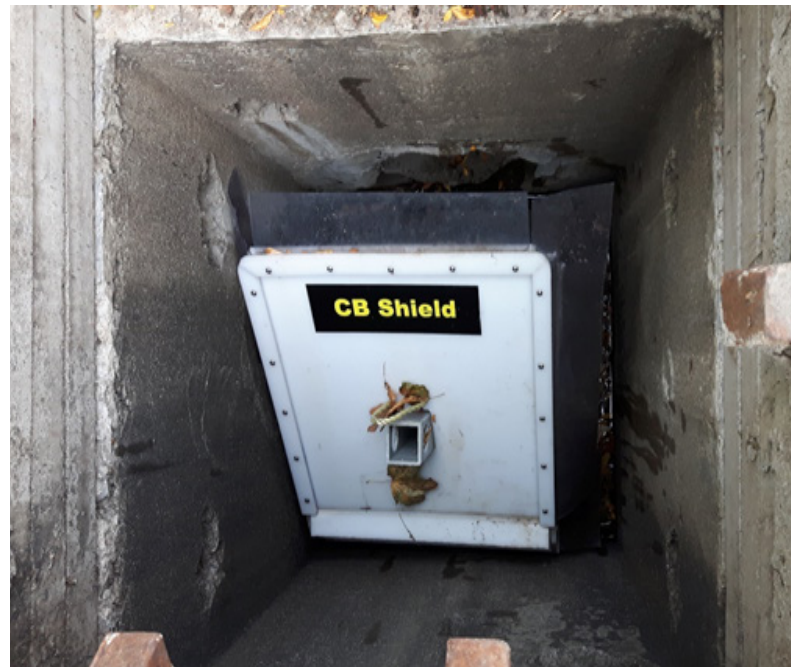
Figure 1 – Example of a CB Shield installed in a typical catch basin

A periodic cleaning of the catch basin sump is required to ensure continued performance; the frequency of cleaning is dependant on the depth of the sump and the pollutant load of the stormwater entering the system. The CB Shield (Figure 1) is a catch basin insert designed to prevent the scour of accumulated sediment in the catch basin sump. The CB Shield is also intended to enhance the capture of sediment in the sump area by reducing sediment resuspension under all storm runoff conditions. Enhancing the capture and retention of sediment in the catch basin sump prevents this material from being washed downstream into receiving water bodies or stormwater infrastructure and, at the same time, can improve (or extend) the maintenance interval between catch basin cleanings. CB Shields have undergone rigorous third-party testing using a modified version of the 'Procedure for Laboratory Testing of Oil Grit Separators developed by TRCA for the Canadian Environmental Technology Verification (ETV) Program (TRCA 2016).

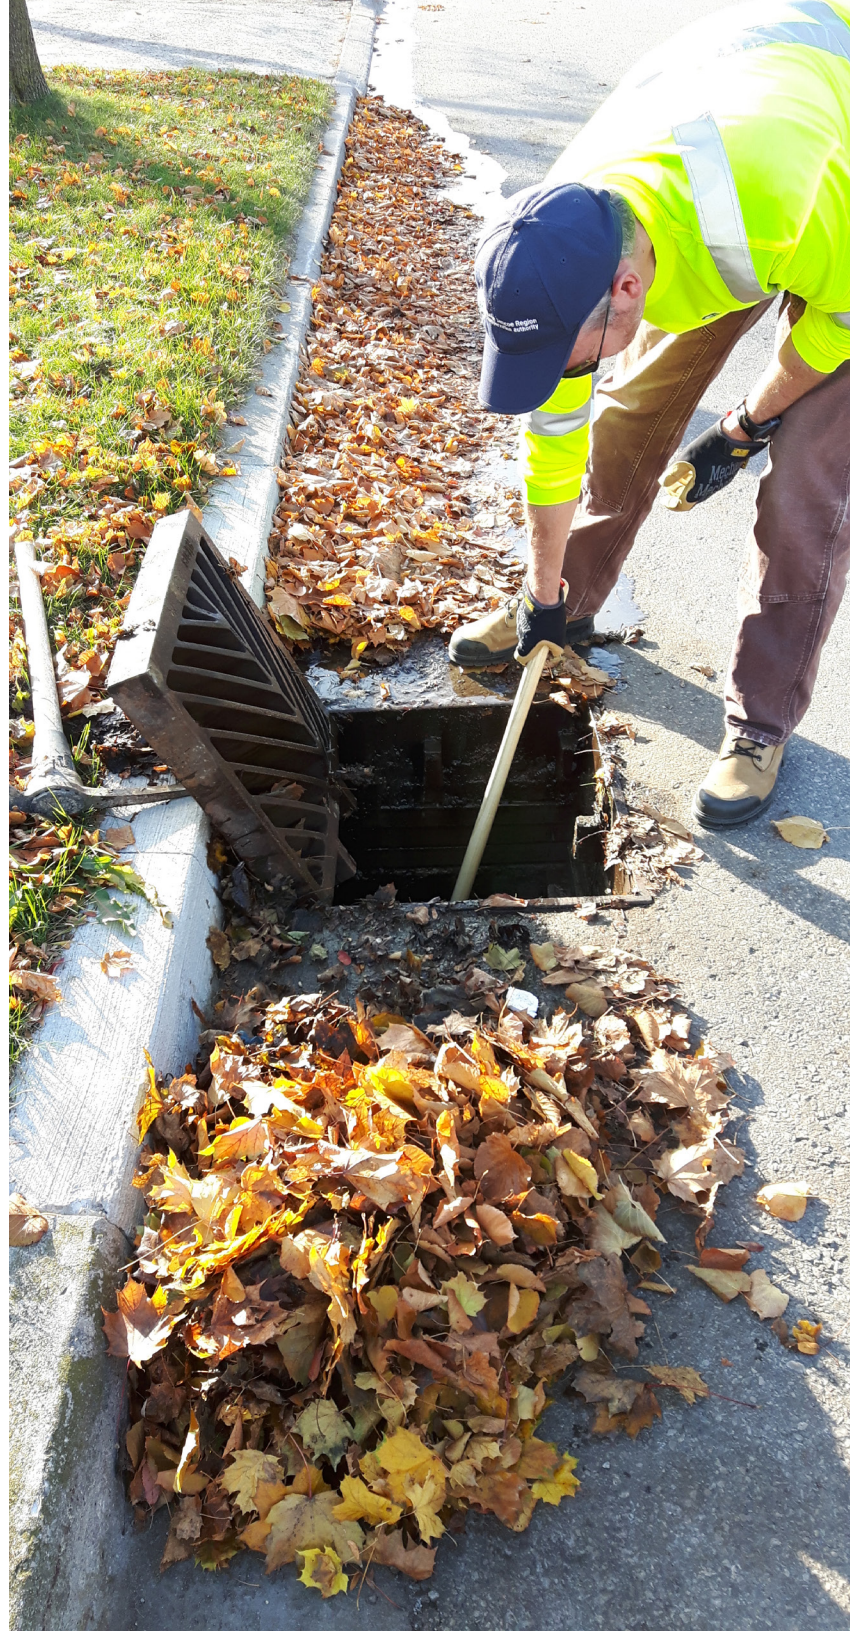
Figure 6- Removal of a CB Shield from a catch basin

Maintenance of the CB Shields is simple, requiring tools and skill sets that are readily available to any municipality. During routine catch basin clean outs, a CB Shield can be easily removed, and the catch basin sump cleaned out as per usual protocols. Any accumulated sediment or debris on the CB Shield can be washed into the catch basin prior to the clean out of the sump. Removing and replacing the CB Shield can be done in approximately 5 minutes and can be completed with com-

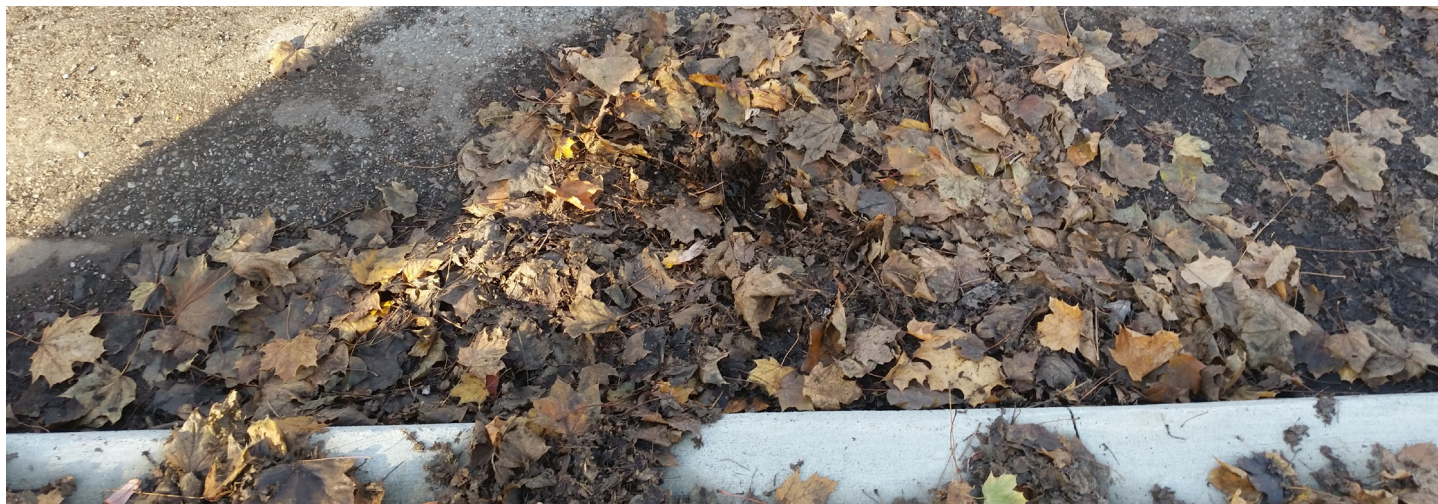
Figure 7- The top grate of a catch basin completely blocked by accumulated leaves, grass clippings and sand

6. On a number of occasions, the top grate of the catch basin was found to be completely blocked by accumulated leaves, grass clippings and sand, compacted by parked cars to the point at which stormwater was no longer entering the catch basin (Figure 7). Regular clean up of the debris via a combination of street sweeping and educating residents to not dispose of or blow leaves and grass onto the road would improve the function of the storm sewer system.
