Black Creek Pioneer Village Visitor Centre Variable Refrigerant Flow Air-source Heat Pump Retrofit

Final System Performance Report

Prepared by:
Toronto and Region Conservation Authority

October 2022

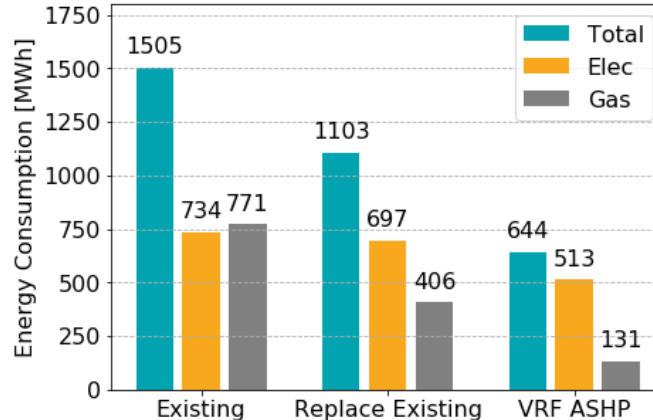
Figure 1-1. An external consultant analyzed the annual energy consumption of a like-for-like replacement of the existing system and that for a VRF ASHP retrofit. The VRF ASHP retrofit was estimated to consume much less gas and electricity than a like-for-like replacement.

As of 2017/2018, the existing system was due for replacement. TRCA hired an external consultant to evaluate different options. Based on building energy modeling, the consultant identified that a variable-refrigerant flow (VRF), also called variable refrigerant volume (VRV), air-source heat pump (ASHP) system would provide deeper carbon emissions savings and a better business case than like-for-like replacement of the existing system. Natural gas consumption with the VRF retrofit option was estimated to be approximately 70% lower than the like-for-like replacement and 83% lower than the current system (Figure 1-1). Electricity reductions were also expected – on the scale of a 30% reduction from the existing system.

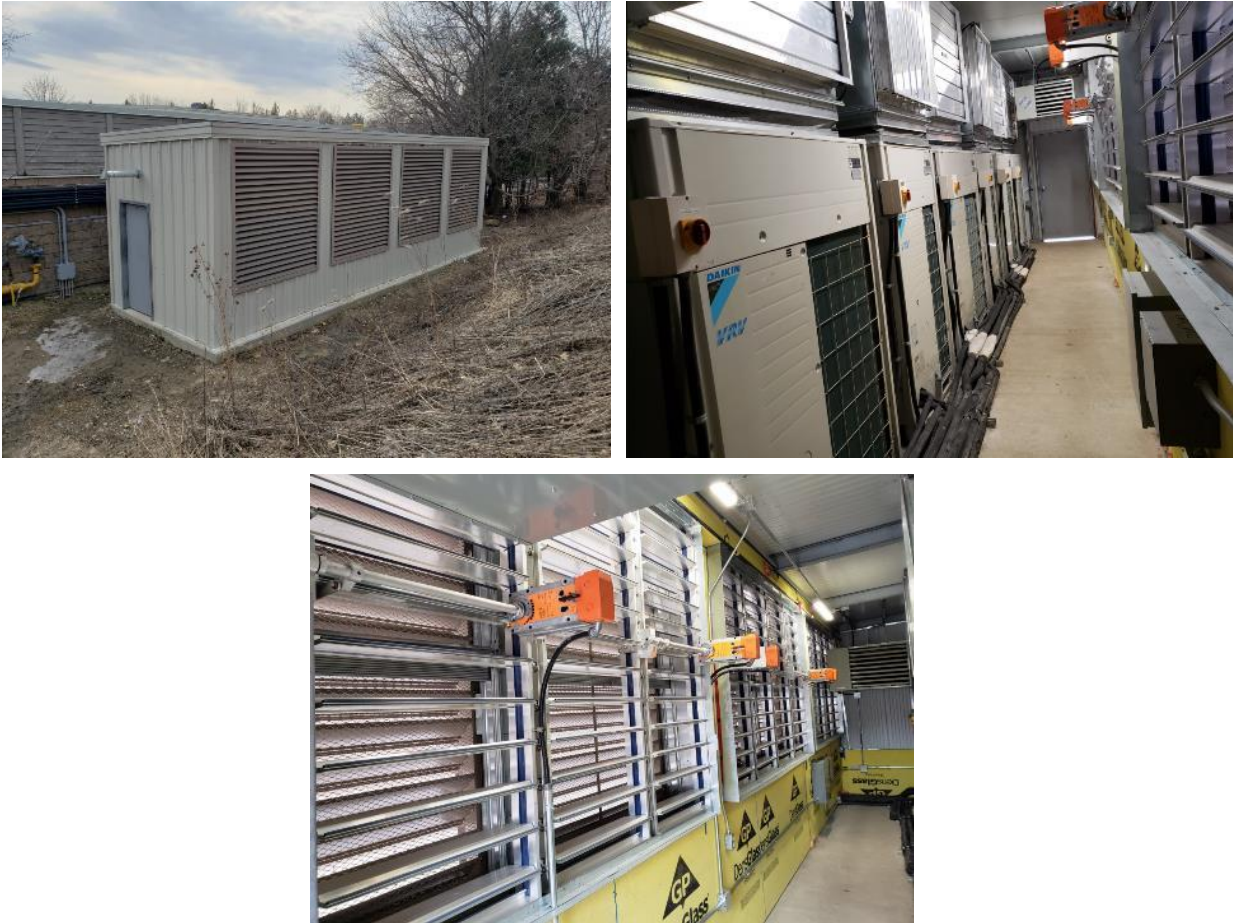
Figure 2-1. (Top left) Enclosure that houses outdoor units. (Top right) Inside view of enclosure showing heat pumps. (Bottom) Inside view showing dampers and gas unit heater.

Collectively, the subsystems connect to 37 indoor fan coils installed throughout the building. The outdoor units were installed in ventilated enclosures (Figure 2-1) heated by a natural gas unit heater (thermal efficiency of 82-83%) in cold conditions. This is one approach to provide back-up heating for the ASHPs. It was used as a cost-saving measure to avoid the additional cost of more advanced heat pumps that can continue to operate in extreme cold without the need of an enclosure.

The outdoor enclosure for the heat pumps was equipped with tempering from a natural gas unit heater. The unit heater turned on in relatively mild conditions which increased the gas consumption of the facility. It is also worth noting that the gas unit heater does not have a high-efficiency and, from a carbon perspective, should be used only when needed.

The high set-point for gas tempering was ultimately related to a condensate management problem within the outdoor enclosure. There was no path for condensate from the defrost cycles to leave the building. When the building dropped to sub-freezing temperatures, the condensate froze on the floor. This occurred initially and ended up heaving the heat pumps in the outdoor enclosure. Heat trace was later installed under the equipment.

The floor in the remainder of the outdoor enclosure would still freeze over with ice, creating a safety hazard. The best solution was proper condensate management in the enclosure. A short-term fix was to keep the outdoor enclosure warmer with the gas unit heater. The latter is what was done at the Visitor Centre.

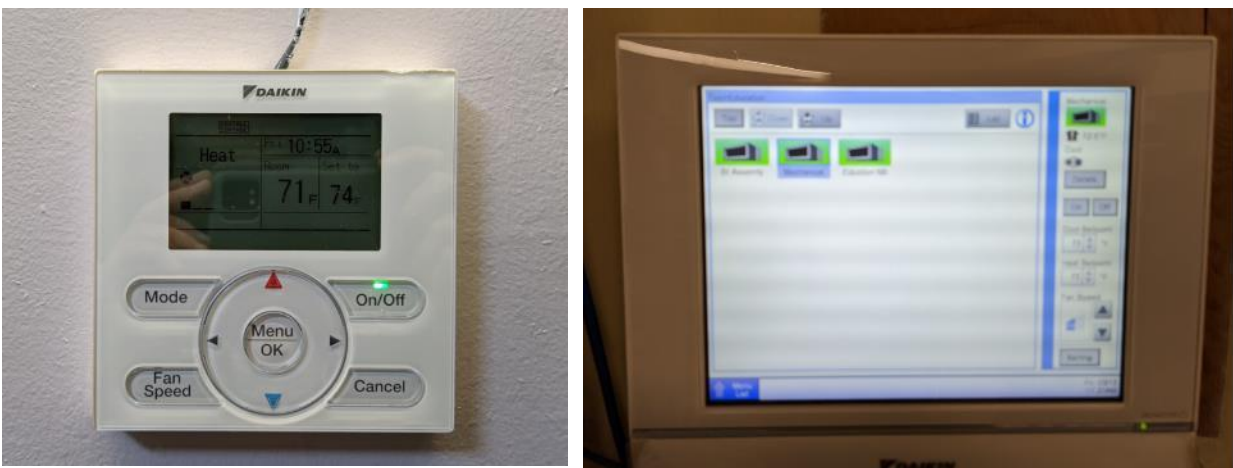
Figure 2-2. (Left) Navigation Remote Controllers provide local controller for the indoor fan coils. (Right) The intelligent Touch Manager provides central control and a user interface for the system, as well as being the BACNet interface for the Johnson Controls building automation system.

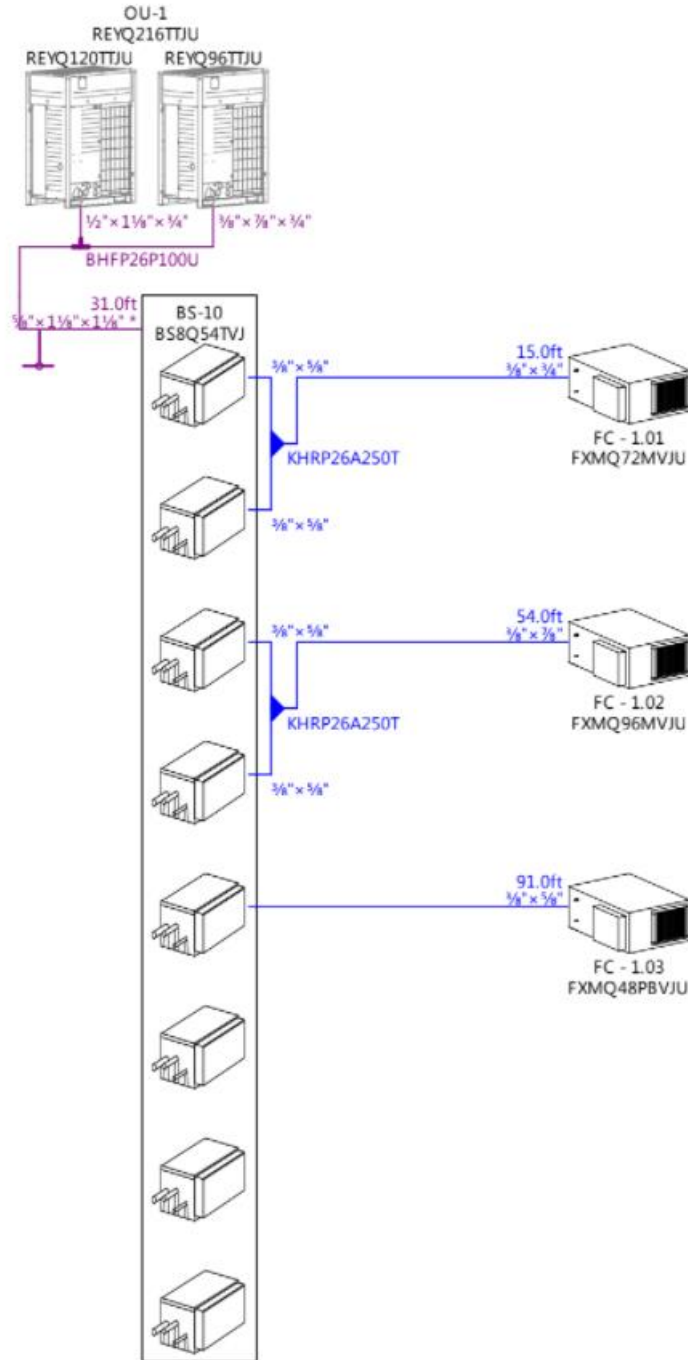
Figure 4-3. Refrigerant connections for the monitored subsystem (Zone 1). OU-1, represents the outdoor units serving this Zone. BS-10, represents the branch box capable of heat recovery. FC-1.01-1.03, represents the indoor fan coils.

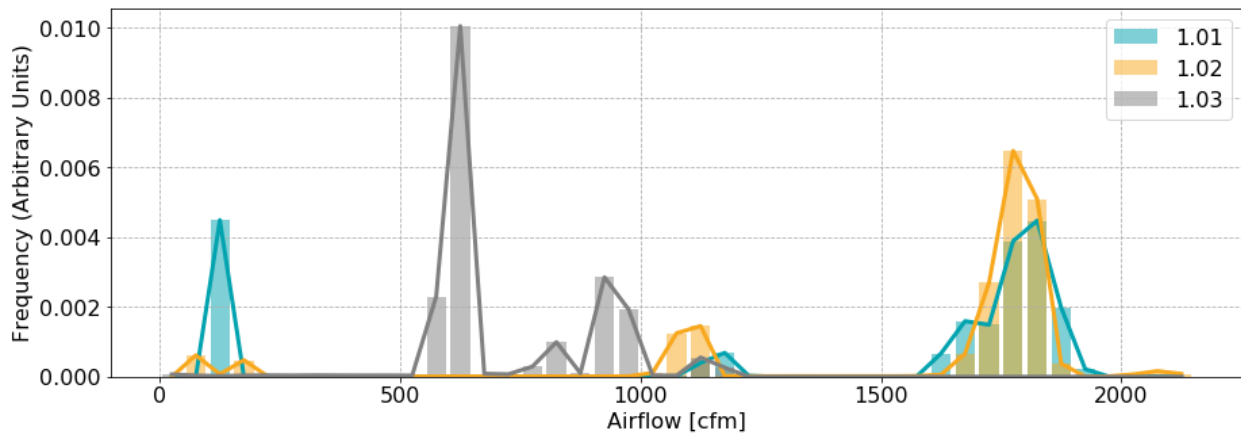
Figure 6-6. A frequency histogram shows the relative fraction of time that each indoor fan coil is providing different airflows during Winter 2020/2021.

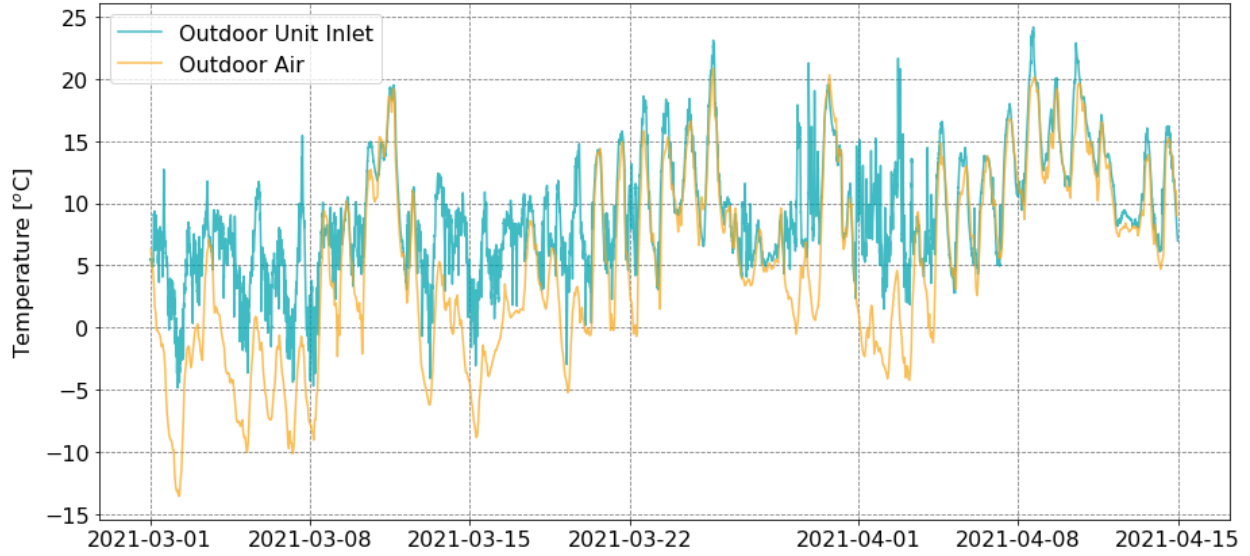
Figure 6-11. In cold conditions the “Outer Unit Inlet” air temperatures are greater than “Outdoor Air” temperature because the inlet air is tempered by natural gas heating.

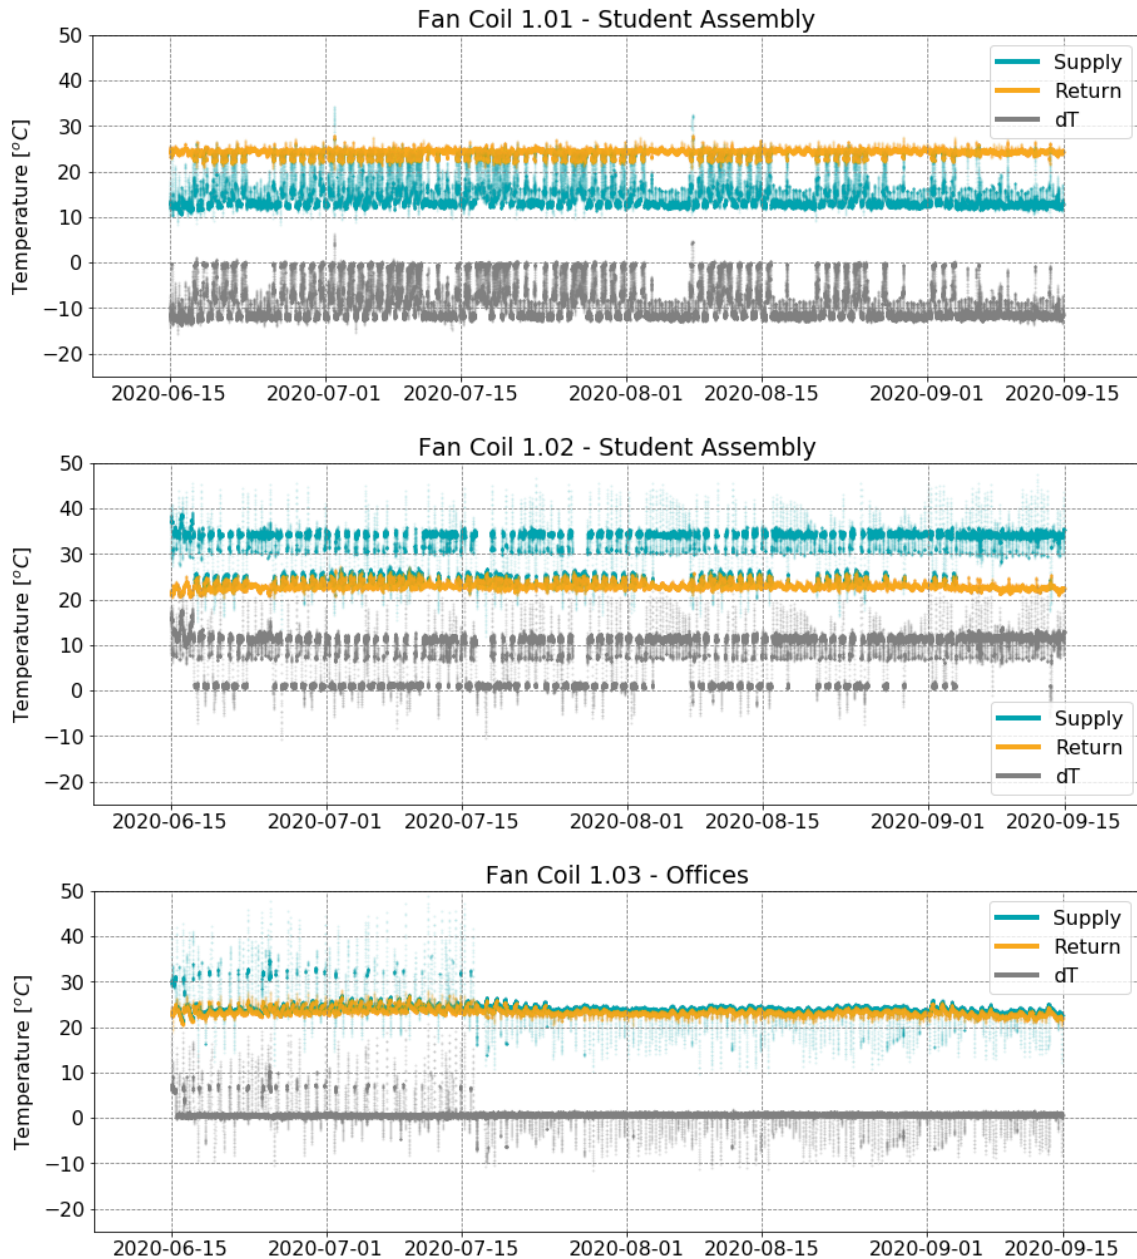
Figure 7-1. Supply and return temperature (and their difference) is shown for Fan Coils 1.01, 1.02, and 1.03.

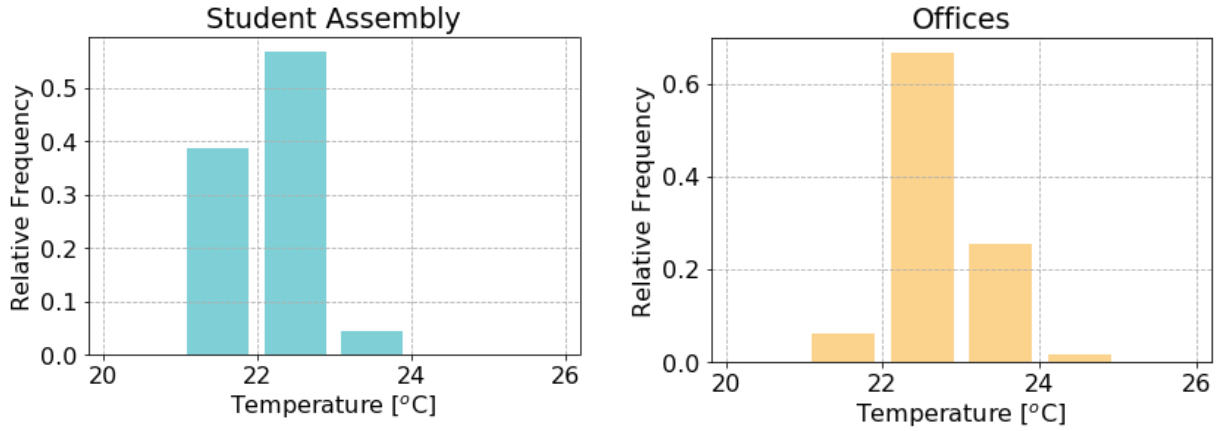
Figure 7-3. Zone temperatures at chest level during Summer 2020.

There is essentially no cooling provided to the Offices and the net cooling to the Student Assembly is also near zero. Despite the lack of cooling being provided, zone temperatures were normal (Figure 7-3). The daily-aggregated heating and cooling provided by each fan coil is shown in Figure 7-8. It is apparent that Fan Coil 1.01 and 1.02 were directly working against each other on a daily basis. This caused unnecessary electricity consumption. Note that electricity monitoring was not set-up for summer operation in Year 1.

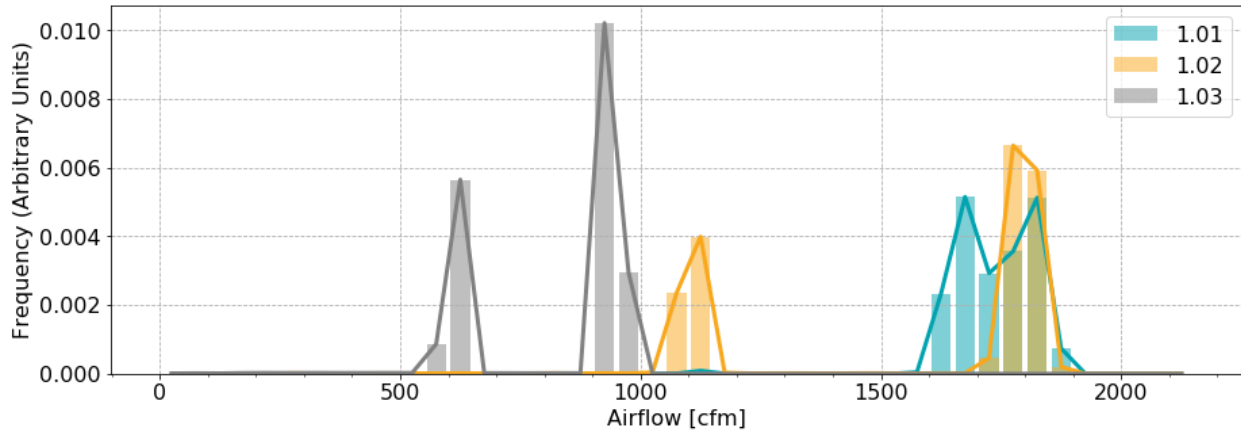
Figure 7-6. Airflow data for Summer 2020 is shown for each of the three fan coils in the monitored subsystem.

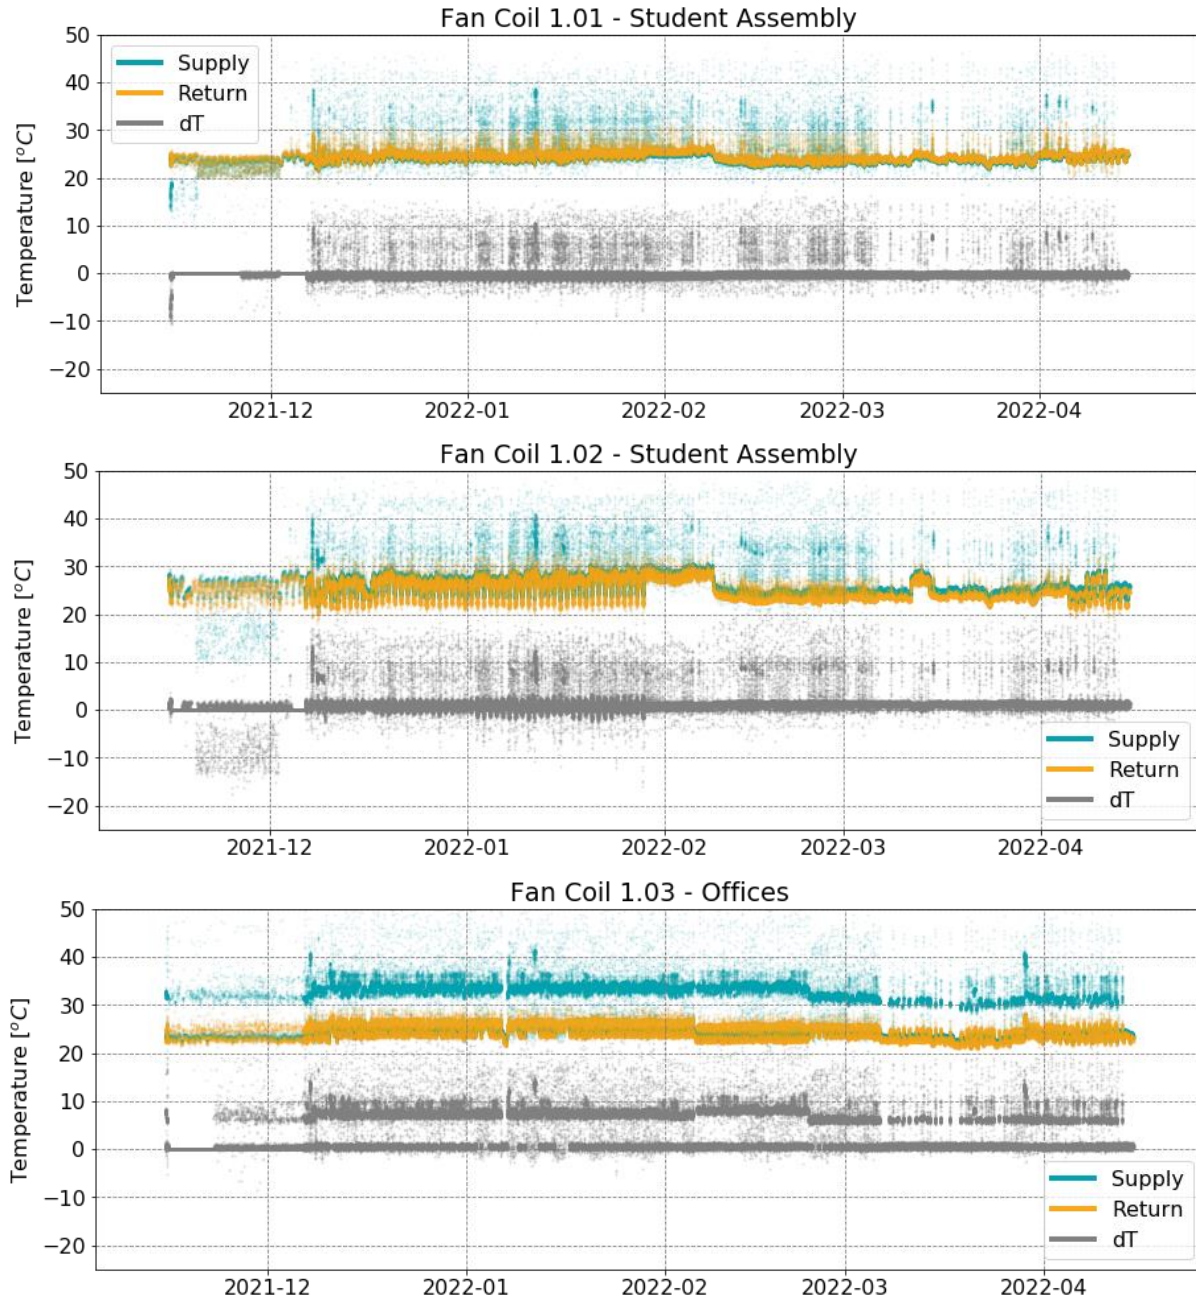
Figure 9-1. Supply and return temperatures (and their difference) is shown for each fan coil during Winter 2021/2022. The simultaneous heating and cooling issue within the Student Assembly was addressed.

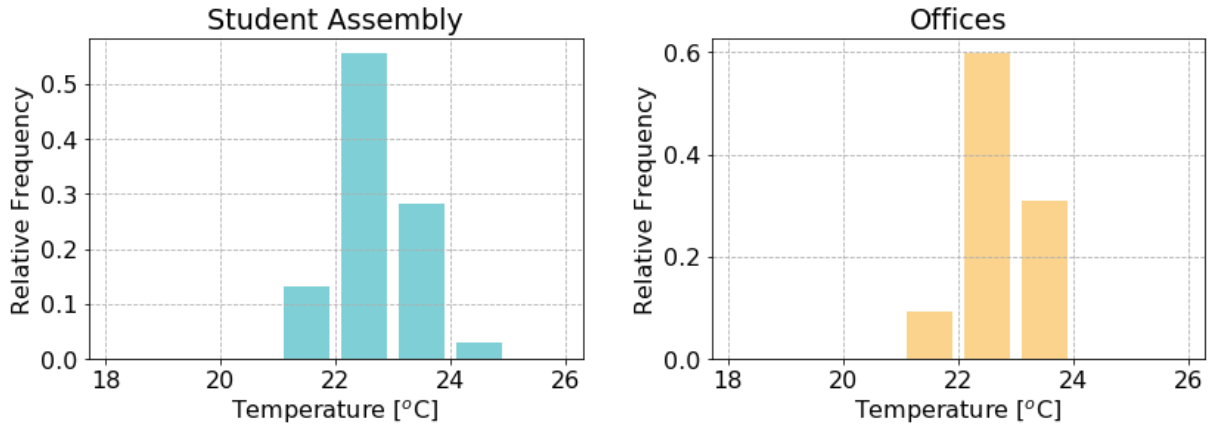
Figure 9-3. Zone temperatures during Winter 2021/2022 measured by monitoring system with sensors located at chest level in the zones near NAVs.

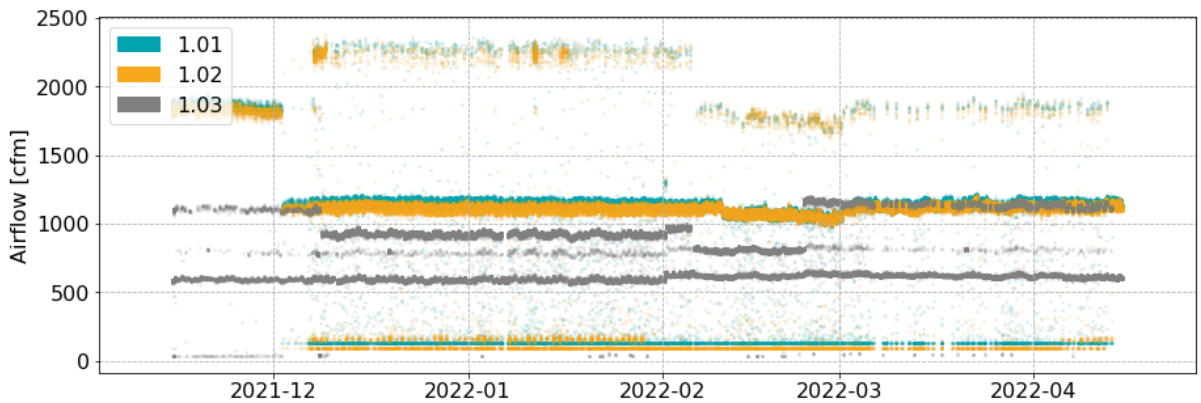
Figure 9-5. A time-series plot of the airflows shows the different fan speeds. While Fan 1.03 operates at four different speeds, Fan Coil 1.01 and 1.02 are nearly always at a single speed.

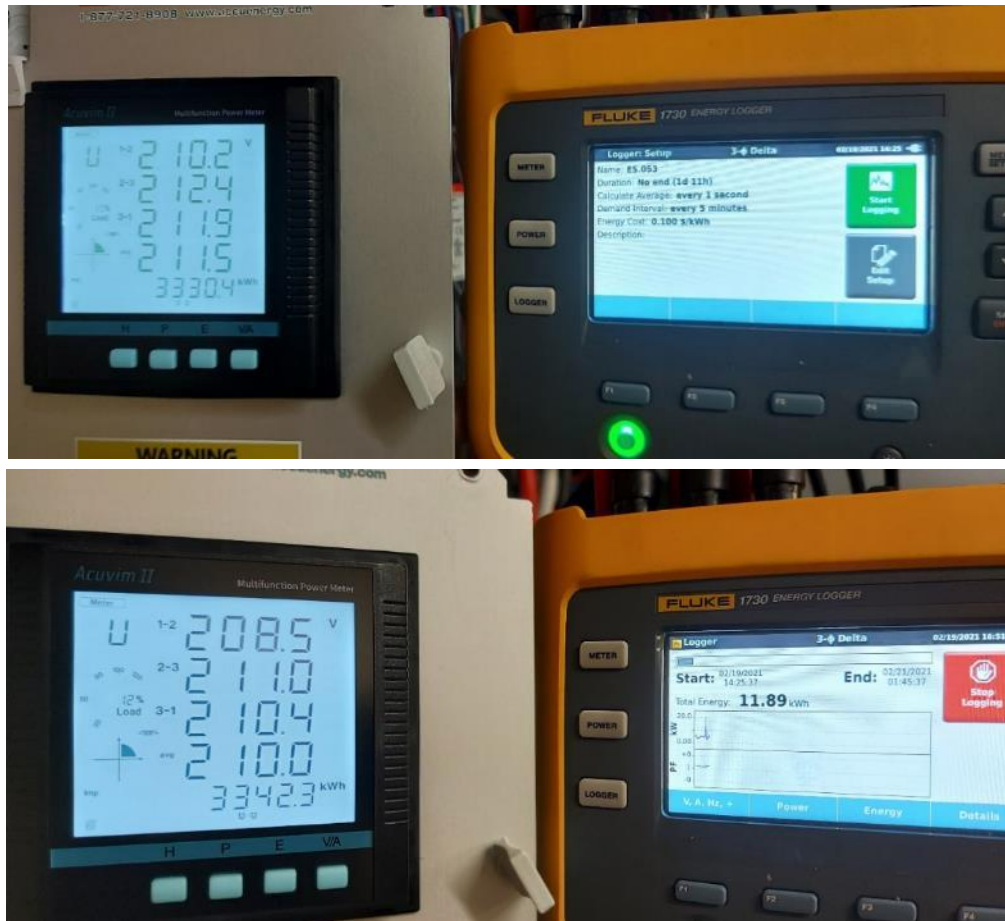
Figure 19-1. A Fluke 1730 Energy Logger was used to verify the electricity consumption measurements of the Acuvim II meter.

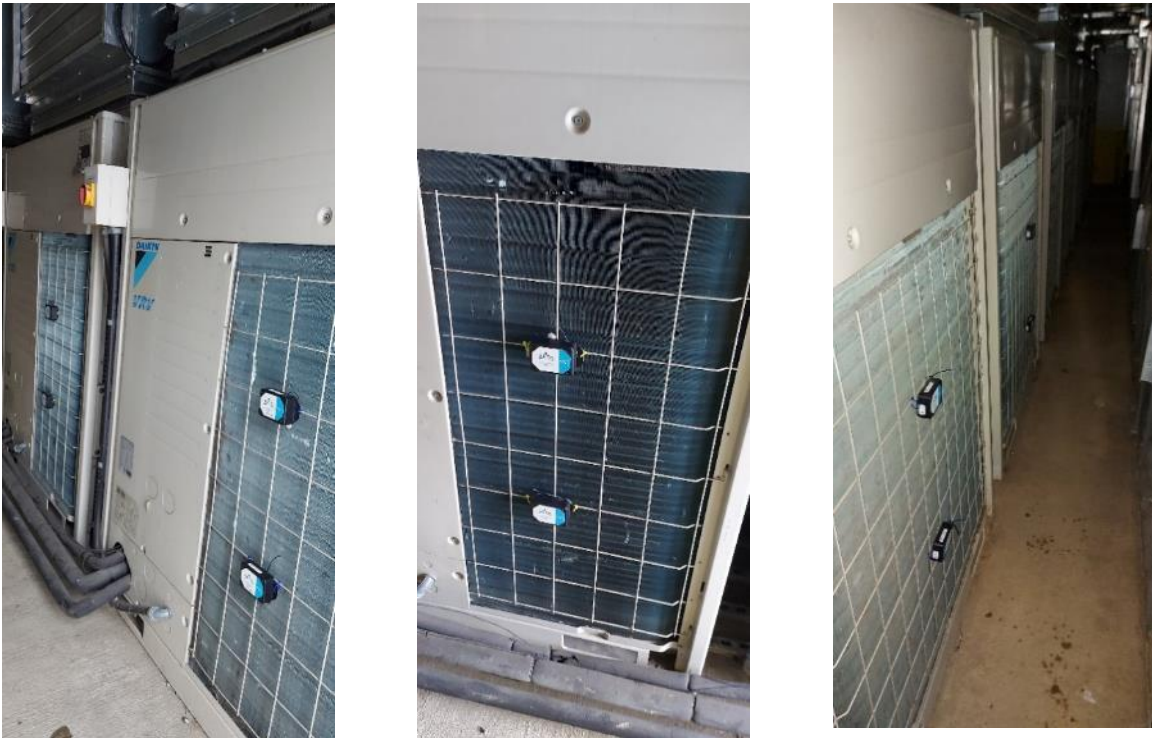
Figure 22-1. Temperature sensors were placed on the front, side, and rear grills, as well as the exhaust, of the two heat pumps forming the outdoor unit for the monitored subsystem.

Outdoor temperature data was obtained from Environment Canada. Inlet temperatures to the outdoor unit were not initially monitored. This was due to budgetary considerations. However, after an initial review of the data which suggested a low heat pump efficiency, it was decided that the inlet/outlet temperatures would provide helpful context. Particularly, it would help to assess the if heat was being removed from the outdoor air.

In February 2021, the indoor temperature/humidity installed throughout each zone of the building were repurposed as inlet/outlet air temperature sensors for the outdoor unit. The outdoor unit is composed of two heat pumps, and air could enter the heat pumps via the front, side, or rear grills. For each heat pump, two temperature sensors were placed on each grill, and one in the exhaust as shown in Figure 22-1. Data losses for one of the exhaust sensors was significant for Winter 2021/2022, and the exhaust temperature for this that year was based on only one of the heat pumps.
