POST-CONSTRUCTION EVALUATION OF STORMWATER EXFILTRATION & FILTRATION SYSTEMS

a.m. candaras associates inc.

October 1997

(Project No. 9321)

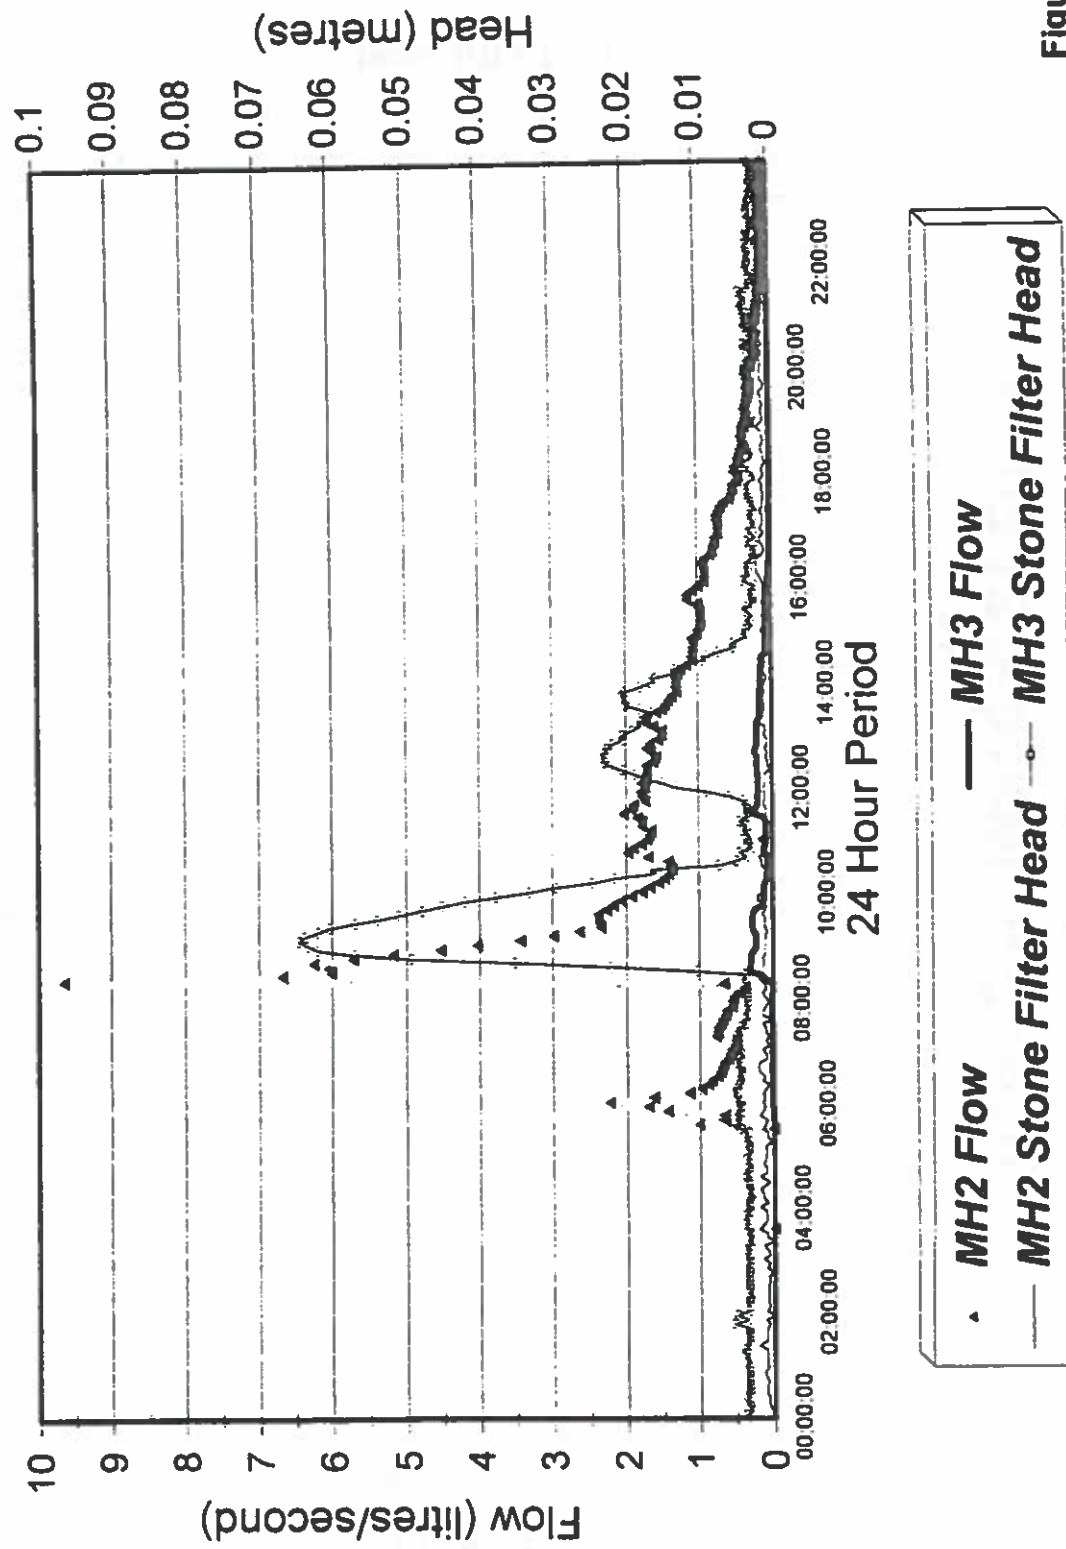
Figure 7.8

The rainfall event of May 26, 1994 consisted of 28.3 mm of rainfall over a 22.5 hour period with approximately 12 mm occurring in the initial 3 hours of the event. The peak inflow to the system was 9.7 l/s and occurred approximately 2 hours into the rainfall event as indicated in Figure 7.8.

During the rainfall event there was a minor increase in the head in the stone filter of approximately 65 mm, as measured at the downstream MH3 which indicated that the stone trench was not full. At MH2 there was no increase in head within the stone trench. The stone trench, perforated pipes and storm sewer were constructed at a grade of 0.65% between MH2 and MH3. Over the 98 m length there is a grade difference of 0.637 m, therefore a static head of 0.637 m must occur in the trench at the downstream MH3 prior to any static head being measured at the upstream MH2. In some cases there could be a dynamic head in the stone trench at MH2 as water is exfiltrated from the perforated pipe. Based on the typical trench cross section the stone trench will be full and overflow will occur to the storm sewer when the depth is about 65 mm at the upstream MH2 and a total head of 1.287 m at MH3 at the invert of the perforated pipe. Accounting for the 300 mm trench below the perforated pipe, the head will be 1.587 m at the downstream trench invert.

A minor flow of approximately 0.3 l/s was observed through the storm sewer during the peak rainfall event with a peak flow of 9.7 l/s which entered the system. This minor flow can be attributed to two sources:

- Minor leakage through the three catchbasins between MH2 and MH3 which were sealed as part of the monitoring exercise.
- Water entering through an abandoned culvert connection to a catchbasin located downstream of MH2 (note that this culvert connection was not plugged).

With the exception of these minor flows, it is evident that this 28 mm rainfall event was substantially infiltrated in the stone trench since there was no net outflow from the system.

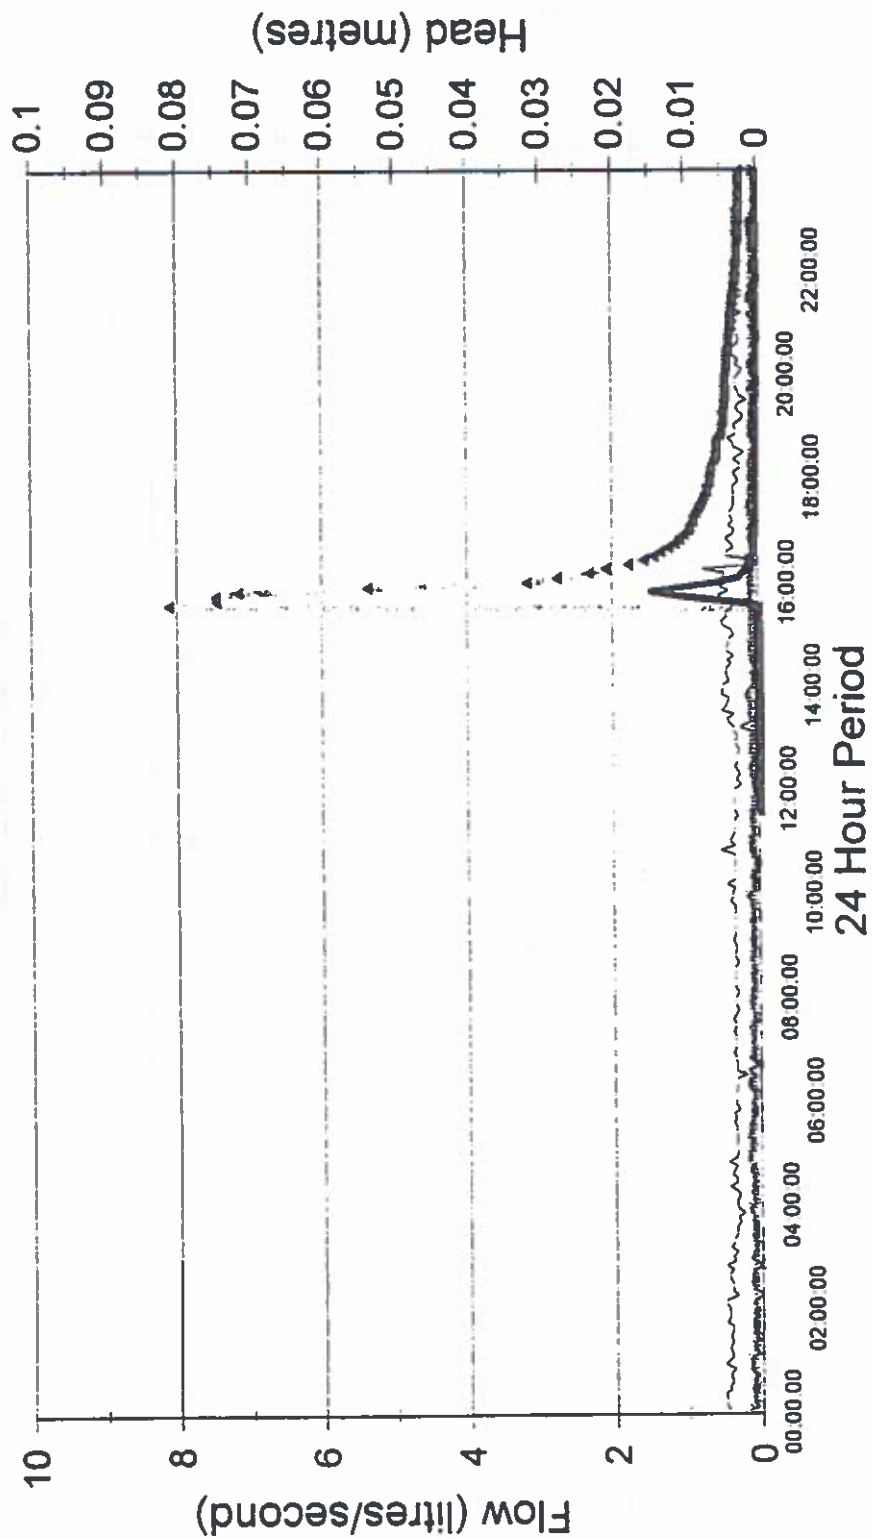
Figure 7.9

A subsequent rainfall event on May 31, 1994 produced 11.1 mm of rainfall over a 0.5 hour period. Although there was less cumulative rainfall than the previous rainfall event of May 26, 1994, this event was more intense and resulted in a peak flow of 8.1 l/s entering the system as indicated in Figure 7.9. At MH3 a minor flow of 1.5 l/s was recorded. Similar to the storm of May 26, 1994 this flow was attributed to infiltration/inflow downstream of MH2 rather than overflows due to the system being full. There was no noticeable change in head in the stone filter at MH2, with a minor change of approximately 5 mm in the stone filter downstream at MH3.

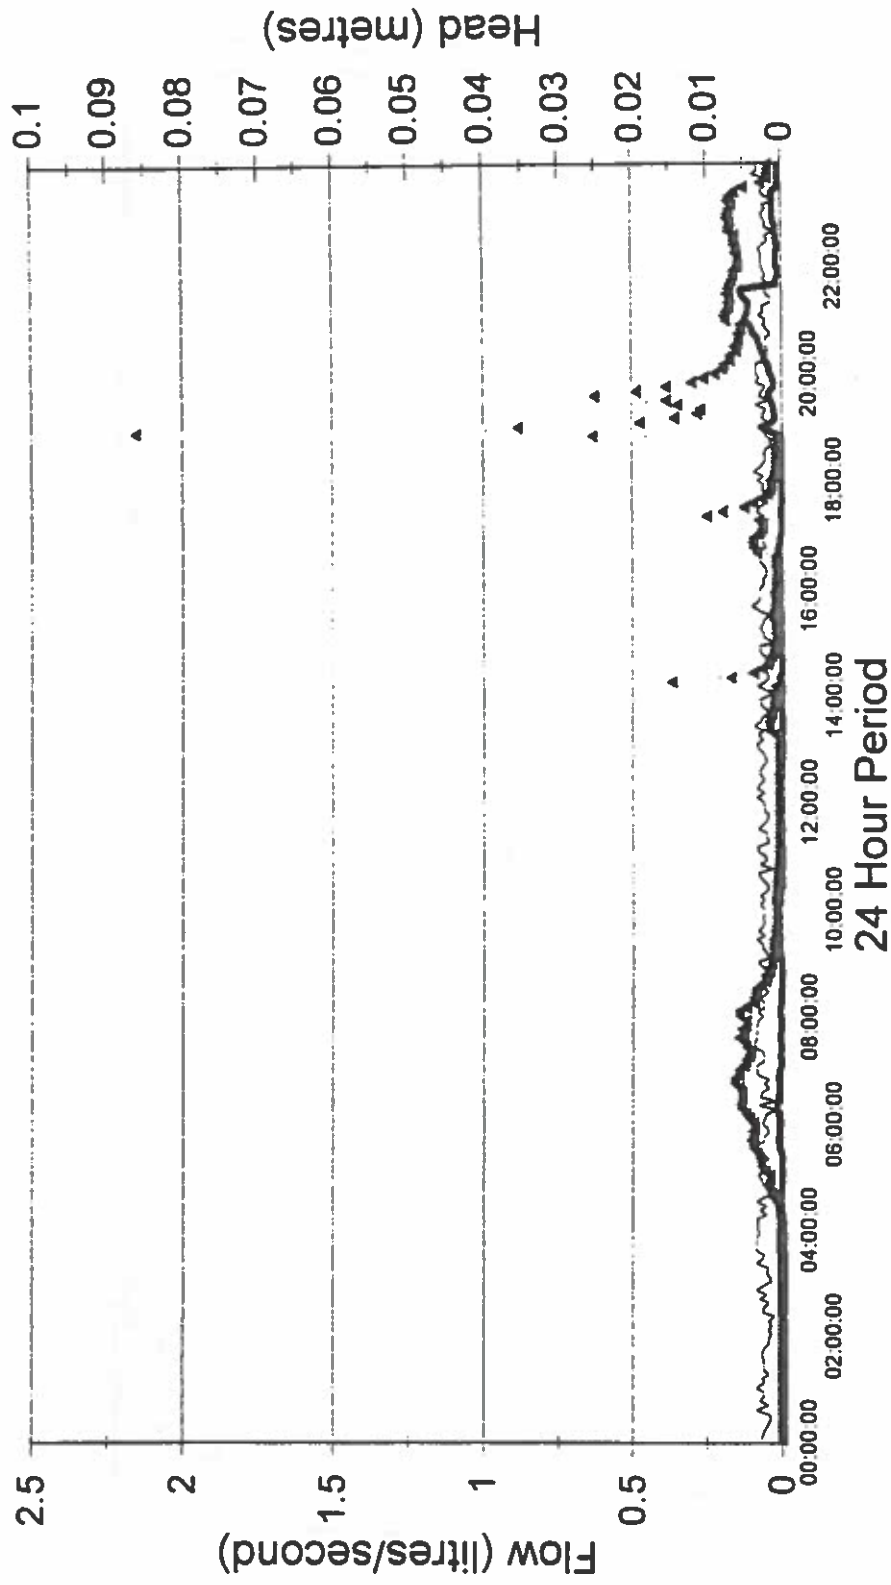
Figure 7.10

The next significant rainfall event occurred on June 24, 1994 at which time 24.1 mm of rainfall fell over a 24 hr. period. The majority of this rainfall (15.5 mm) occurred in the last 6 hours. The peak flow to the system during that event was 2.2 l/s as indicated in Figure 7.10. As with the previous events, some minor infiltration/inflow occurred in the system between MH2 and MH3 as indicated by the peak flow of 0.1 l/s.

The recorded data indicated that for this 24.1 mm rainfall event, total infiltration occurred in the system.

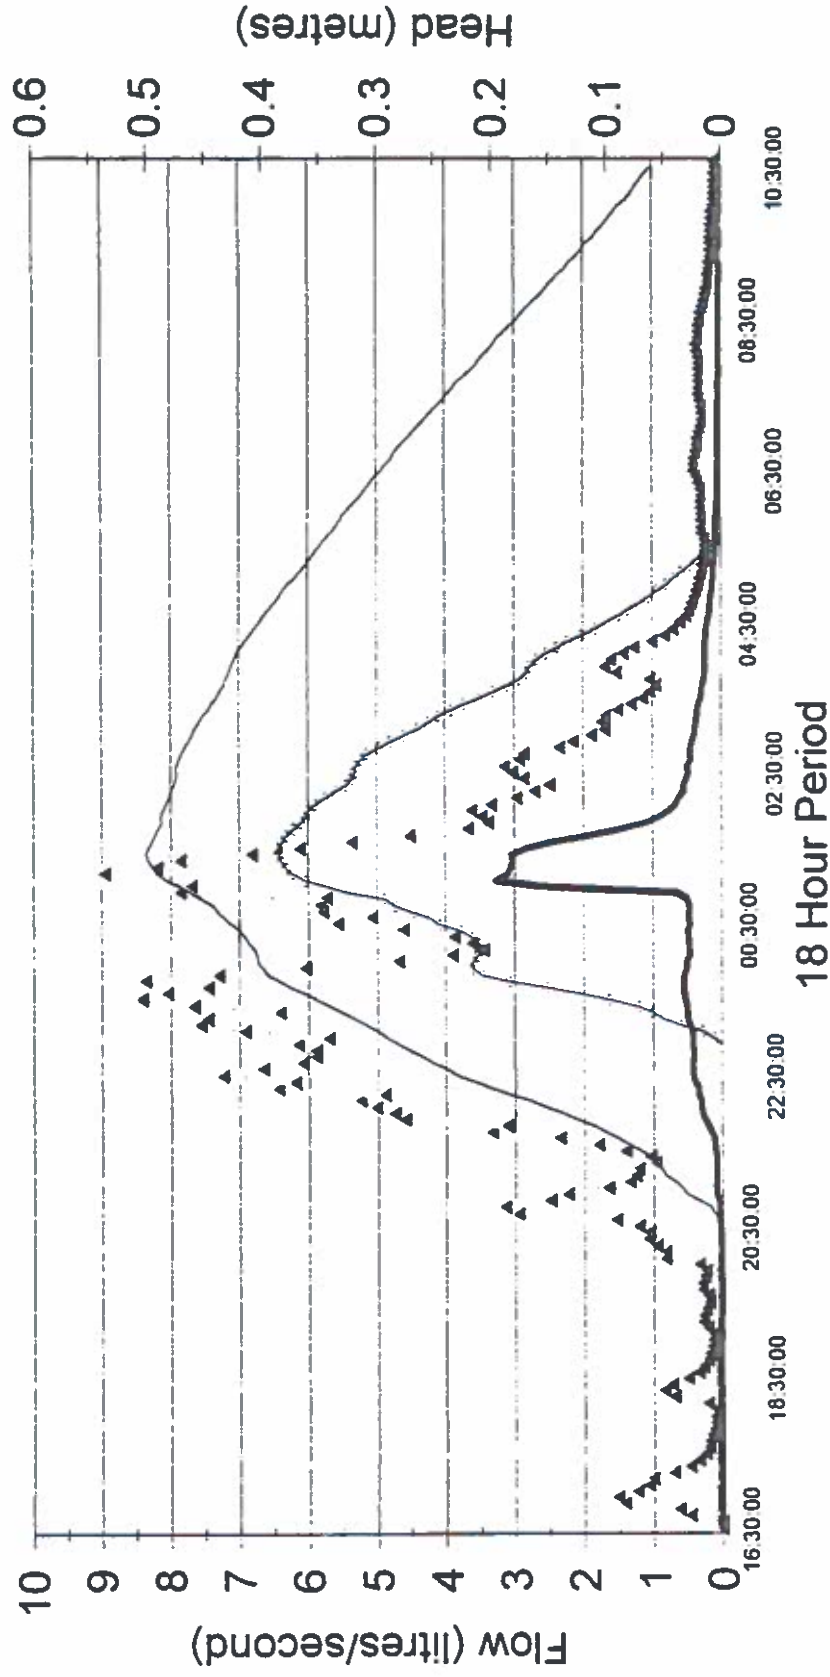
18 hour period. As indicated in Figure 7.11 the resulting inflow to the system at MH2 peaked at 10 l/s with flows ranging from 6 l/s to 10 l/s over a 3.5 hour period. Although the cumulative rainfall from this event was approximately double that of May 26, 1994, the peak flows from both events were similar.

During this event the head in the stone trench increased and was recorded at both MH2 and MH3. The maximum recorded depths were 0.38 m at MH2 and 0.5 m at MH3. These depths would indicate that the filter stone was filled. It appears that during the rainfall event the inflow to the system was both being stored in the stone and infiltrated into the soil.

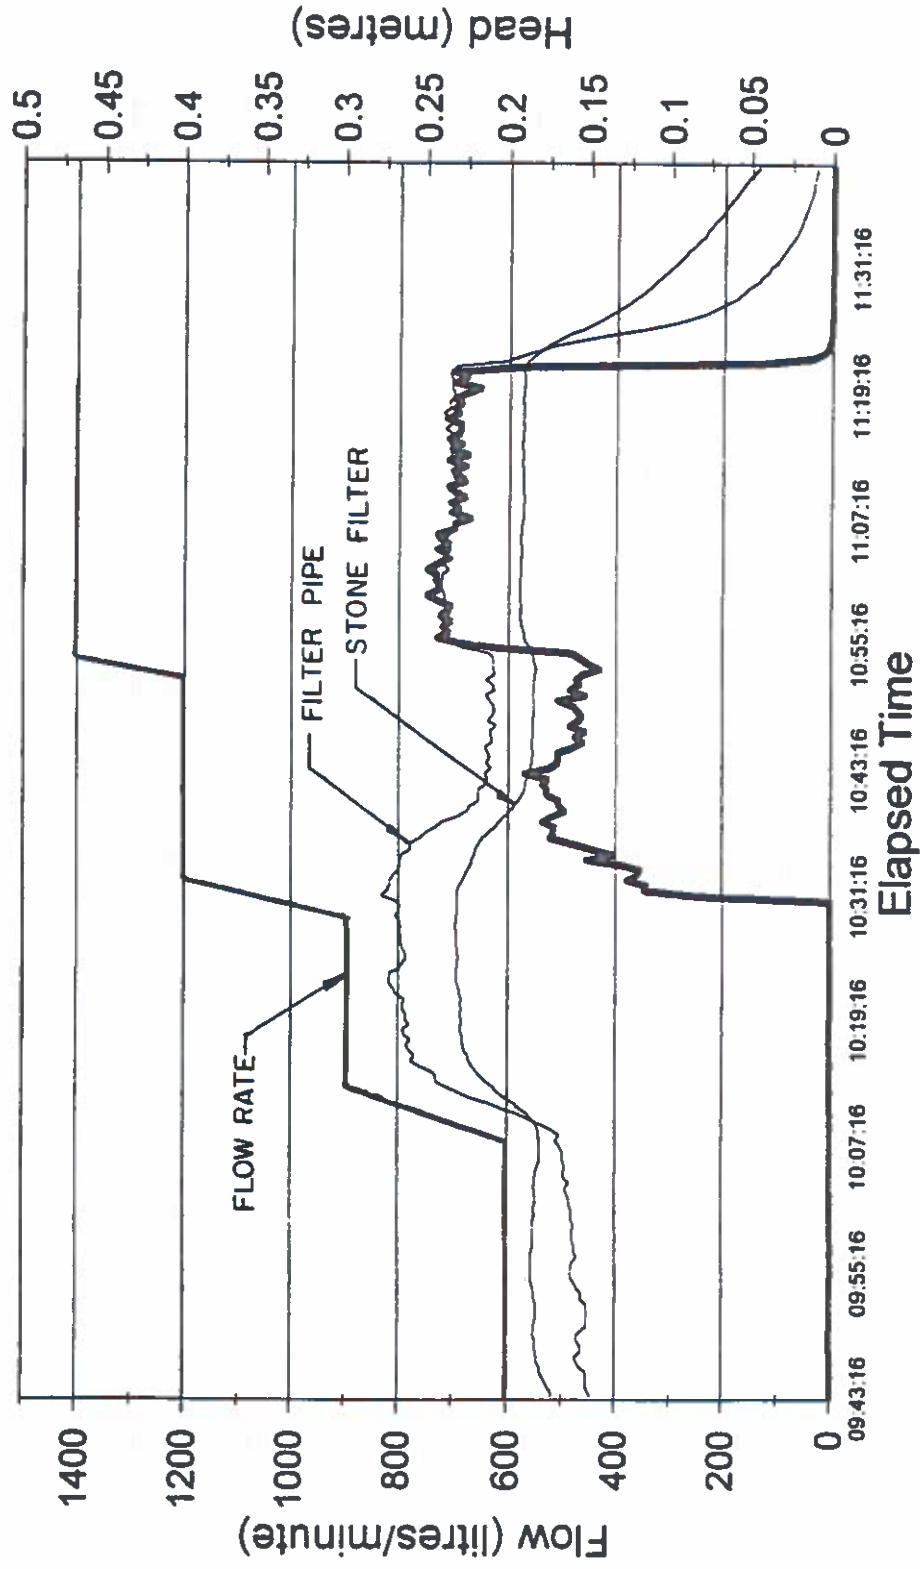
Figure 8.1

- The input to the system at the catchbasin location (labelled as "flow rate" on Figure 8.1).
The discharge through the perforated filter pipe at the base of the system (labelled as "filter pipe" on Figure 8.1).
- The head or water level in the stone material surrounding the filter pipe (labelled as "stone filter" on Figure 8.1).

- The flow or discharge through the non-perforated portion of the sewer (main sewer pipe) which comprises those flows which do not enter the filtration pipe (labelled as "main pipe" on Figure 8.1).

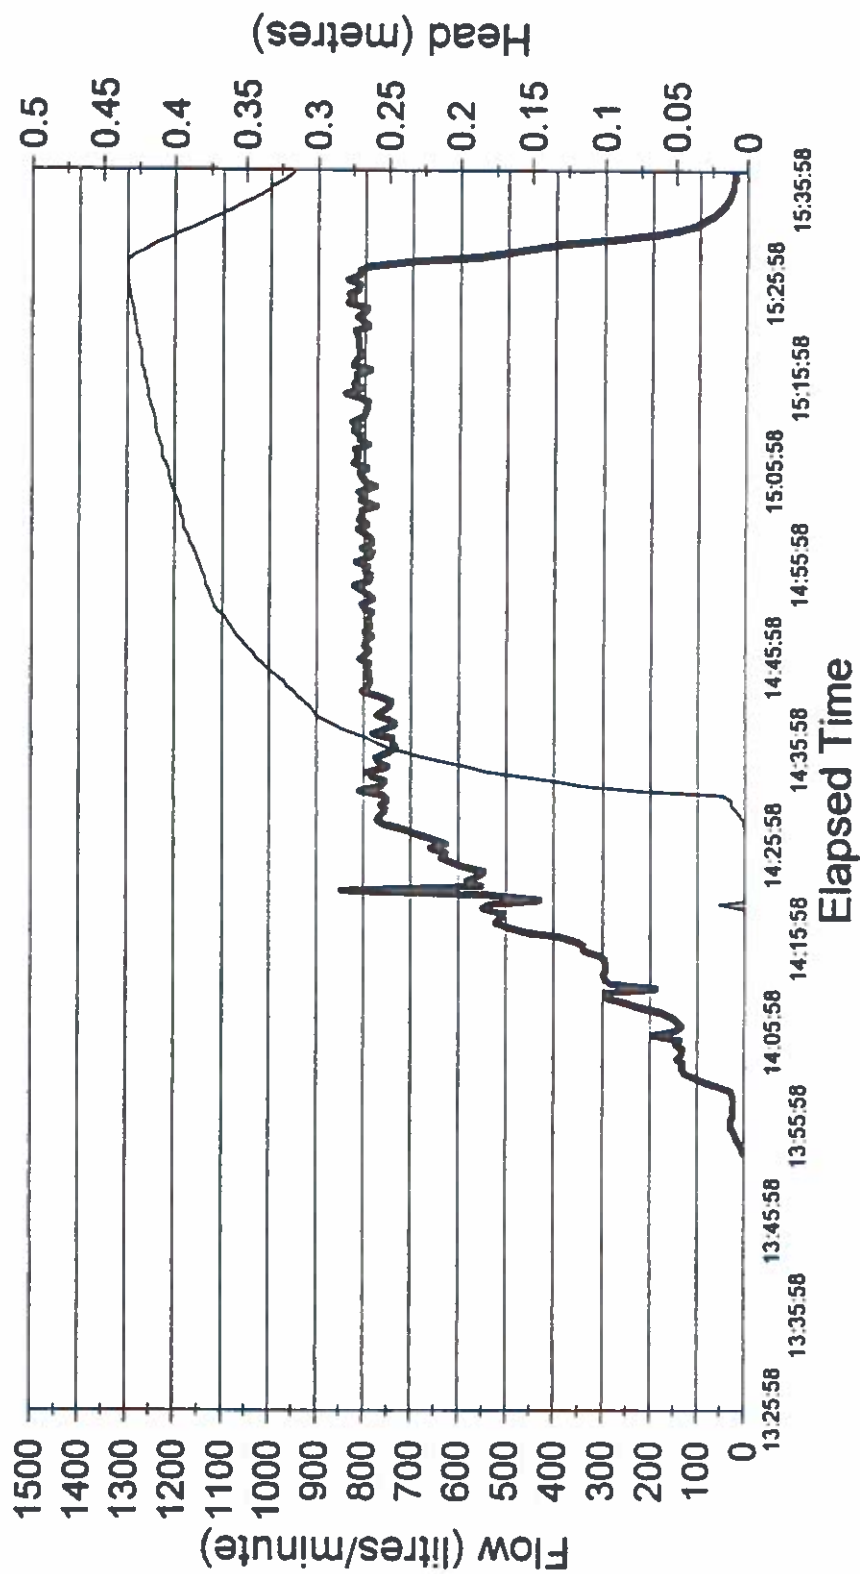
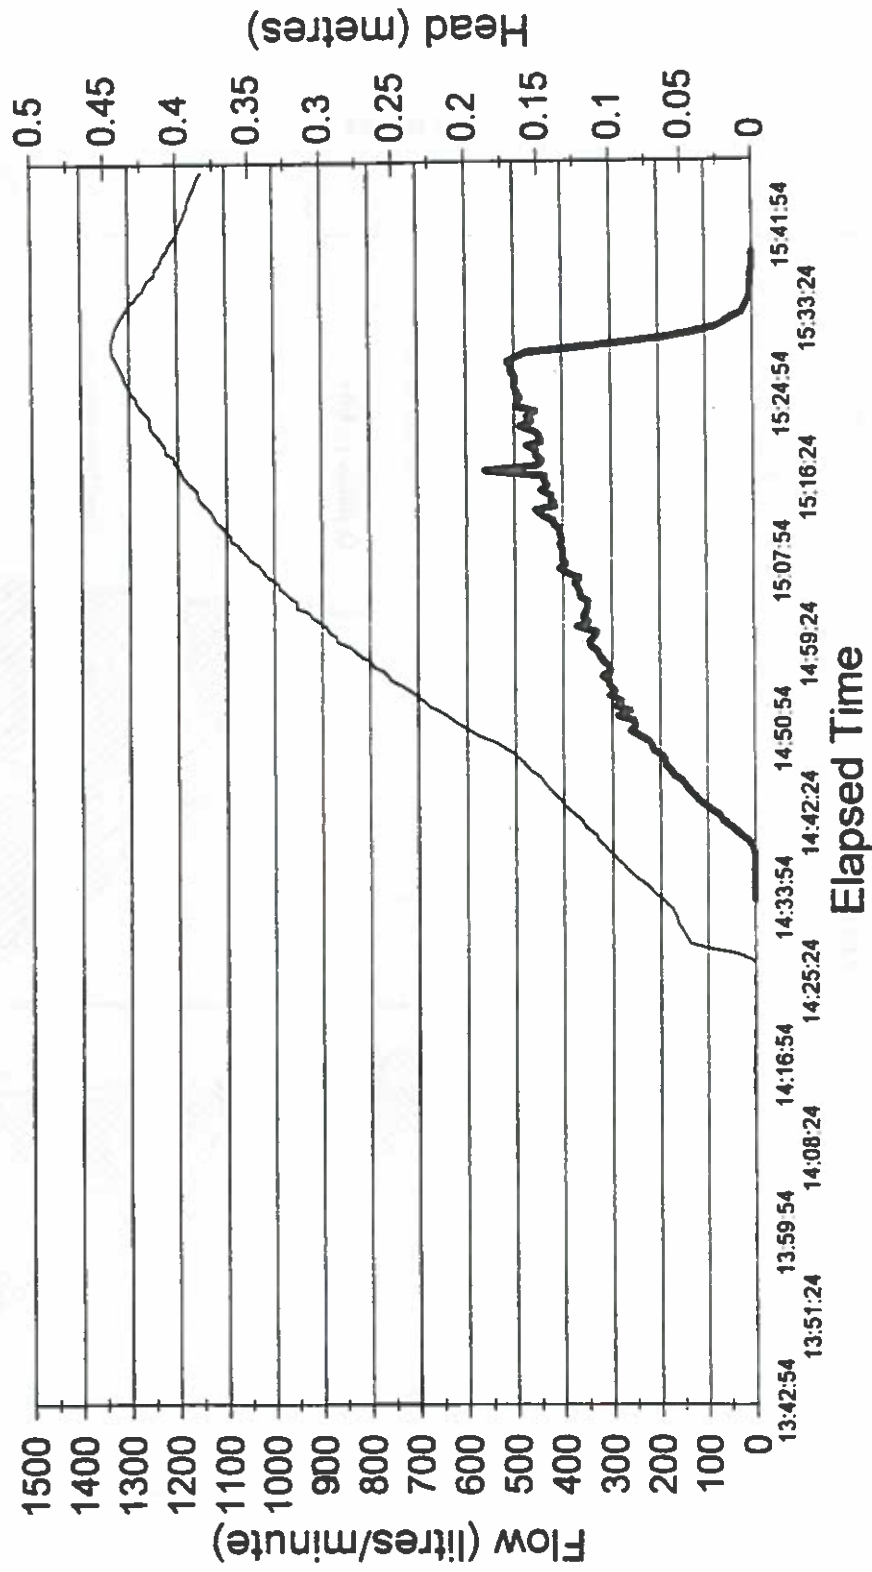
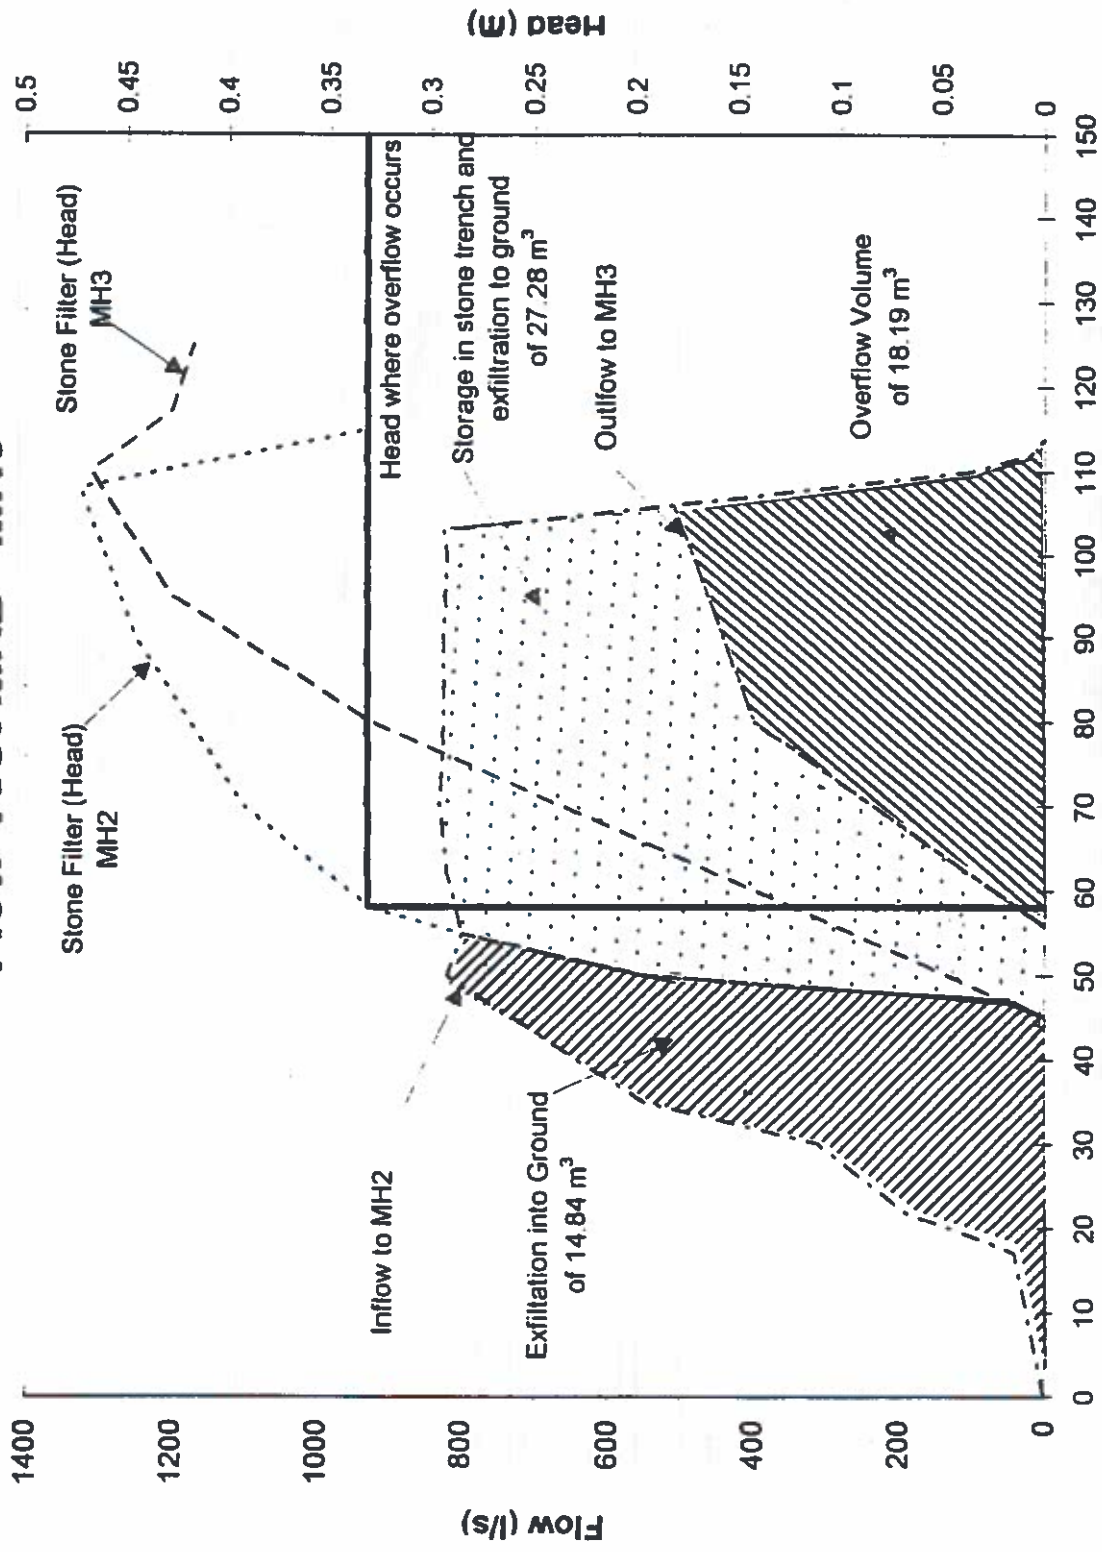
As indicated in Figures 8.2 and 8.3 an inflow occurred into the system for a period of approximately 45 minutes and reached a peak flow of 800 l/m (13.3 l/s), before any flow was

noted in the outlet of the main pipe at MH3. During this period, some water infiltrated into the soil beneath the system while the remainder of water was stored in the voids of the granular material. This is evidenced by the increase in head in the stone filter, which began to occur after approximately 40 minutes. The increase was uniform across the base of the stone filter accumulating to a maximum depth of about 0.45 m. The peak inflow at MH2 of 13.3 l/s exceeded the peak flow recorded for any storm recorded during the monitoring period. This substantiated the findings during the monitoring period that no overflow occurred during the rainfall events.
