Low Impact Development

Permeable Pavements Maintenance

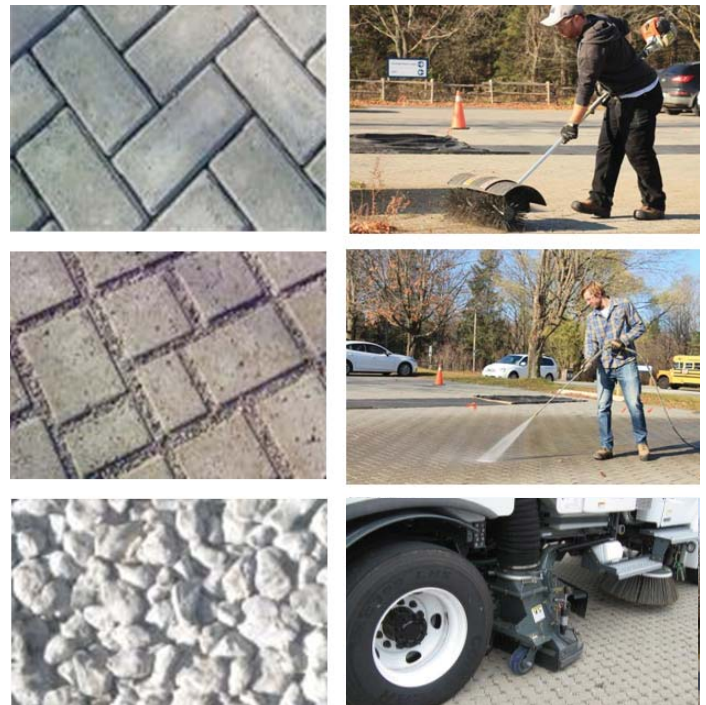
Figure 1. Maintenance tests were conducted on three permeable pavements using three different methods. The three pavements were (from top to bottom) (i) Aqua-pave™ (4% open space); (ii) Eco-optiloc™ (12% open space), and (iii) hydromedia™ pervious concrete (approx. 30% open space). The three methods were (from top to bottom) (i) power brush + vacuum maintenance; (ii) pressure wash + vacuum maintenance, and (iii) vacuum maintenance only (control).
