# Existing Building Commissioning of Kortright Visitor Centre

## PROJECT SUMMARY

<b>Building Name:</b>	Kortright Visitor Centre
<b>Type:</b>	Mixed-use; Office; Community/Rec Centre; Convention Centre
<b>Location:</b>	Vaughan, Ontario
<b>Project:</b>	Retro-commissioning of a mixed-use institutional building
<b>Commissioning Scope:</b>	Retro-commissioning of heating and cooling system, domestic hot water system, lighting, and ventilation system. Performed using internal staff.
<b>Size of Commissioned Area:</b>	Approximately 30,000 ft <sup>2</sup>
<b>Total Commissioning Investment:</b>	Approximately \$40,000 of staff time was spent for planning, investigation, and reporting (not including staff training). An additional \$5,000 of staff time was used for implementation. Costs increased due to documentation gaps, overall lack of visual indicators of system parameters, and the state of repair of systems.
<b>Estimated Energy Cost Savings:</b>	\$8,500 per year (for <i>all</i> measures identified but some not implemented yet)

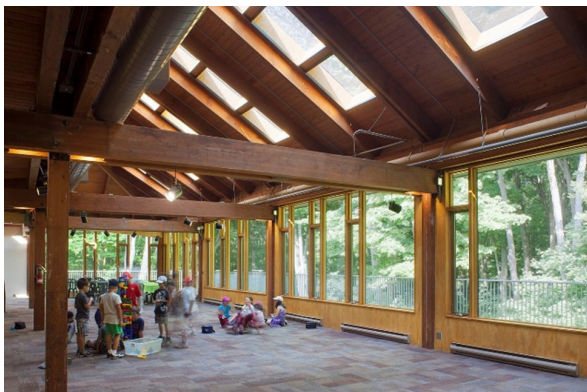
Figure 1. Interior picture of the Kortright Visitor Centre showing daylighting.

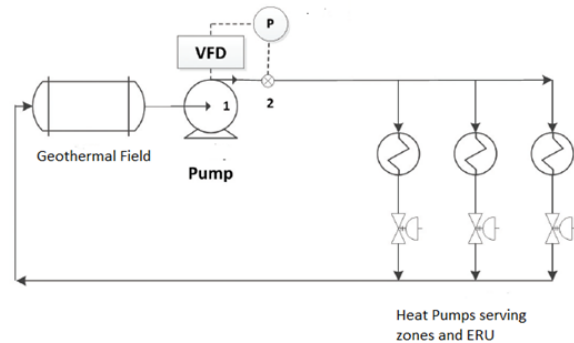
Figure 2. Simplified schematic of the geothermal system. Note that it shows only three GSHPs and a single pump. There are actually six GSHPs and two circulator pumps, as well as additional hydronic circuits and components.

- **The ground loop circulators are not operating according to the design intent,** but rather at a constant high-speed year-round regardless of the heating or cooling load. This has been the case since 2012 and is due to the control point pressure transducer having not been installed. Previous monitoring studies have found that running the ground loop circulator pump at a constant high speed can increase the overall power consumption of the full geothermal system by on the scale of 50%.<sup>1</sup>
