APPENDIX C

VISUAL INDICATOR PROTOCOLS

C.1 CONTRIBUTING DRAINAGE AREA CONDITION

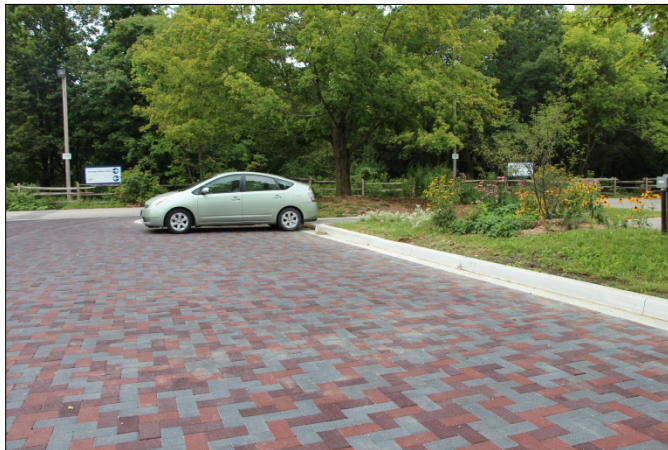
PASS: CDA has not changed in size or land cover. Sediment, trash or debris is not accumulating and point sources of contaminants are not visible.

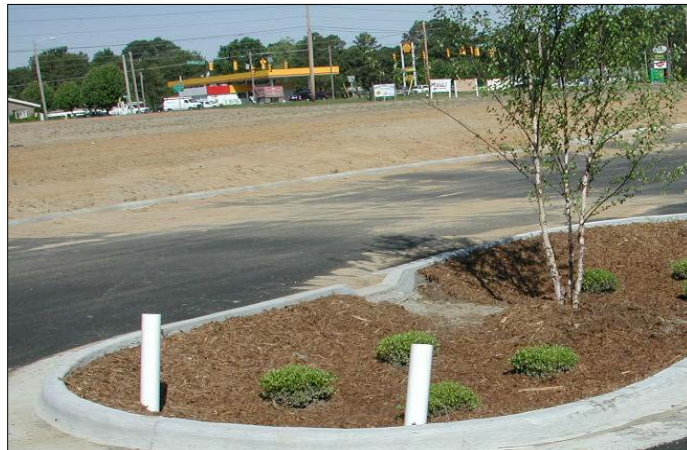
FAIL: Size of the CDA has changed from design assumptions. A point source for contaminants is visible (i.e. lack of sediment controls on adjacent construction site). (Source: NCCE)

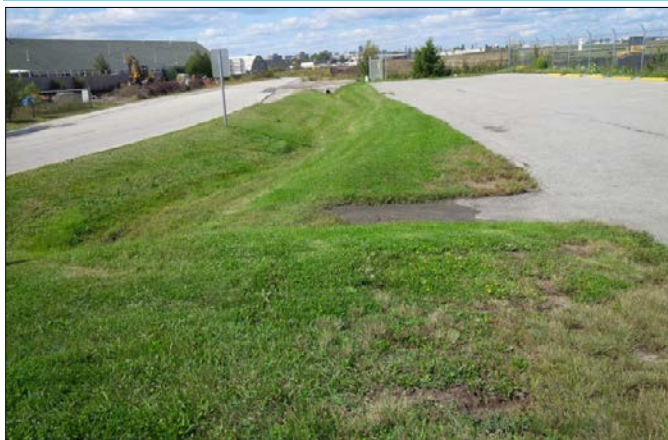
PASS: CDA has not changed in size or land cover. Sediment, trash or debris is not accumulating and point sources of contaminants are not visible.

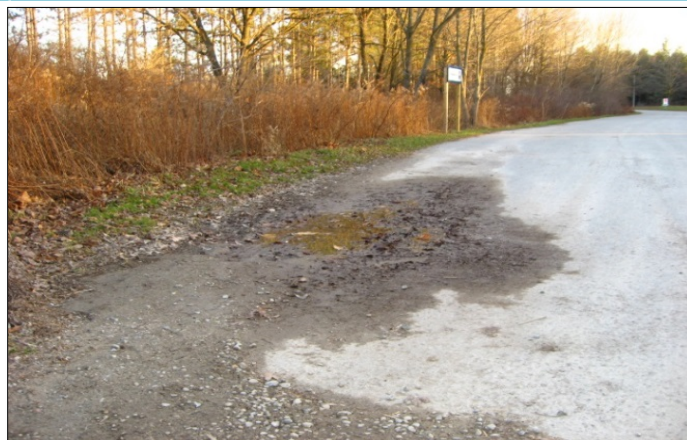
FAIL: Ponding and sediment accumulation on the CDA is visible indicating runoff is not freely entering the BMP and that the pavement has not been swept recently.

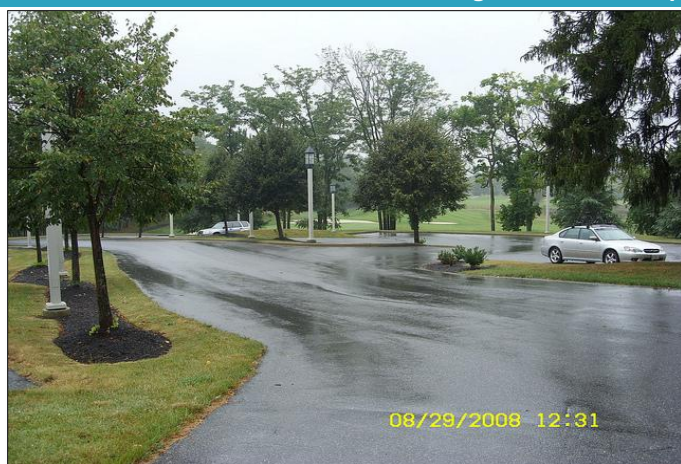
PASS: CDA has not changed in size or land cover. Sediment, trash or debris is not accumulating and point sources of contaminants are not visible. (Source: CSN)

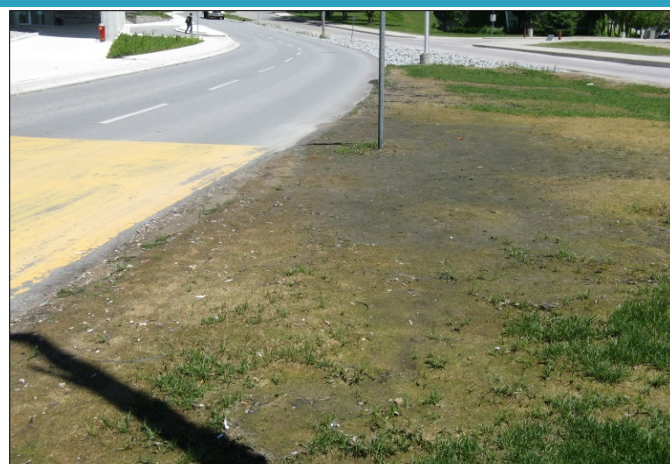
FAIL: Size of the CDA or land cover within it has changed from design assumptions. Accumulation of sediment on the CDA is visible.

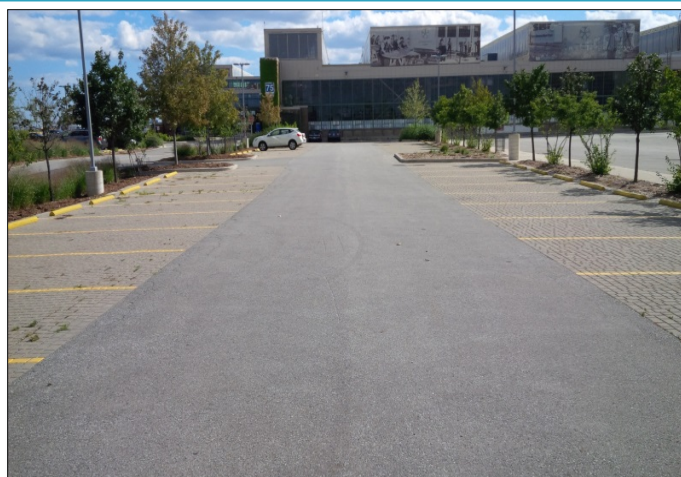
PASS: CDA has not changed in size or land cover. Sediment, trash or debris is not accumulating and point sources of contaminants are not visible.

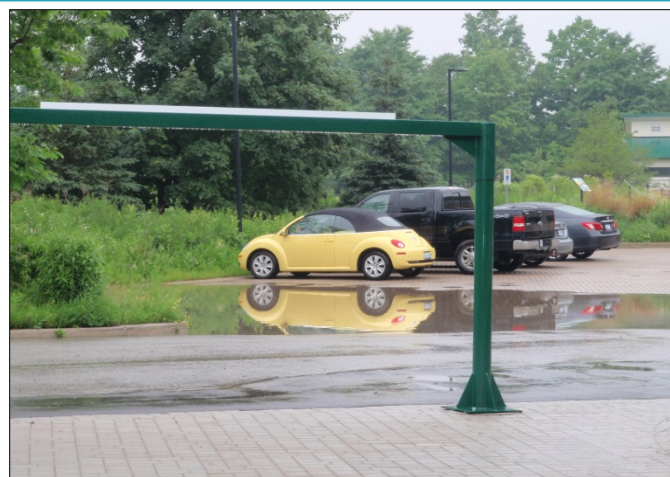
FAIL: Size of the CDA has changed from design assumptions (i.e. large asphalt area drains to a small portion of the permeable pavement). Evidence of surface ponding is visible.

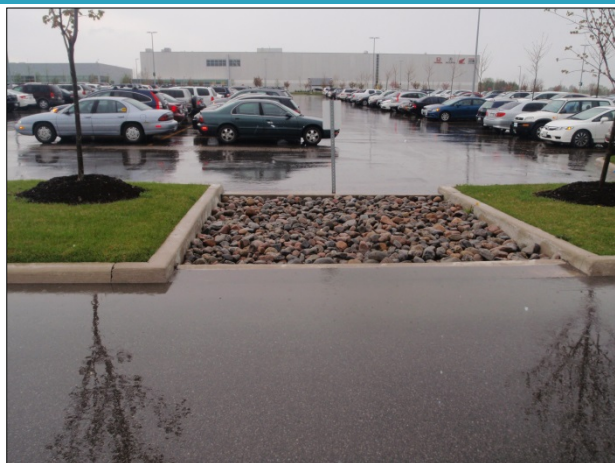
PASS: CDA has not changed in size or land cover. Sediment, trash or debris is not accumulating and point sources of contaminants are not visible.

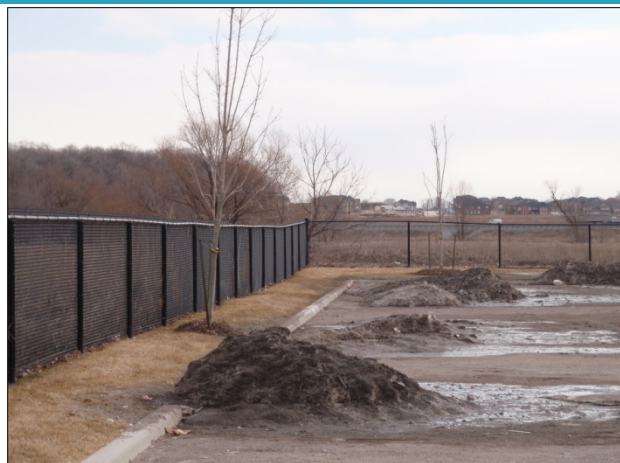
FAIL: Point sources of contamination are present (i.e. accumulated sediment and debris from melted snow piles).

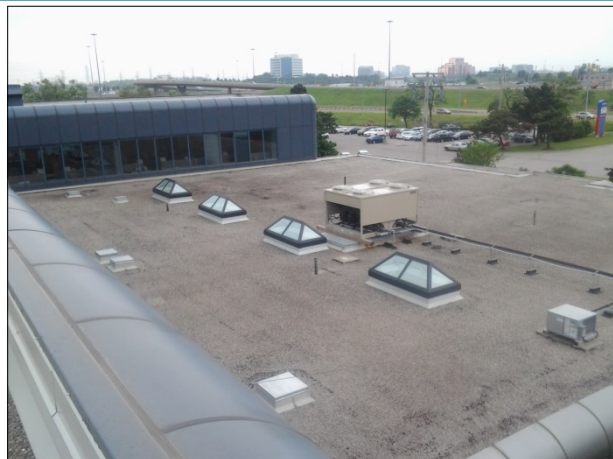
PASS: CDA has not changed in size from design assumptions. Sediment, trash or debris is not accumulating and point sources of contaminants are not visible.

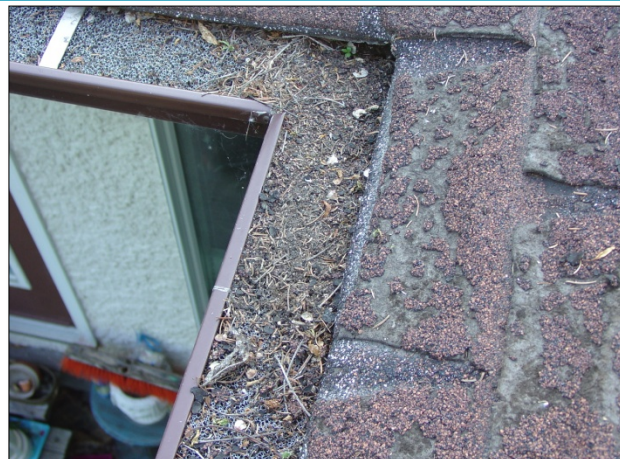
FAIL: Sediment and debris is accumulating on the CDA due to deteriorating roof shingles. Eavestroughs need cleaning.

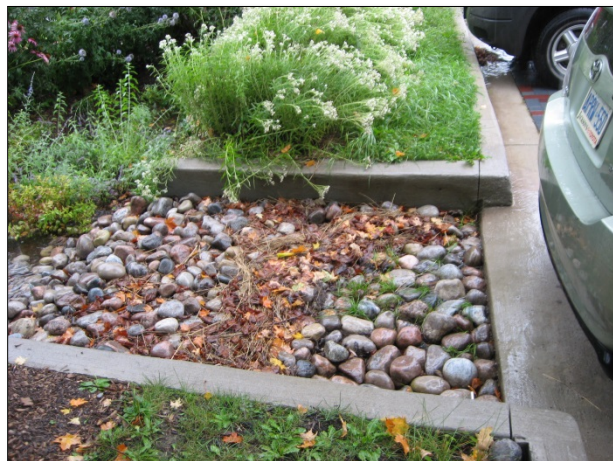
PASS: There is no evidence of damage or displacement of the inlet structure that would prevent runoff from freely entering the BMP.

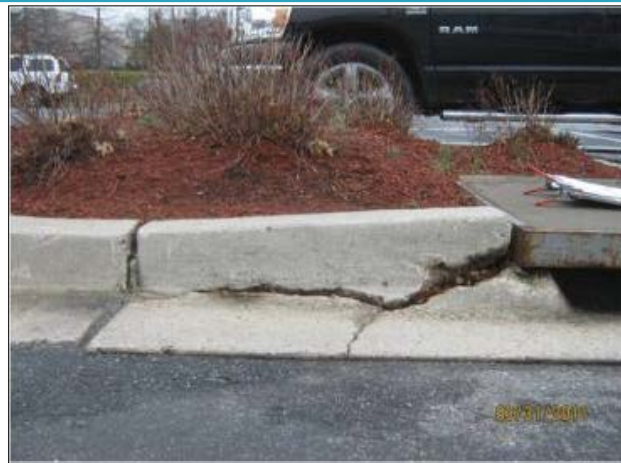
FAIL: The inlet structure has been damaged or displaced and requires repair. (Source: CSN)

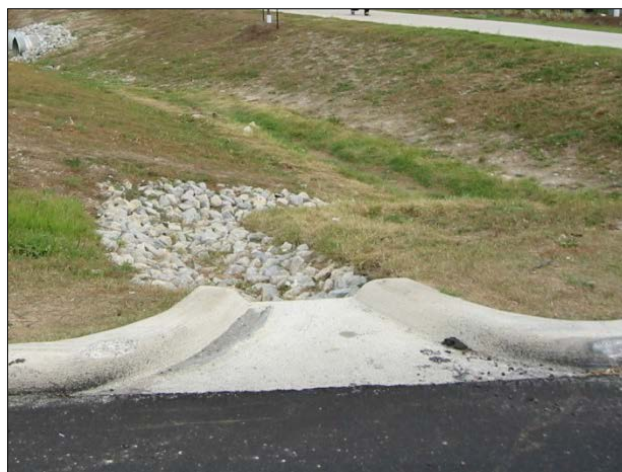
PASS: There is no evidence of damage or displacement of the inlet structure and no erosion gullies on the filter bed.

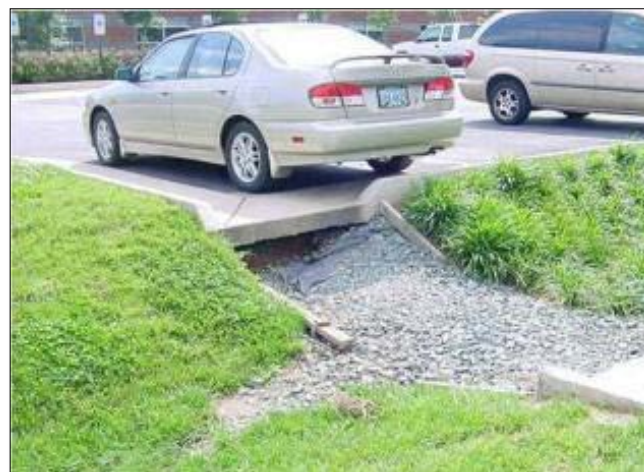
FAIL: Excessive erosion at the inlet is visible and undermining the integrity of the adjacent pavement. (Source: CSN)

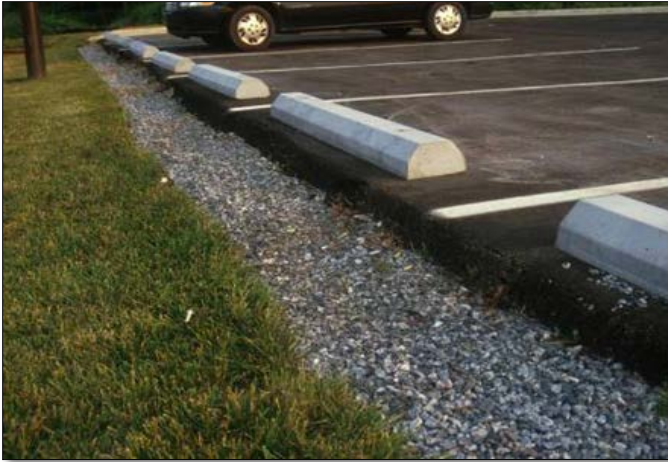
PASS: There is no evidence of damage to the gravel diaphragm inlet that would prevent runoff from entering the BMP nor excessive erosion of the filter bed. (Source: Aquafor Beech)

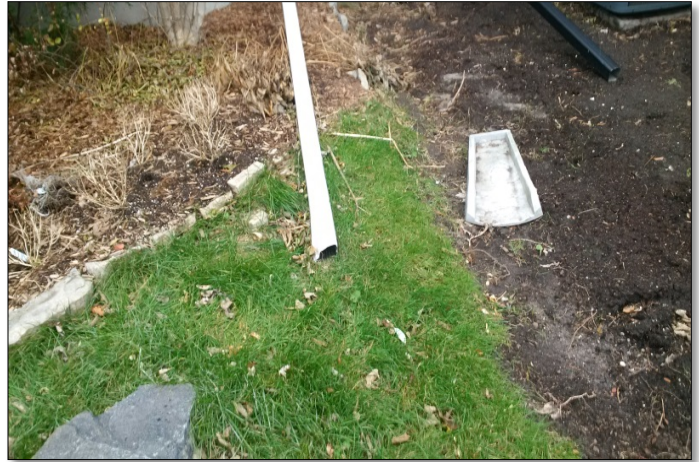
FAIL: Splash pad has been displaced and could lead to excessive erosion of the filter bed.

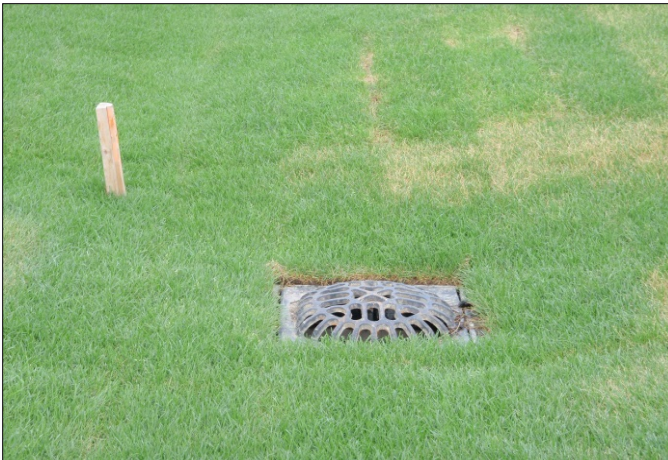
PASS: There is no evidence of damage or displacement of the inlet that would prevent runoff from freely entering the BMP.

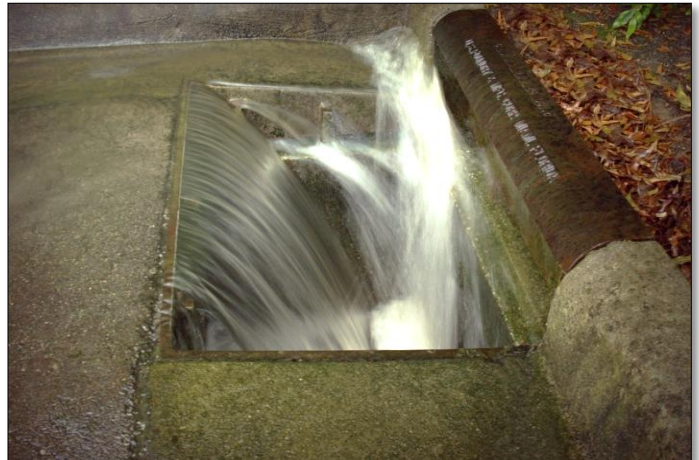
FAIL: The catchbasin cover is missing, creating dangerous conditions and allowing large debris to enter the BMP. (Flickr Hive Mind).

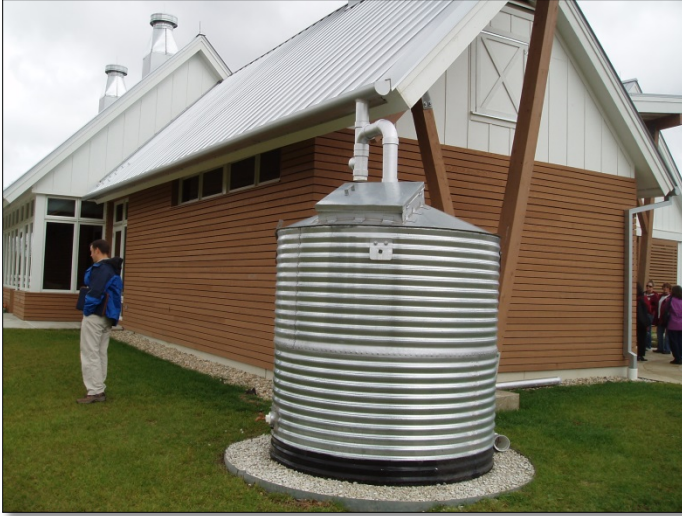
PASS: Inlet pipe and couplings are securely connected to the CDA and cistern. (Source: Lake County SMC)

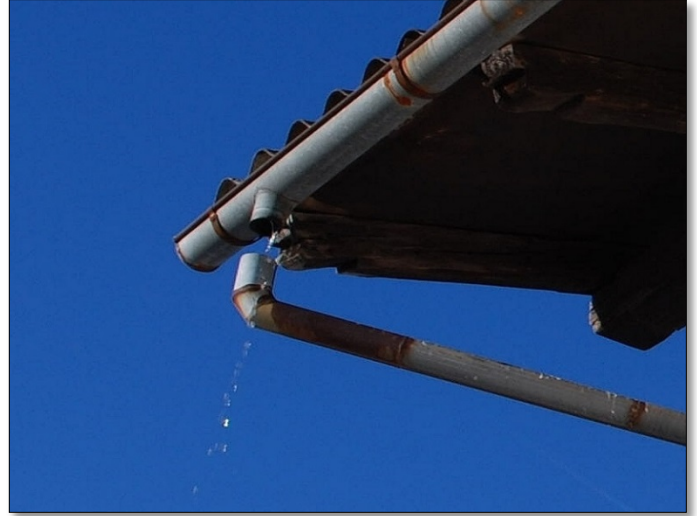
FAIL: The roof downspout is disconnected from the eavestrough, preventing runoff from entering the cistern.

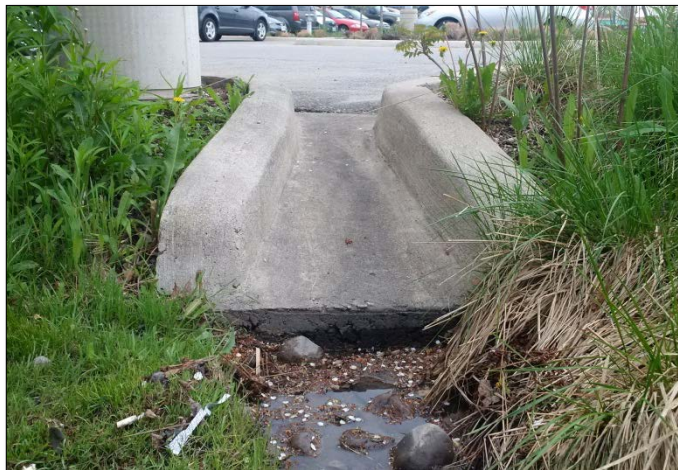
PASS: There are no obstructions at the inlet and stormwater can freely flow into the BMP.

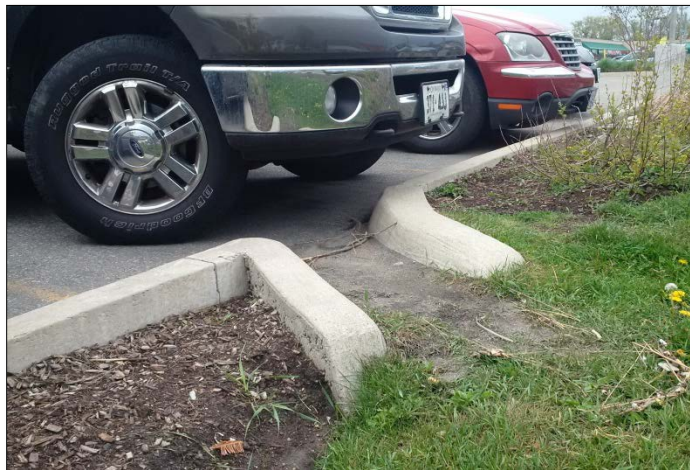
FAIL: Accumulated sediment and vegetation is preventing stormwater from entering the BMP. Sediment on the pavement surface in front of the inlet indicates ponding is occurring.

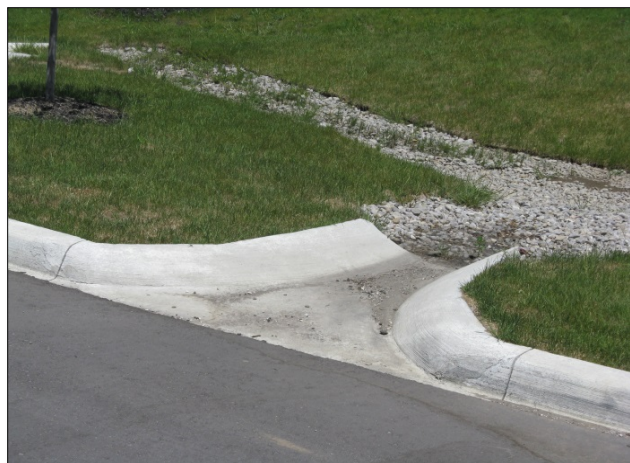
PASS: There are no obstructions at the inlet and stormwater can freely flow into the BMP.

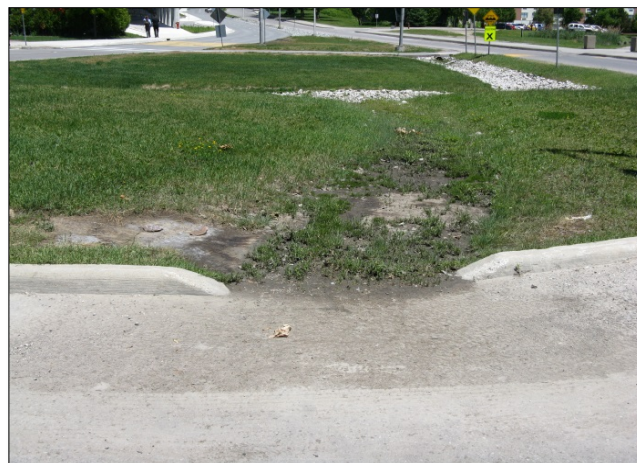
FAIL: Accumulated sediment and vegetation is preventing stormwater from entering the BMP. Sediment on the pavement surface in front of the inlet indicates ponding is occurring.

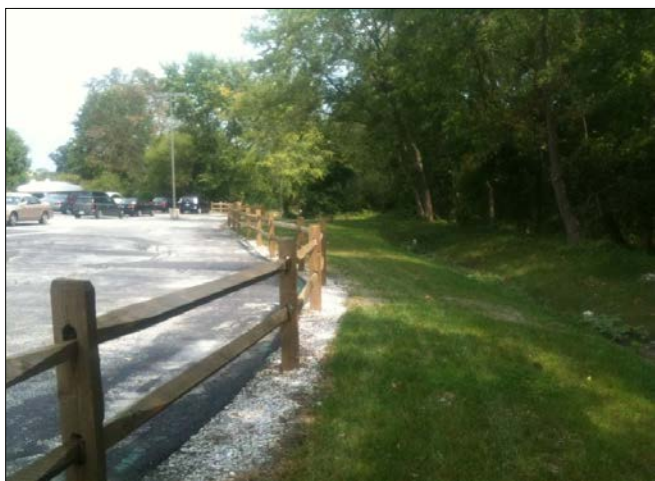
PASS: There are no obstructions at the inlet and stormwater can freely flow into the BMP as sheet flow from the pavement and gravel diaphragm. (Source: CSN).

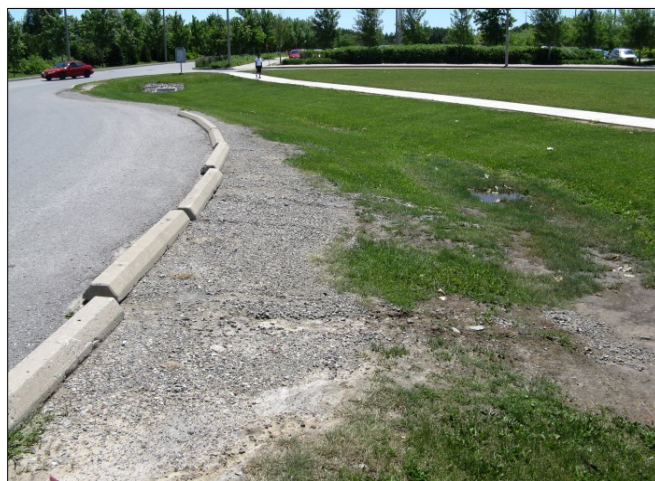
FAIL: Concrete barriers are preventing stormwater from entering the BMP as sheet flow from the pavement. Sediment has accumulated at the inlet edge of the BMP.

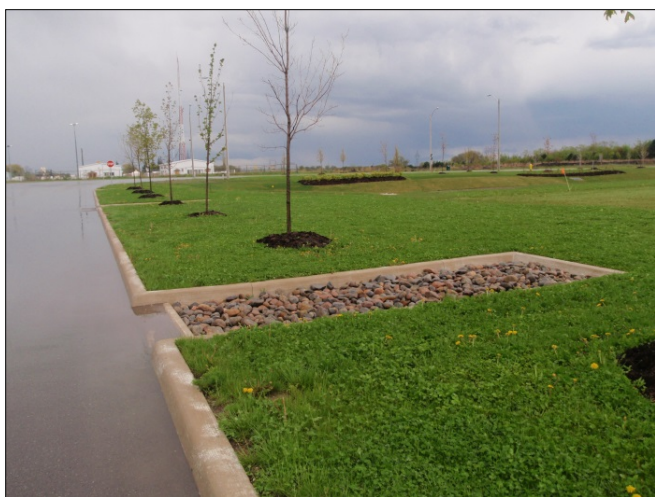
PASS: There are no obstructions at the inlet and stormwater can freely flow into the BMP.

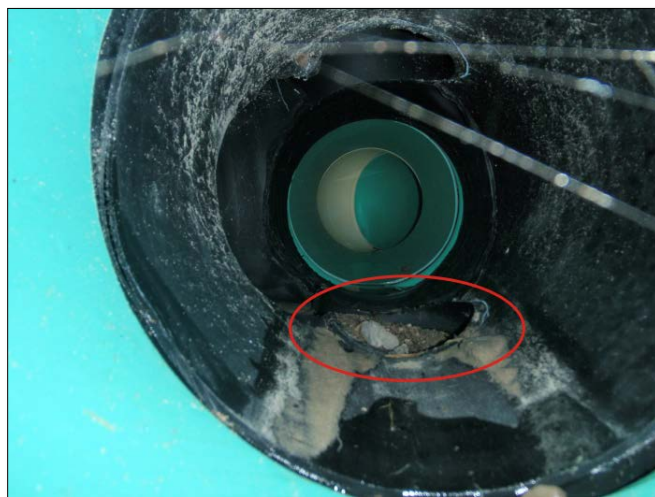
FAIL: Sediment has accumulated in the inlet pipe to the infiltration trench and is fully obstructing flow of stormwater into the BMP.

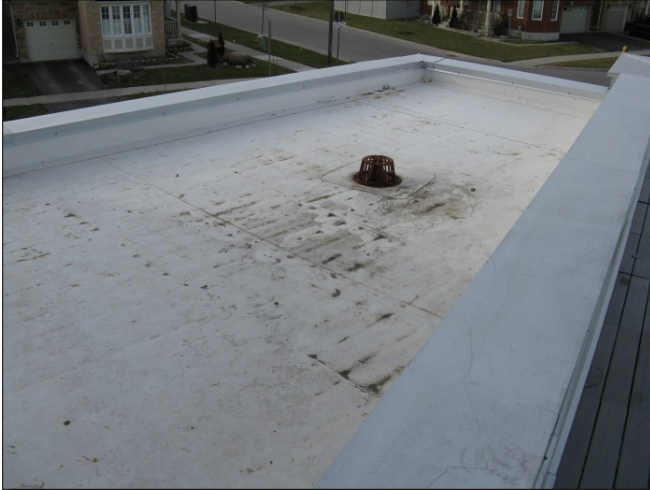
PASS: There are no obstructions at the inlet and stormwater can freely flow into the BMP

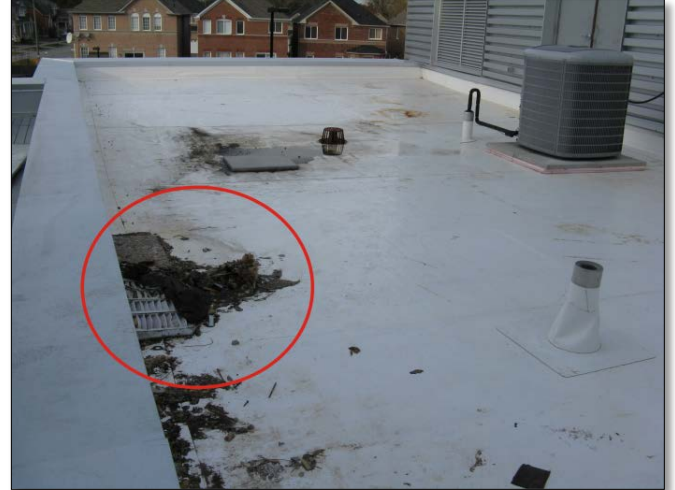
FAIL: Accumulated sediment and debris is blocking inflow over greater than one third of the inlet width and preventing stormwater from freely entering the BMP.

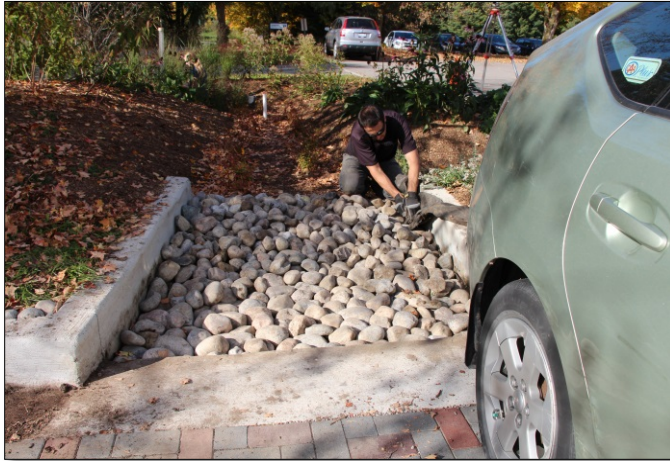
PASS: Forebay is free of sediment, trash and debris. Stones to slow down and spread out inflowing water remain in place.

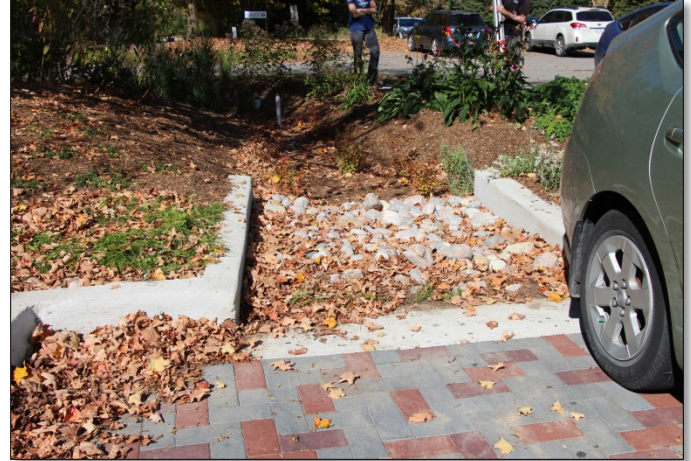
FAIL: Forebay has accumulated sediment and vegetation is growing in it which is impairing its function and preventing stormwater from freely entering the BMP.

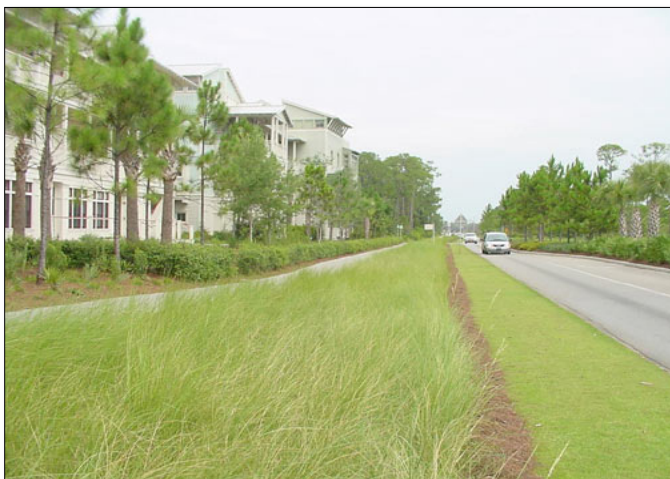
PASS: The grass filter strip pretreatment is free of sediment, trash and debris. (Source: Abbey and Associates).

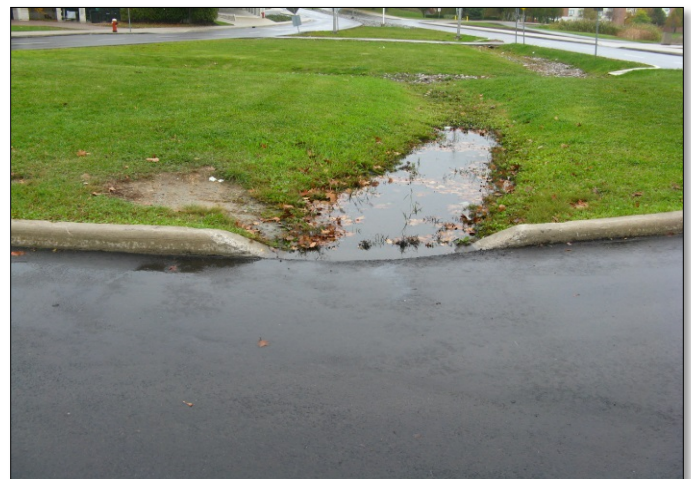
FAIL: Sediment and debris has accumulated in the forebay and is preventing stormwater from flowing into the BMP.

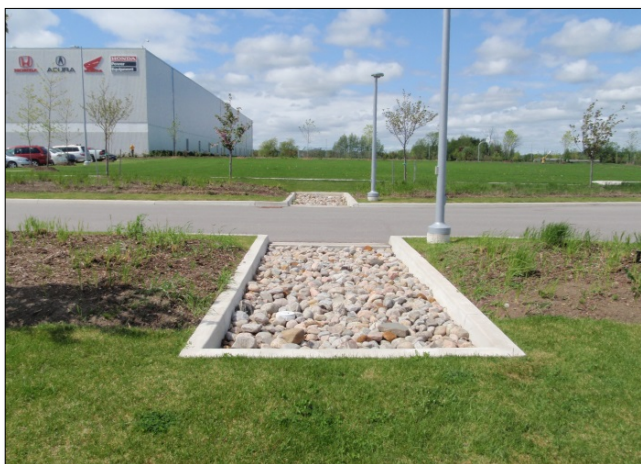
PASS: Geotextile-lined stone inlet is free of sediment, trash and debris. Stones to slow down and spread out inflowing water remain in place.

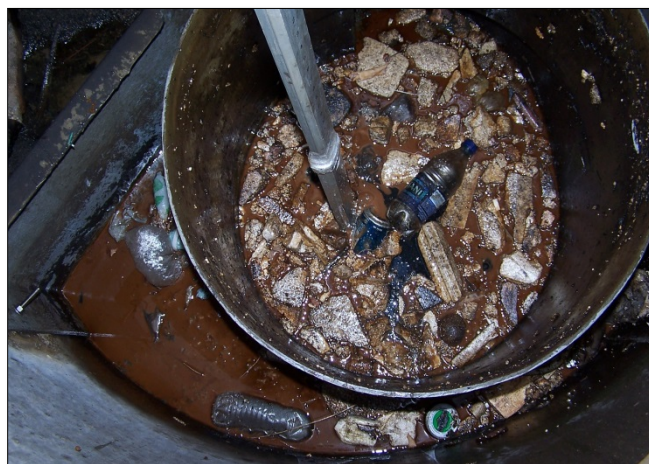
FAIL: Accumulated sediment, trash and debris in the hydrodynamic (i.e., oil and grit) separator is occupying greater than 50% of its storage capacity. (Source: SWC Canada)

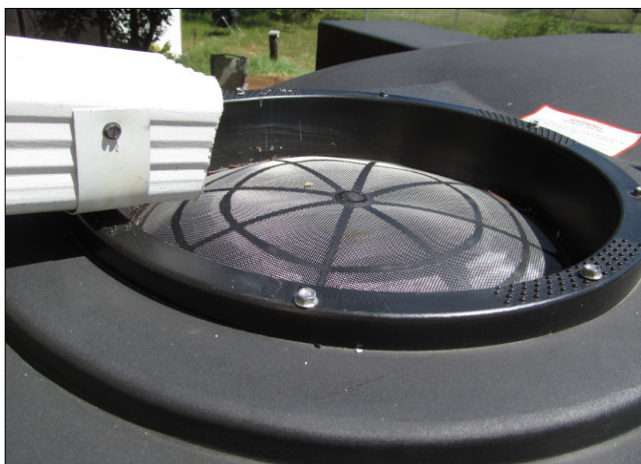
PASS: The pretreatment filter of the cistern is free of sediment and debris.

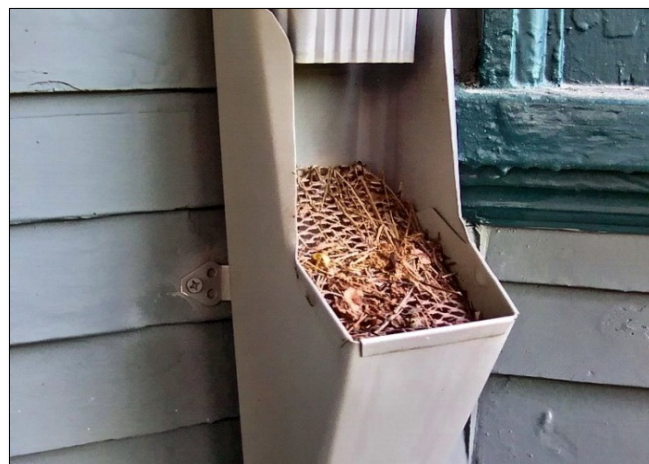
FAIL: The pretreatment filter on the roof downspout is partially covered by debris which could prevent stormwater from freely entering the BMP (Source: DMR).

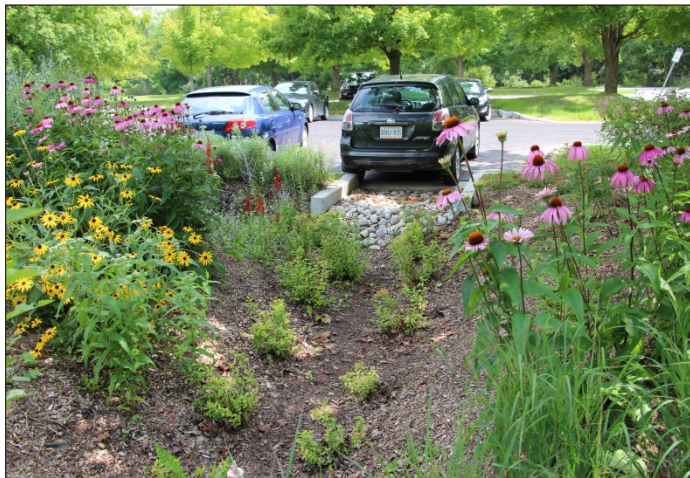
PASS: No signs of soil erosion are visible on the filter bed immediately downstream of the inlet and no stones have been displaced from the forebay.

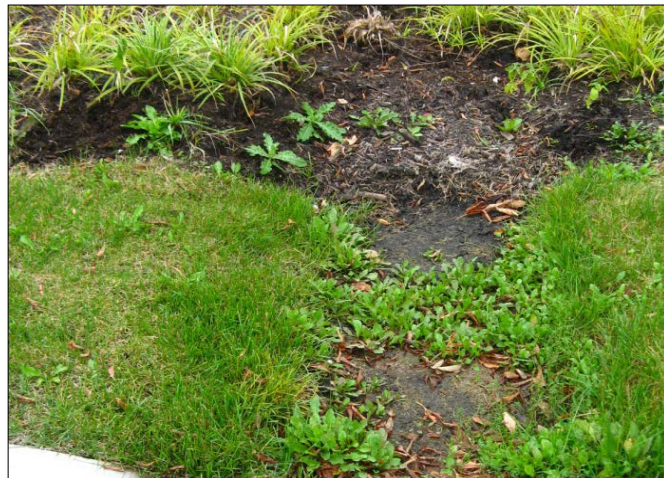
FAIL: Erosion gully and bare soil is visible on the grass filter strip pretreatment at the inlet indicating it is not sufficiently slowing and spreading out the inflow of stormwater to the BMP.

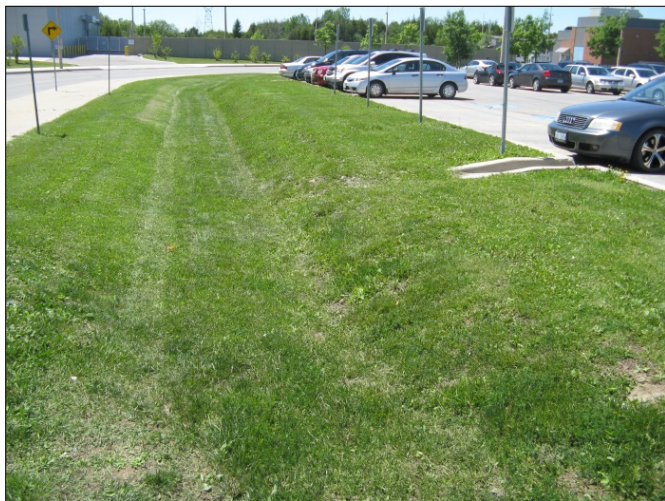
PASS: No erosion gullies or bare soil present at the inlet.

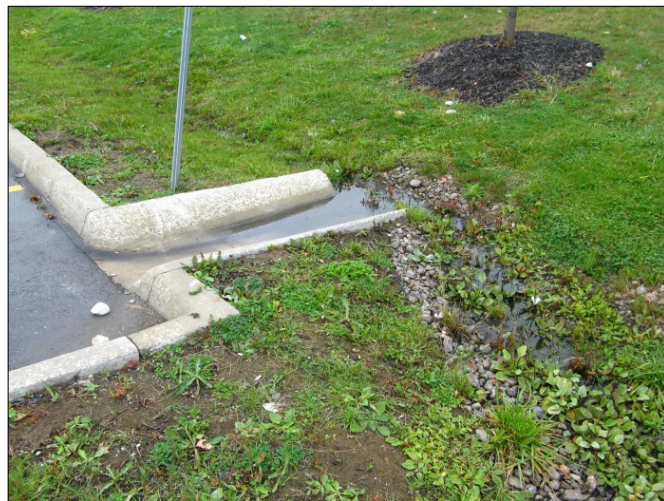
FAIL: Erosion gullies and bare soil areas are visible on the swale surface at the inlet.

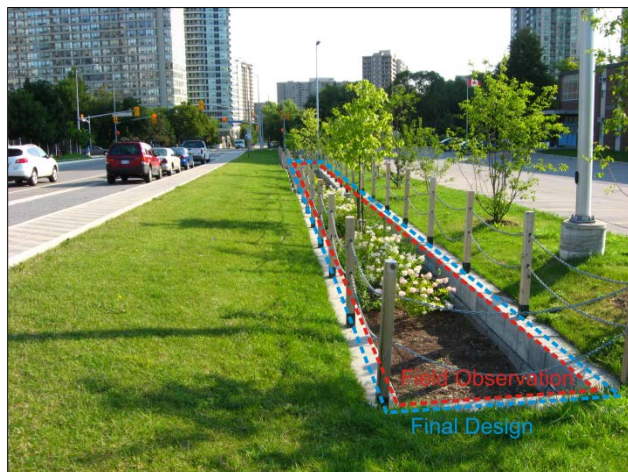
PASS: The footprint area of the BMP does not significantly deviate from the final design and should not negatively affect its stormwater management treatment performance.

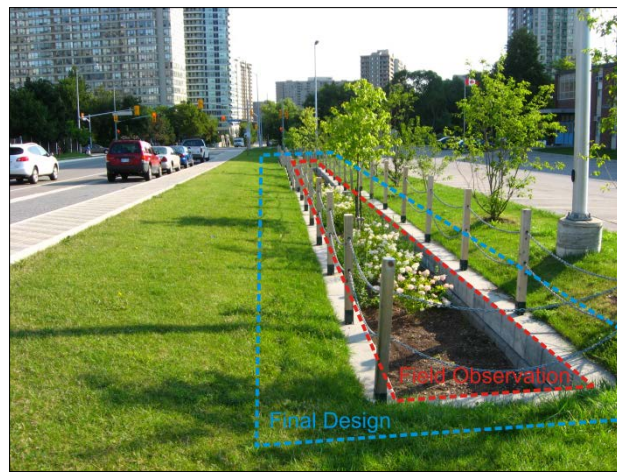
FAIL: The footprint area of the BMP is significantly smaller than what was specified in the final design.

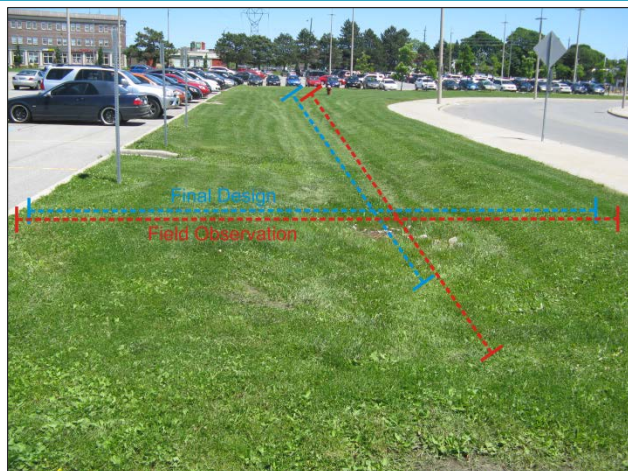
PASS: The footprint area of the BMP does not significantly deviate from the final design and should not negatively affect its stormwater management treatment performance.

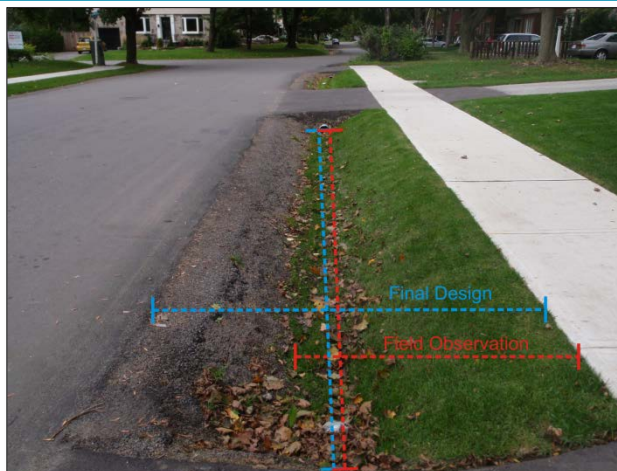
FAIL: The footprint area of the swale is significantly smaller than what was specified in the final design due to half the width having been paved over.

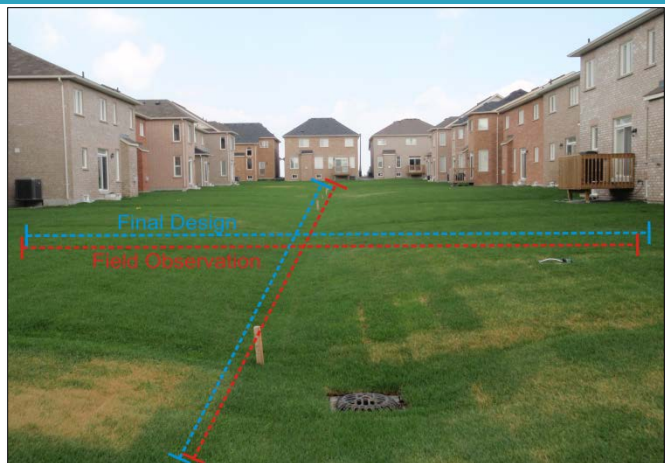
PASS: The footprint area where soil amendments have been implemented does not significantly deviate from the final design and should not negatively affect its stormwater management treatment performance.

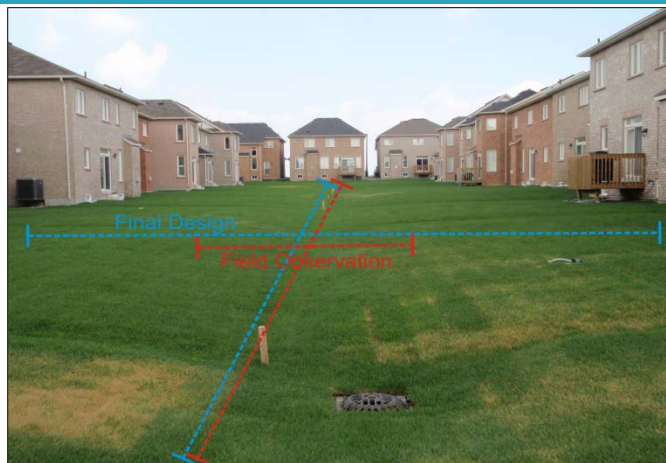
FAIL: The footprint area where soil amendments have been implemented is significantly smaller than what was specified in the final design.

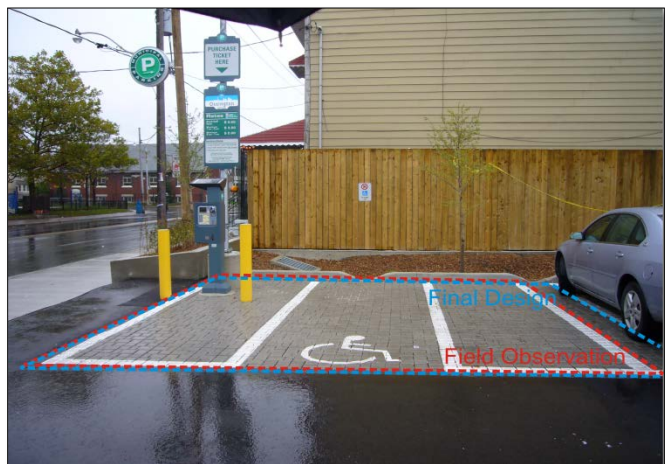
PASS: The footprint area of the BMP does not significantly deviate from the final design and should not negatively affect its stormwater management treatment performance.

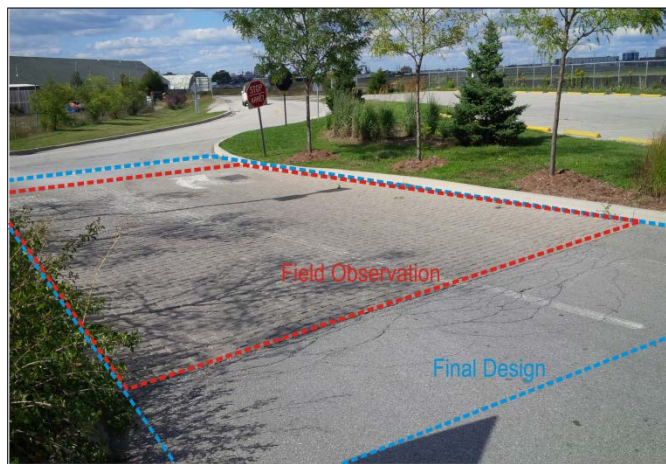
FAIL: The footprint area of the BMP is significantly smaller than what was specified in the final design.

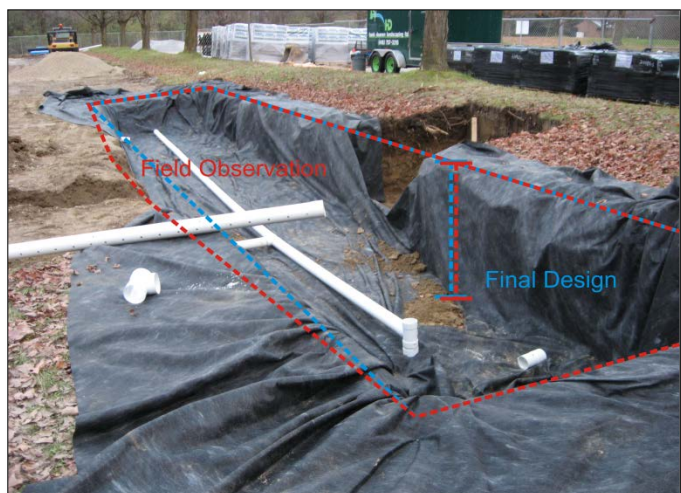
PASS: The footprint area and depth of the bioretention cell does not significantly deviate from the final design and should not negatively affect its stormwater management treatment performance.

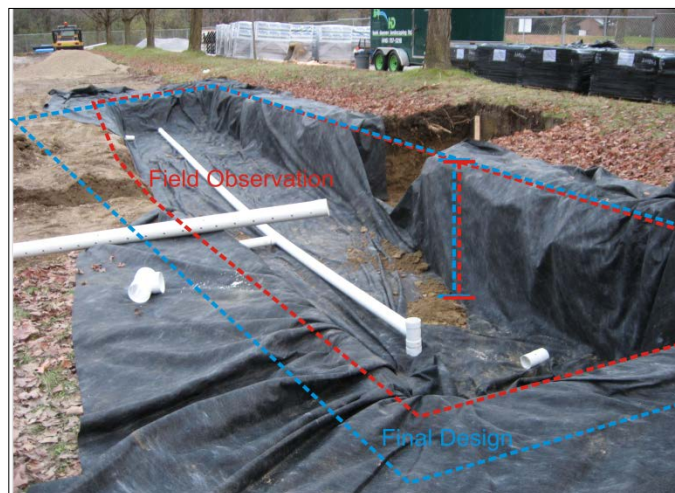
FAIL: The footprint area of the bioretention cell deviates significantly from the final design.

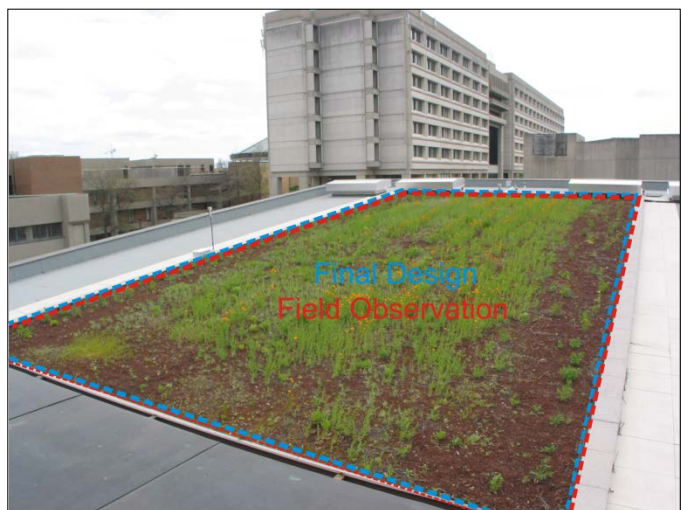
PASS: The footprint area of the green roof matches what was specified in the final design.

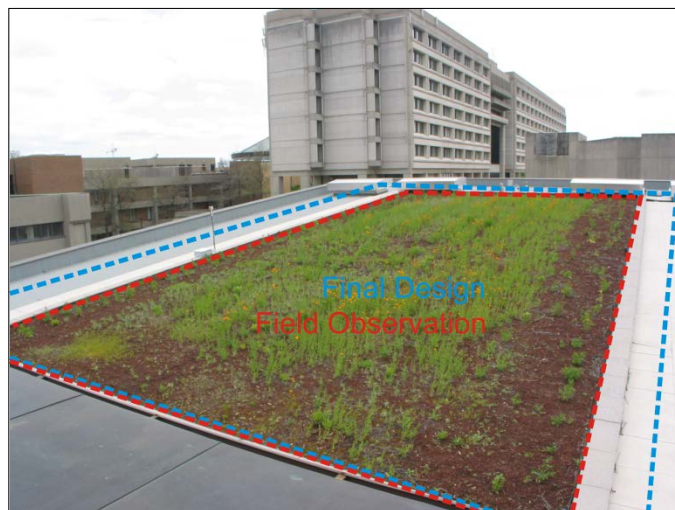
FAIL: The footprint area of the green roof is significantly smaller than what was specified in the final design.

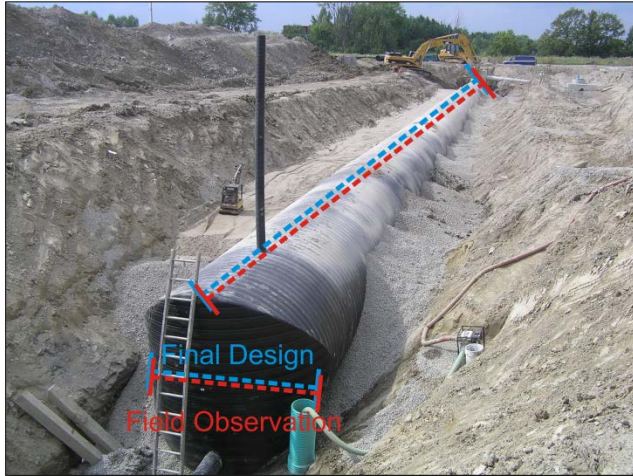
PASS: The size of the cistern matches what was specified in the final design.

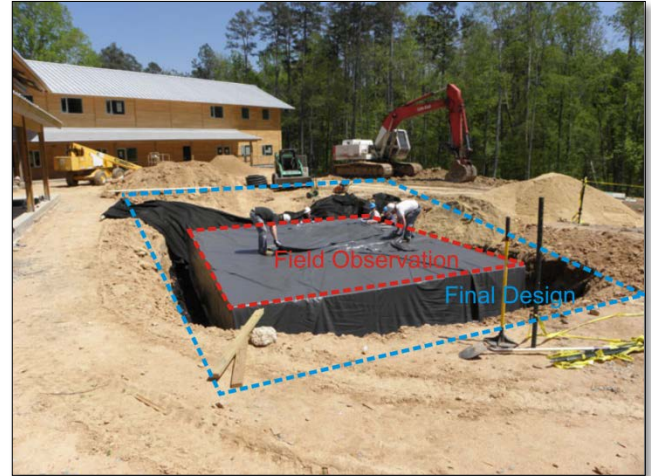
FAIL: The size of the cistern being installed is much smaller than what was specified in the final design.

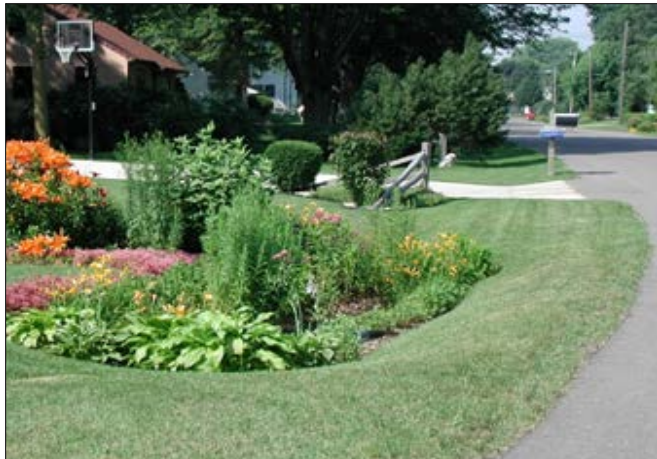
PASS: No erosion gullies, bare soil areas or ruts are visible on the side slopes. (Source: City of Maplewood)

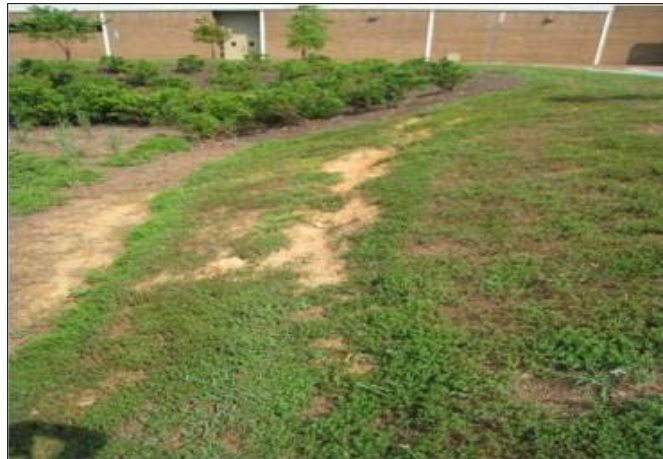
FAIL: The side slopes of the BMP contain bare soil areas and show clear signs of erosion. (Source: CSN)

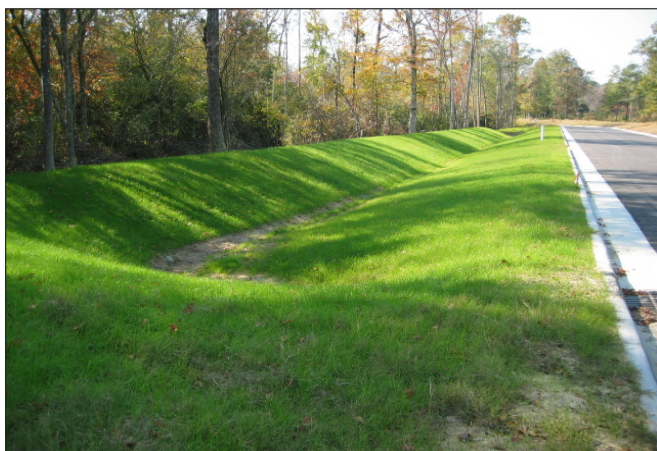
PASS: No erosion gullies, bare soil areas or ruts are visible on the side slopes. (Source: Thomas Engineering).

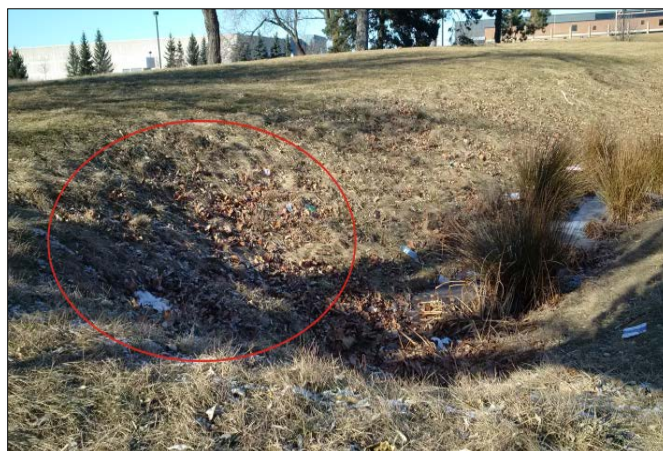
FAIL: Erosion gullies and bare soil areas exist on a portion of the side slopes due to steep slope.

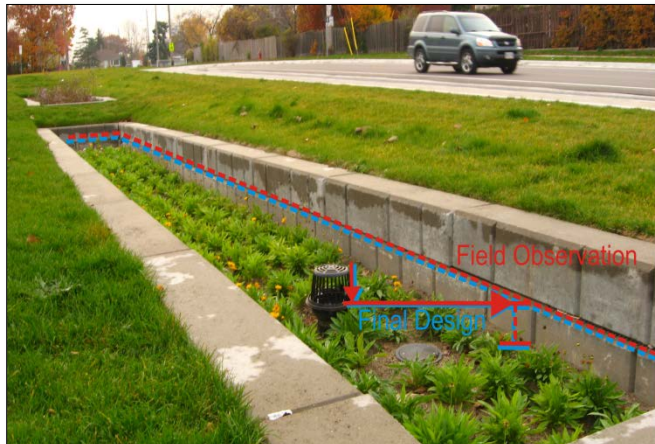
PASS: The overflow outlet elevation and maximum surface ponding area match what was specified in the final design.

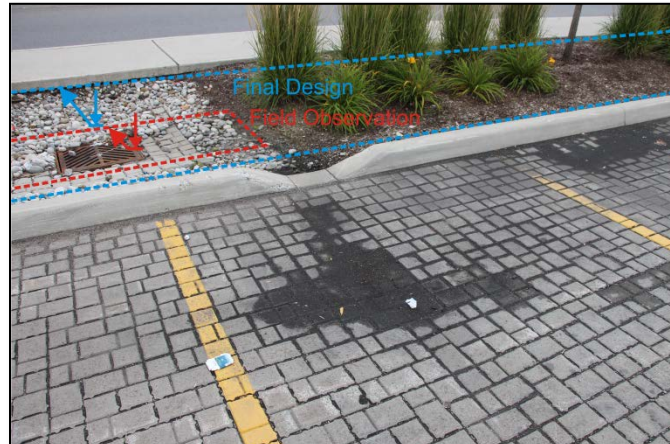
FAIL: The elevation of the overflow outlet is lower than what was specified in the design, producing a much smaller surface ponding area than intended and reducing the stormwater treatment capacity of the bioretention cell.

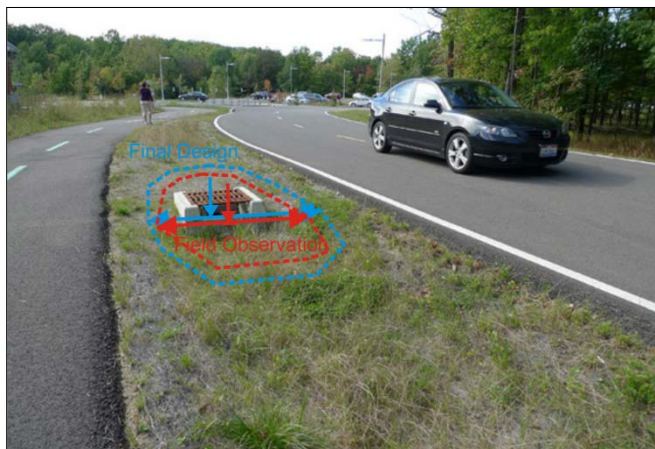
PASS: The overflow outlet elevation and maximum surface ponding area closely match what was specified in the final design.

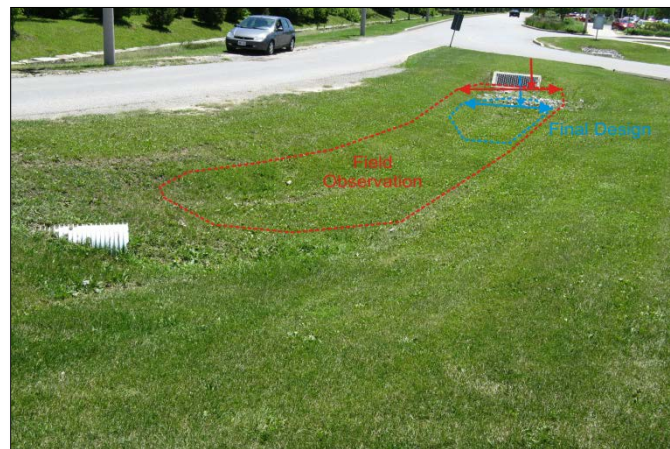
FAIL: The elevation of the overflow outlet is higher than what was specified in the design, producing a much larger surface ponding area than intended which could produce standing water for prolonged periods and cause vegetation to die off.
