2011

Stormwater Pond Maintenance and Anoxic Conditions Investigation
FINAL REPORT

Lake Simcoe Region Conservation Authority

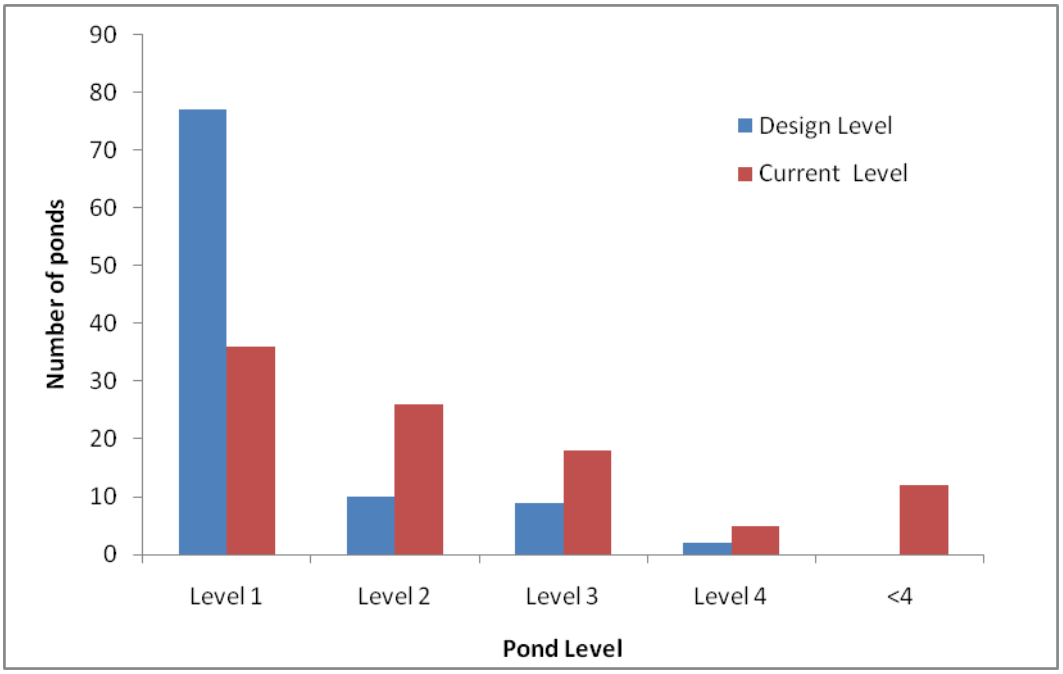
Figure 2: Pond Design Efficiency Level vs. 2010 Surveyed Efficiency Level.

As outlined in the Methods section, each pond was surveyed and this data was used to calculate the permanent pool volume of each pond as of summer 2010. Appendix B displays pond characteristics and volume as originally designed compared with the volumes calculated based on the 2010 survey. Of the 98 ponds surveyed, 77 were originally designed to meet Level 1 criteria, 9 to meet Level 2 criteria, 9 to meet Level 3 criteria and 2 to meet Level 4 criteria. When the ponds were surveyed in 2010, only 36 were still operating at Level 1 efficiency. 27 of the surveyed ponds were found to have dropped by 1 level, 16 that had dropped by 2 levels,

and 1 that had dropped by 3 levels. A further 12 ponds had filled with sediment to the point where they no longer had a permanent pool volume or a volume lower than Level 4 efficiency. Figure 2 shows current number of ponds at each level compared to design level. Figure 3 displays only the ponds that have dropped by one or more levels of efficiency. Figure 4 displays the ponds that have not decreased in efficiency but colour coding those that are within 10% of their designed efficiency threshold.

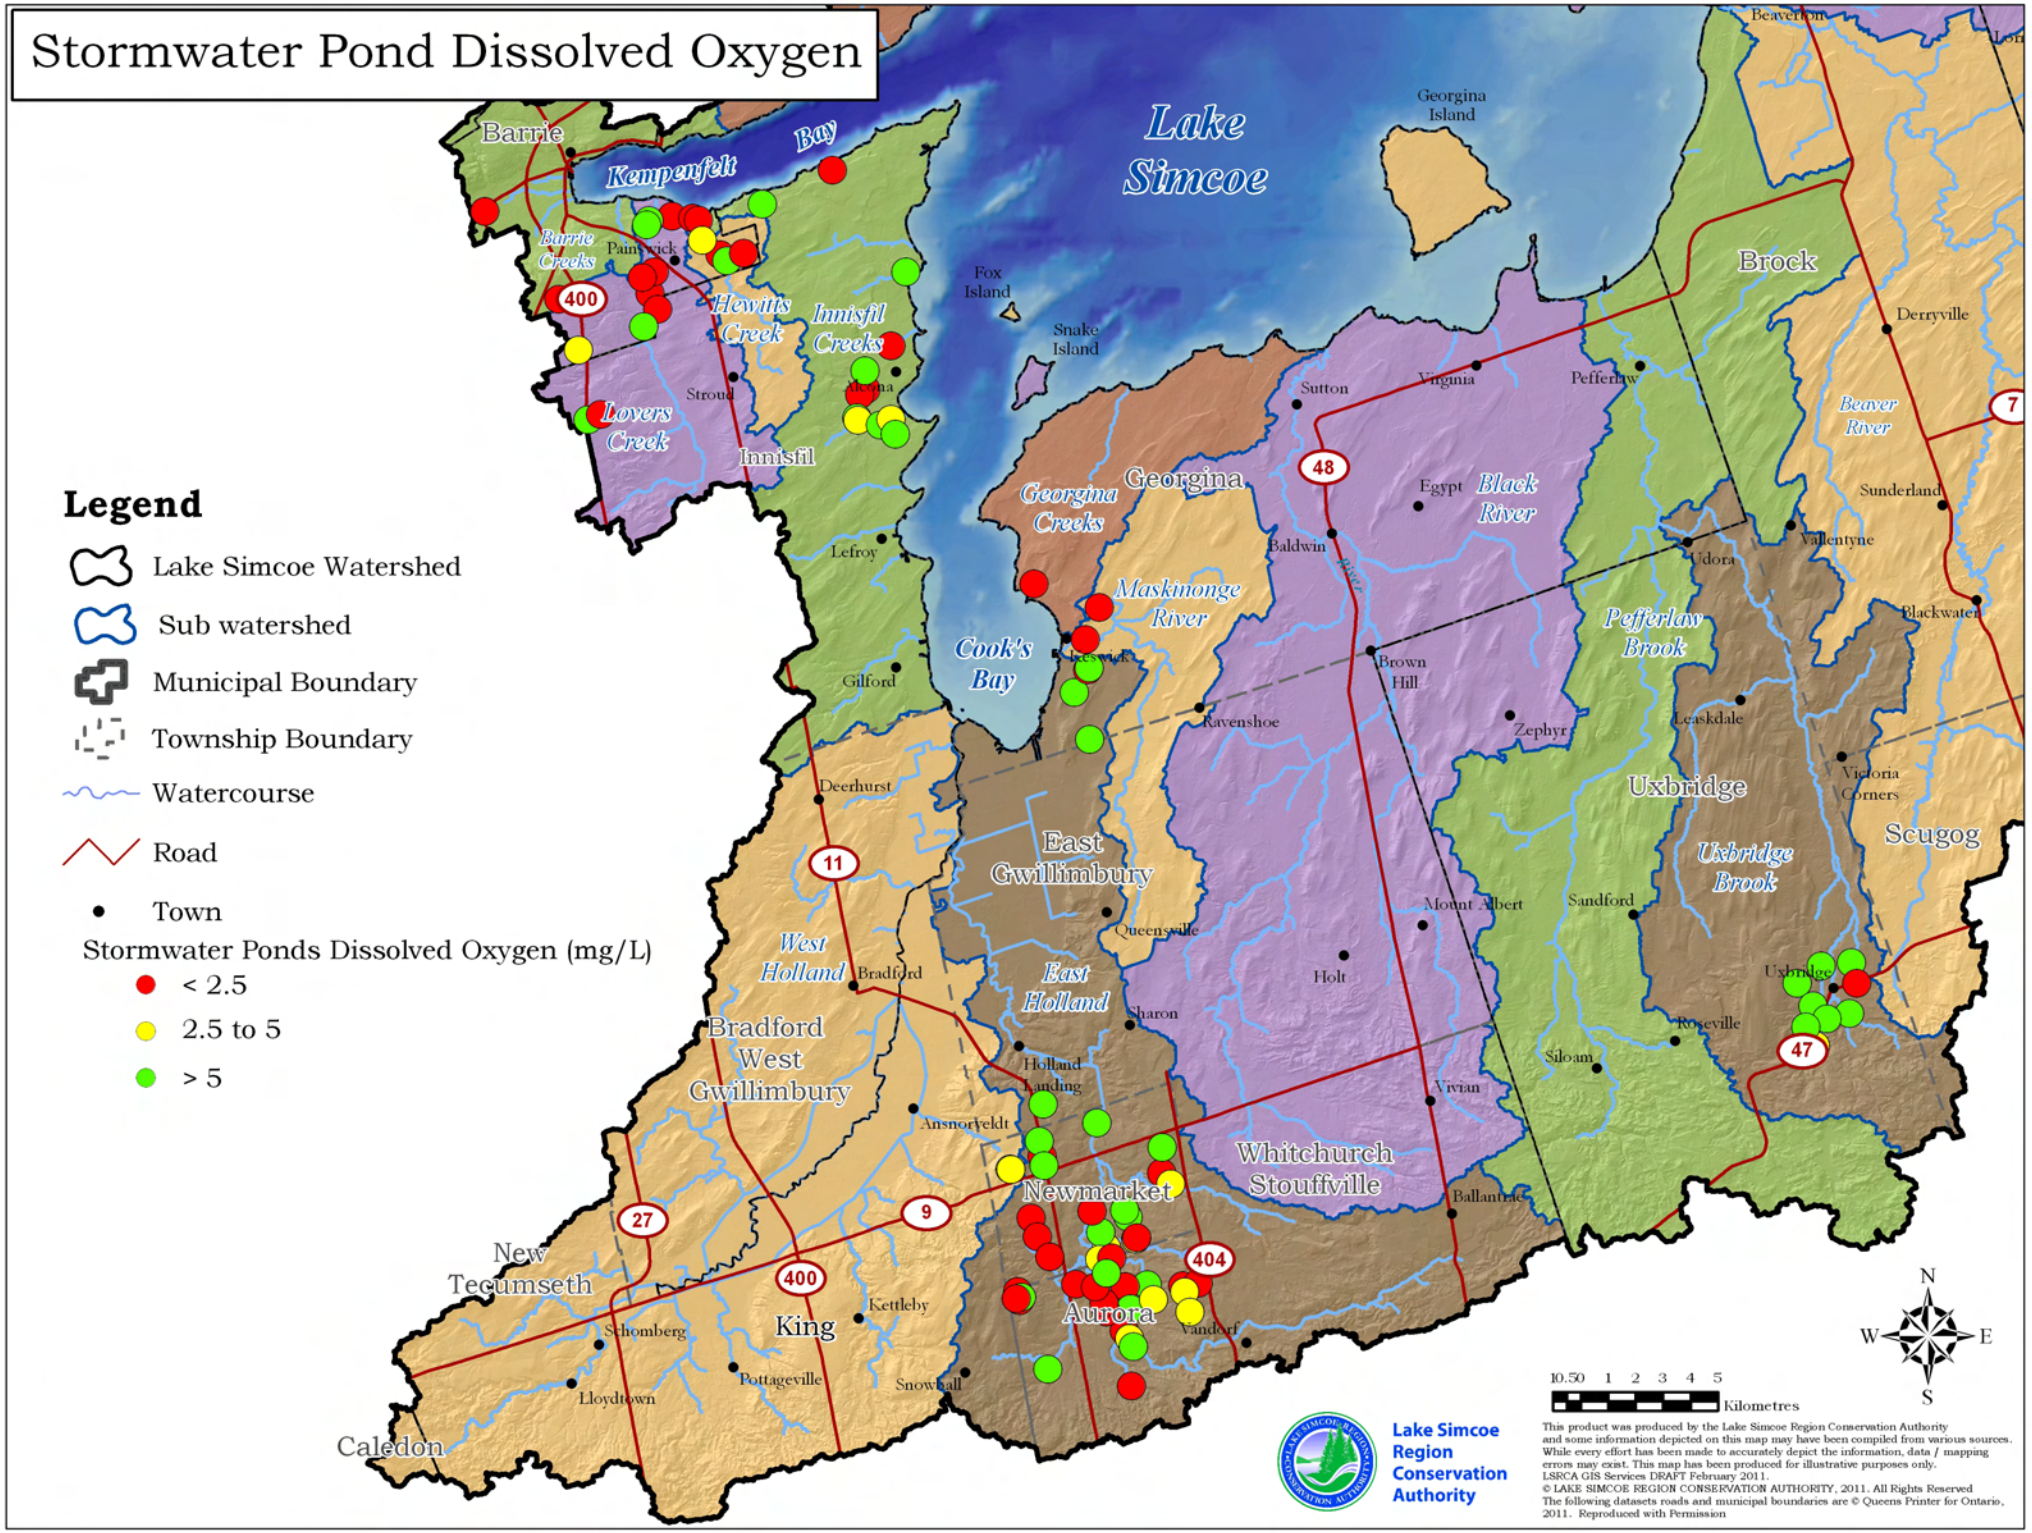
Stormwater Pond Dissolved Oxygen

In order to determine the prevalence of low oxygen conditions in stormwater ponds, repeated sampling was carried out for dissolved oxygen in the study sites, with hypoxic / anoxic conditions being recorded in 42 of 98 ponds (Figure 5). As these spot dissolved oxygen samples were collected during the day, they do not capture night conditions when ponds are more likely to experience low oxygen conditions. Further some samples were collected into October when the hot conditions that promote anoxic / hypoxic conditions were not as prevalent. This would therefore suggest that the number of ponds identified with low oxygen conditions is conservative and those ponds identified in Figure 5with dissolved oxygen levels between 2.5 to 5 mg/L are likely experiencing anoxic / hypoxic conditions at night.

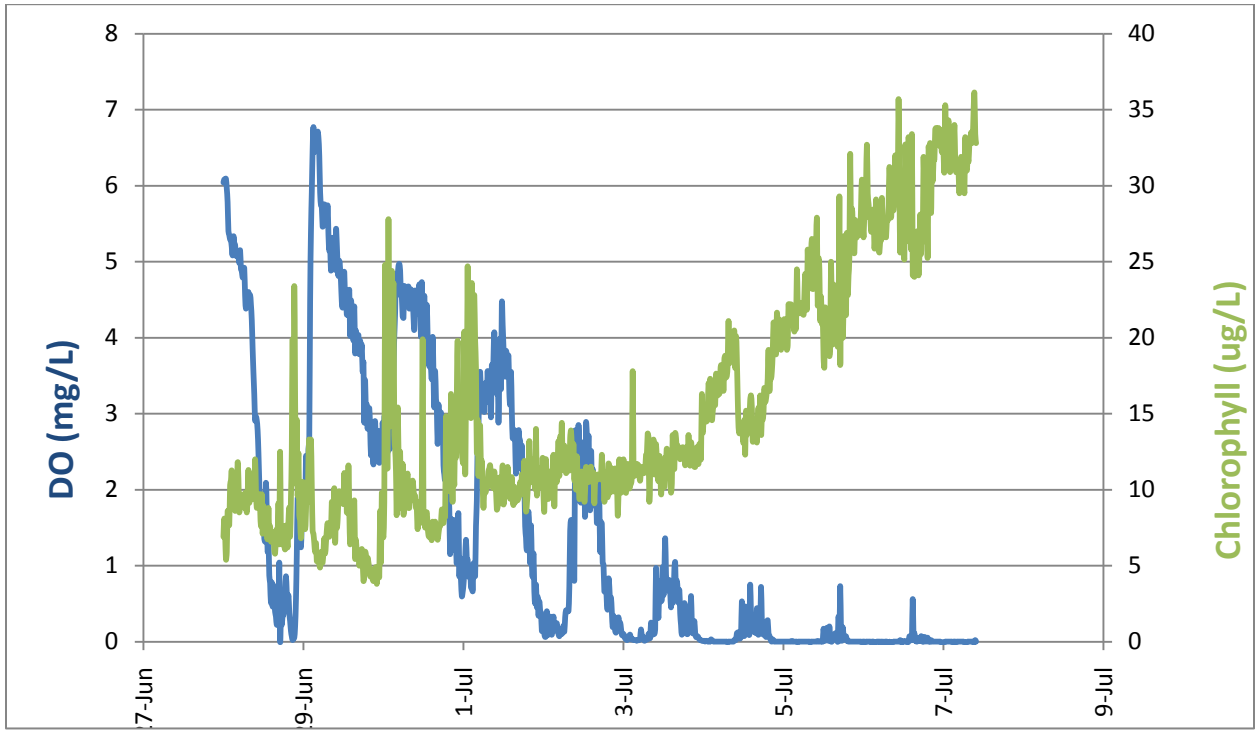
Figure 6: Dissolved Oxygen and Chlorophyll Concentrations in N-CW21, June 27th to July 9th, 2010.

Figure 6 graphs dissolved oxygen and chlorophyll concentrations over a 13 day dry period in a 9 year old pond, N-CW21, with a depth of 1.5 m. Dissolved oxygen can be seen to dramatically decrease overnight with corresponding increase in chlorophyll concentrations. By July 2nd dissolved oxygen concentrations stay below 2 mg/L and chlorophyll concentrations increase dramatically. With precipitation events, the water column mixes, re-oxygenates, and water column P concentrations and chlorophyll a decreased. Of interest, this same pattern was recorded in six of six study sites in the Holland River, and 12 of 22 study sites in Lake Simcoe (B.K. Ginn, pers. comm.).
