APPENDIX C

VISUAL INDICATOR PROTOCOLS

C.1 CONTRIBUTING DRAINAGE AREA CONDITION

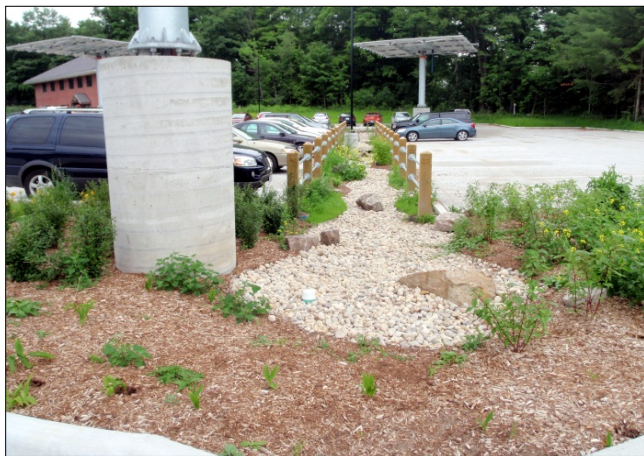
PASS: There is no standing water on the surface of this bioretention cell.

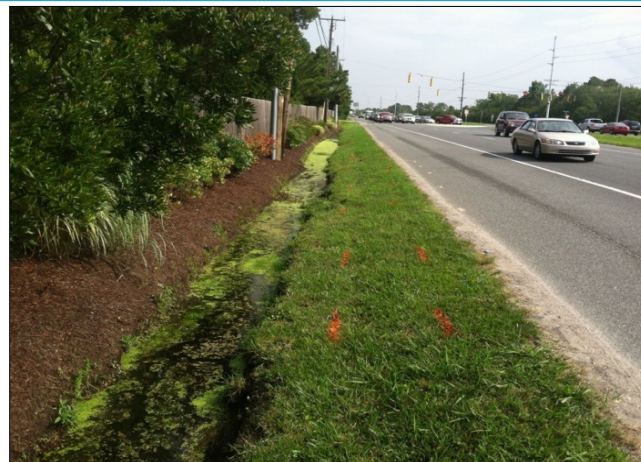
FAIL: There is standing water and highly saturated soils on the surface of this dry swale. Presence of algae indicates the swale does not drain between storms. (Source: James Urban).

MAINTENANCE TRIGGER: There is standing water on the BMP surface > 24 hours after the end of a storm event. Presence of highly saturated soil and bare soil areas.

FOLLOW-UP TASKS: Flush the sub-drain if present. Confirm maximum surface ponding depth matches final design. Schedule Forensic Inspection and Testing (FIT) to assess the cause of slow surface drainage. The FIT involves inspecting the sub-drain for obstructions, draining the BMP, checking for sediment accumulation on BMP surface, measuring surface infiltration rate, and testing of the surface soil/filter media for compaction, texture and organic matter content.

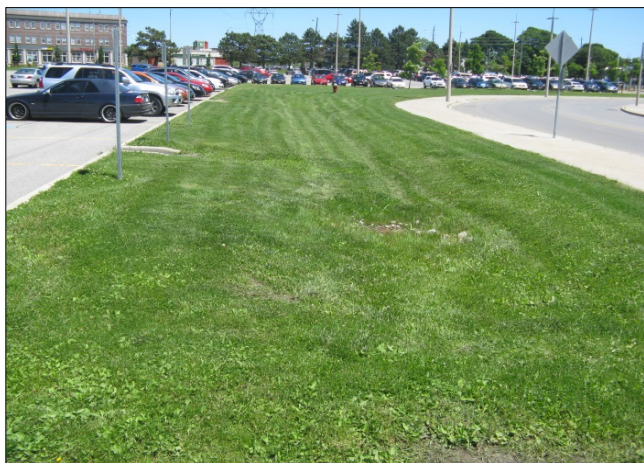
PASS: There is no standing water on the surface of the swale and no bare soil areas around the outlet that would indicate surface ponding occurs regularly.

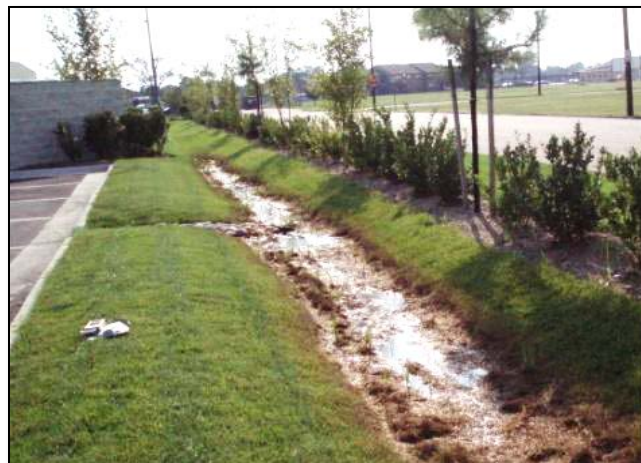
FAIL: There is standing water and highly saturated soils on the surface of swale. Dead vegetation and bare soil areas indicate that surface ponding occurs regularly. (Source: CSN).

MAINTENANCE TRIGGER: There is standing water on the BMP surface > 24 hours after the end of a storm event. Presence of highly saturated soil and bare soil areas.

FOLLOW-UP TASKS: Confirm maximum surface ponding depth matches final design. Schedule Forensic Inspection and Testing (FIT) to assess the cause of slow surface drainage. A FIT involves draining the BMP, checking for sediment accumulation on BMP surface, measuring surface infiltration rate and testing of the surface soil/filter media for compaction, texture and organic matter content.

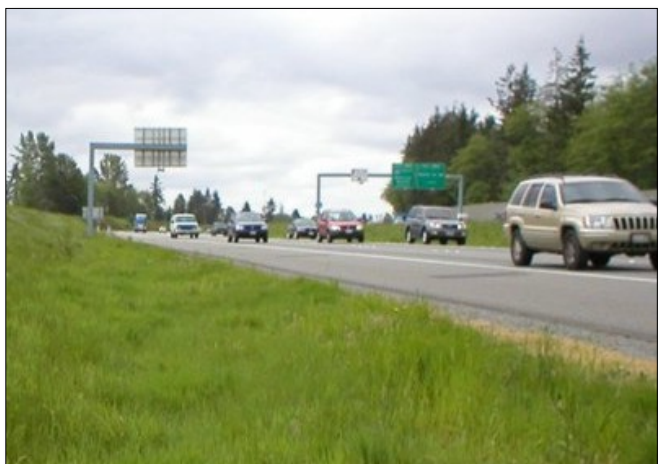
PASS: There is no standing water on the vegetated filter strip and no bare soil areas that would indicate surface ponding occurs regularly. (Source: Washington State DOT)

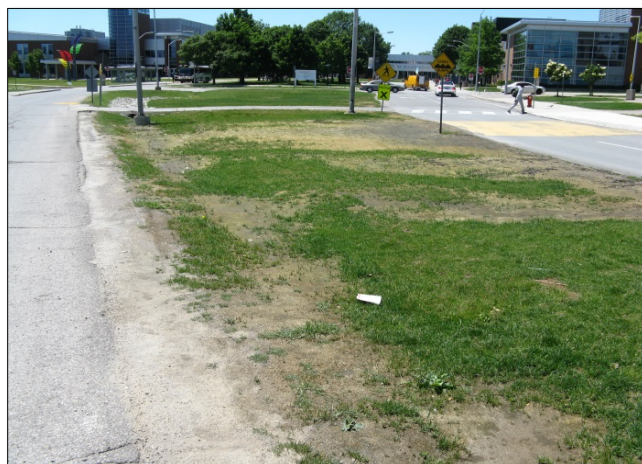
FAIL: Presence of large patches of dying vegetation and bare soil indicate that surface ponding occurs regularly and that the vegetated filter strip does not drain well.

MAINTENANCE TRIGGER: There is standing water on the BMP surface > 24 hours after the end of a storm event. Presence of highly saturated soil and bare soil areas.

FOLLOW-UP TASKS: Schedule Forensic Inspection and Testing (FIT) to assess the cause of slow surface drainage. A FIT involves draining the BMP, checking for sediment accumulation on BMP surface, measuring surface infiltration rate and testing of the surface soil/filter media for compaction, texture and organic matter content.

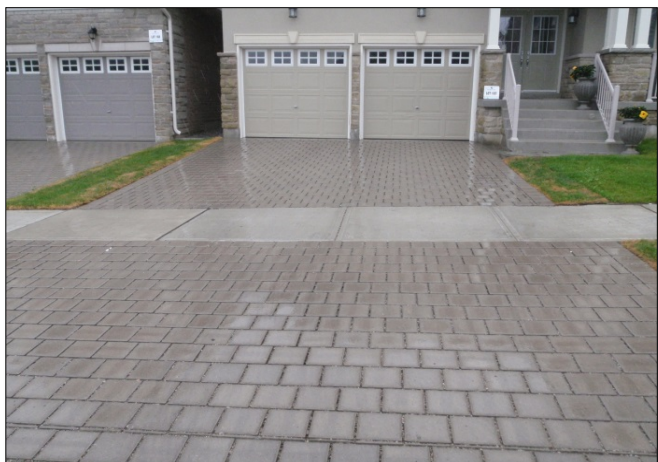
PASS: There is no standing water on the surface of the permeable pavement shortly after a storm event and no signs of sediment accumulation to suggest that surface ponding occurs regularly.

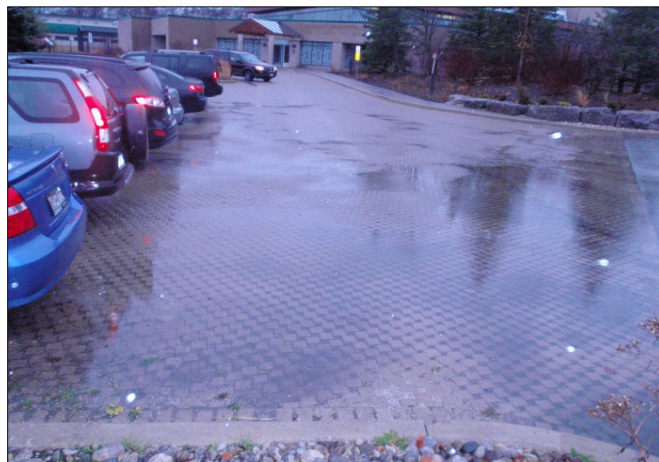
FAIL: There is standing water on the permeable pavement surface during a storm event. Sediment accumulation on the pavement surface indicates that surface ponding occurs regularly.

MAINTENANCE TRIGGER: There is standing water on the BMP surface.

FOLLOW-UP TASKS: Flush the sub-drain if present. Schedule Forensic Inspection and Testing (FIT) to assess the cause of slow surface drainage. A FIT involves inspecting the sub-drain for obstructions, draining the BMP, checking for sediment accumulation on BMP surface and measuring surface infiltration rate.

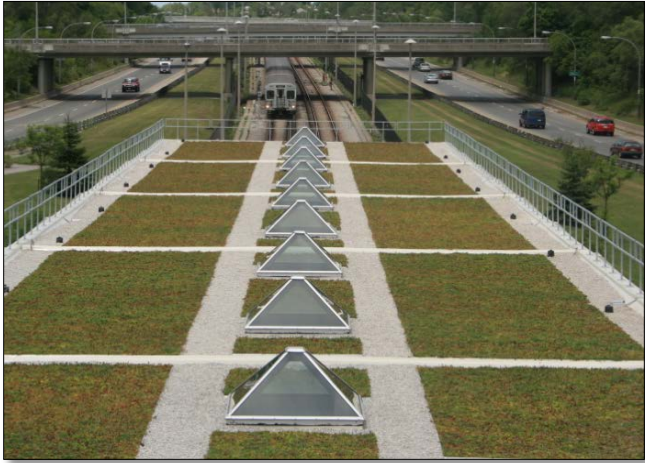
PASS: There is no standing water on the green roof surface shortly after a storm event.

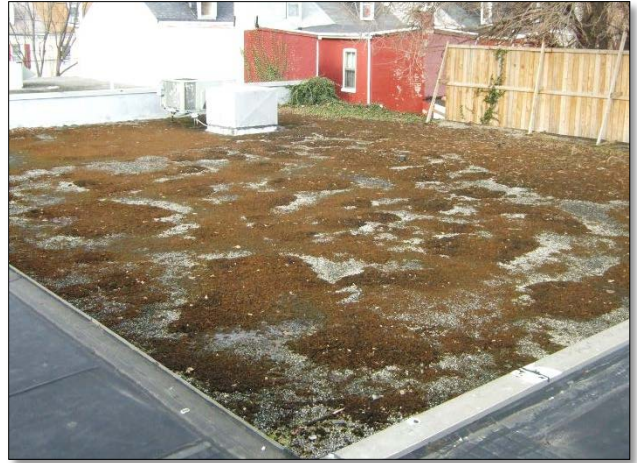
FAIL: Standing water is present on the green roof surface and in the sub-drain system and bare soil areas are visible.
(Source: J.V. Heidler)

MAINTENANCE TRIGGER: There is standing water on the green roof surface or in the overflow outlet > 3 hours after the end of a storm event.

FOLLOW-UP TASKS: If the overflow outlet is draining slowly, flush the pipe with a hose or schedule drain snaking service to unclog it. If the green roof surface is draining slowly, schedule Forensic Inspection and Testing (FIT) with an agent of the green roof system provider to assess the cause of slow drainage and determine corrective actions. A FIT could involve draining the BMP, checking for sediment accumulation on BMP surface, measuring surface infiltration rate and testing the growing media for compaction, texture and organic matter content. It may also involve excavation of portions of the green roof to inspect the drainage layer.

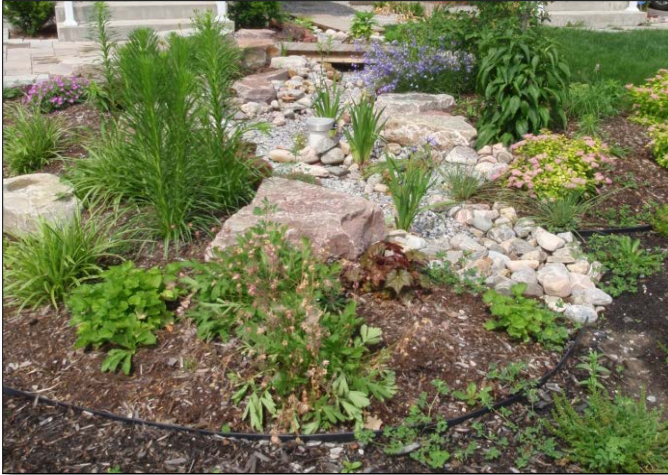
PASS: There is no trash in or around the bioretention area that could possibly block inlets and outlets.

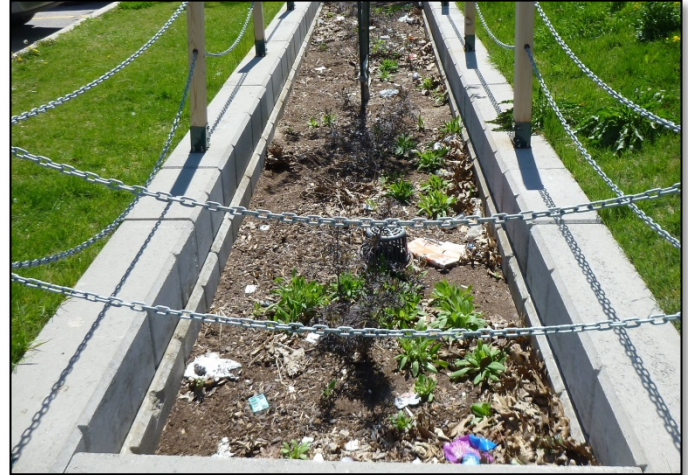
FAIL: The bioretention cell contains trash which could block the overflow outlet and is impairing aesthetic value. (Source: CVC).

MAINTENANCE TRIGGER: Presence of trash is impairing aesthetic value or function of the BMP.

FOLLOW-UP TASKS: Pick up the trash, sort out recycleables and properly dispose of any remaining items. Assess the CDA for point sources such as overflowing trash cans. If problems persist, consider providing recycling bin/trash can nearby.

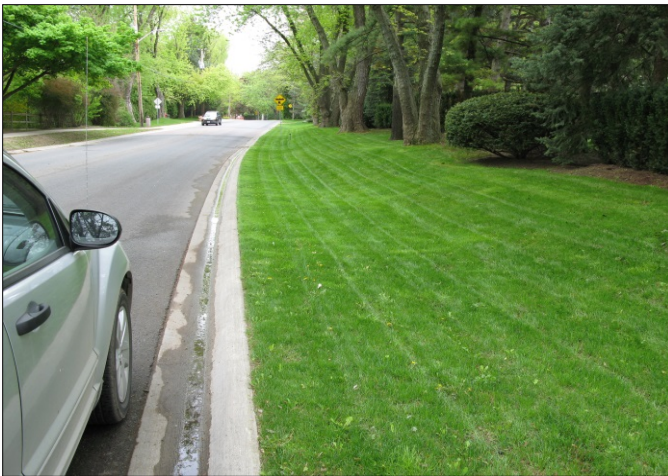
PASS: There is no trash in or around the swale that could possibly block inlets and outlets.

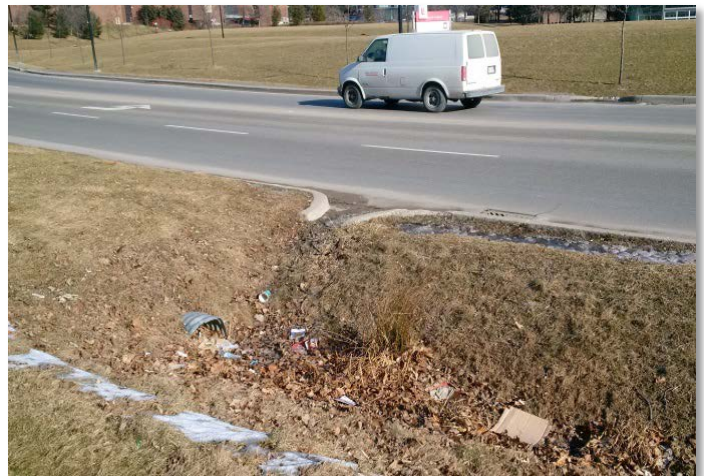
FAIL: The swale contains trash which could block the overflow outlet and is impairing aesthetic value.

MAINTENANCE TRIGGER: Presence of trash is impairing aesthetic value or function of the BMP.

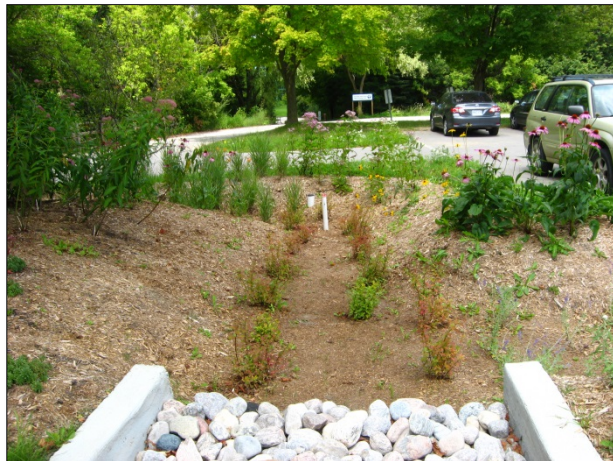
PASS: There are no erosion gullies or bare soil areas on the filter bed surface and mulch cover remains in place.

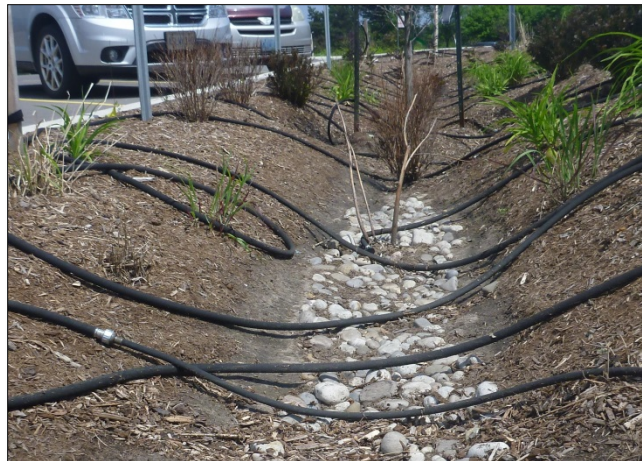
FAIL: Erosion gullies and bare soil areas are present on the filter bed surface, indicating that concentrated flow occurs regularly. (Source: CVC)

MAINTENANCE TRIGGER: Erosion gullies or bare soil areas ≥ 30 cm in length are visible. Foot or vehicle traffic has damaged the filter bed surface or is preventing vegetation from becoming established.

FOLLOW-UP TASKS: Repair erosion gullies, replant bare soil areas and irrigate as needed until vegetation cover is established or restore mulch or stone cover. If water is entering the BMP in an unintended area, install a flow diversion device or re-grade the CDA to prevent it. If problems persist, consider adding inlets, check dams, stone cover, soil/turf reinforcements or re-grading to reduce slope and spread out the flow of water.

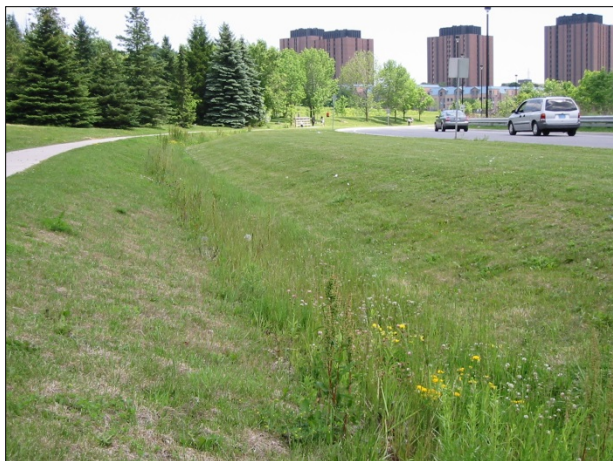
PASS: There are no erosion gullies or bare soil areas on the swale surface.

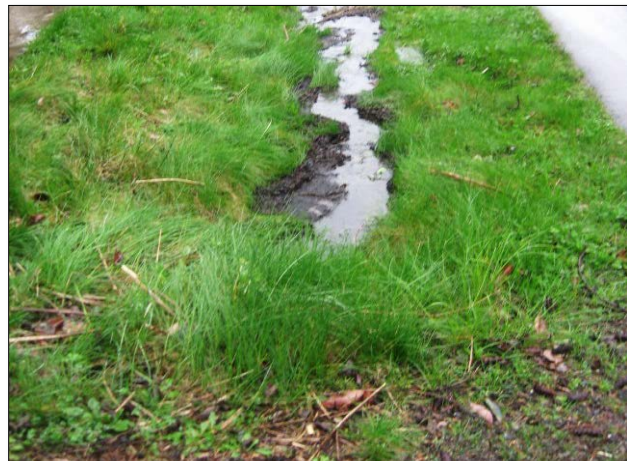
FAIL: Large erosion gully is present on the swale surface indicating that concentrated flow occurs regularly.

MAINTENANCE TRIGGER: Erosion gullies or bare soil areas ≥ 30 cm in length are visible. Foot or vehicle traffic has damaged the filter bed surface or is preventing vegetation from becoming established.

FOLLOW-UP TASKS: Repair erosion gullies, replant bare soil areas and irrigate as needed until vegetation cover is established or restore mulch or stone cover. If water is entering the BMP in an unintended area, install a flow diversion device or re-grade the CDA to prevent it. If problems persist, consider adding inlets, check dams, stone cover, soil/turf reinforcements or re-grading to reduce slope and spread out the flow of water.

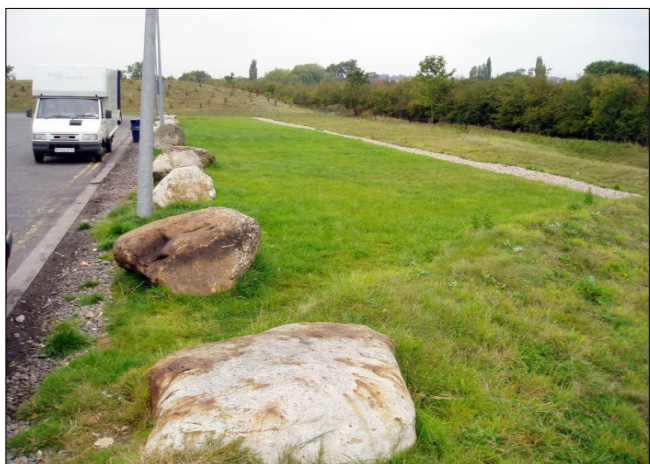
PASS: There are no erosion rills, gullies or bare soil areas on the filter strip surface. (Source: CIRIA)

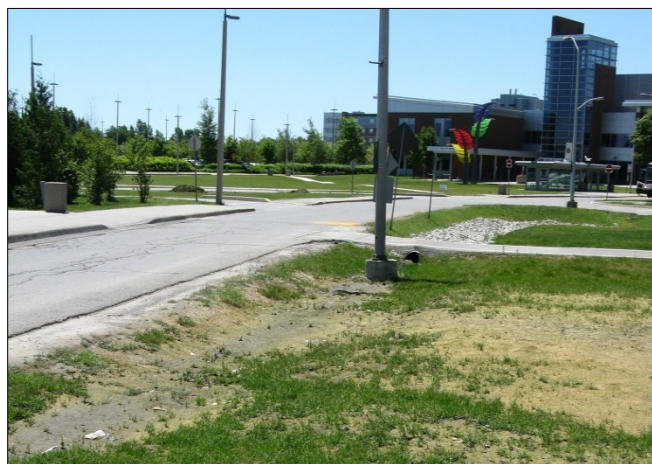
FAIL: Scour erosion along the inlet edge is visible. Bare soil areas and bright green biofilm on the filter strip surface indicate that concentrated flow and surface ponding occurs regularly.

MAINTENANCE TRIGGER: Erosion gullies or bare soil areas ≥ 30 cm in length are visible. Foot or vehicle traffic has damaged the filter bed surface or is preventing vegetation from becoming established.

FOLLOW-UP TASKS: Repair erosion gullies, replant bare soil areas and irrigate as needed until vegetation cover is established or restore mulch or stone cover. If water is entering the BMP in an unintended area, install a flow diversion device or re-grade the CDA to prevent it. If problems persist, consider adding gravel diaphragms, check dams, soil/turf reinforcements, splash pads at roof downspouts or re-grading to reduce slope and spread out the flow of water.

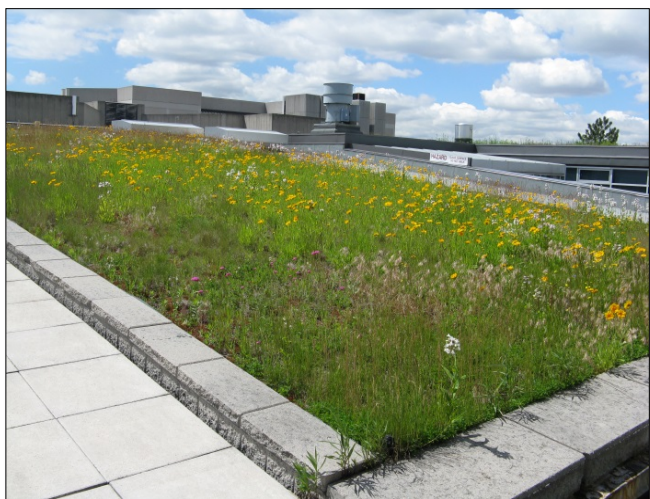
PASS: There are no bare areas or signs of erosion of growing media from concentrated flowing water or wind scour on the green roof (i.e. filter bed) surface.

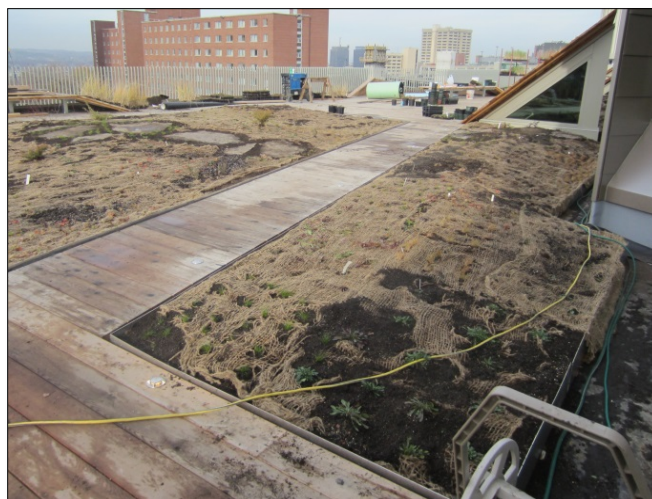
FAIL: Wind scour of protective matting and growing media on the green roof (i.e. filter bed) surface is visible in several locations. (Source: Recover Green Roofs)

MAINTENANCE TRIGGER: Erosion gullies or bare areas ≥ 30 cm in length are visible. Foot traffic has damaged the filter bed surface or is preventing vegetation from becoming established.

FOLLOW-UP TASKS: Repair erosion gullies or wind scoured areas, replant and irrigate as needed until vegetation cover is established. If water is entering the BMP in an unintended area, install a flow diversion device or re-grade the CDA to prevent it. If problems persist, consider adding matting to protect growing media from scour until vegetation is established and/or wind barriers along the perimeter (e.g. stone, brick or paved parapets).

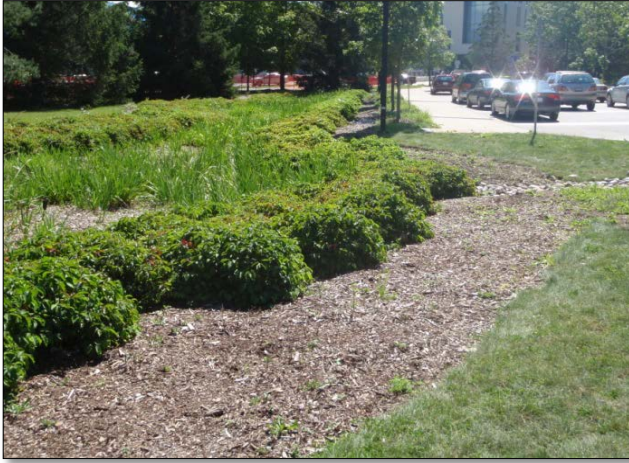
PASS: Mulch depth is within the range specified in the final design (i.e. 5 to 10 cm) and covers all non-vegetated portions of the filter bed.

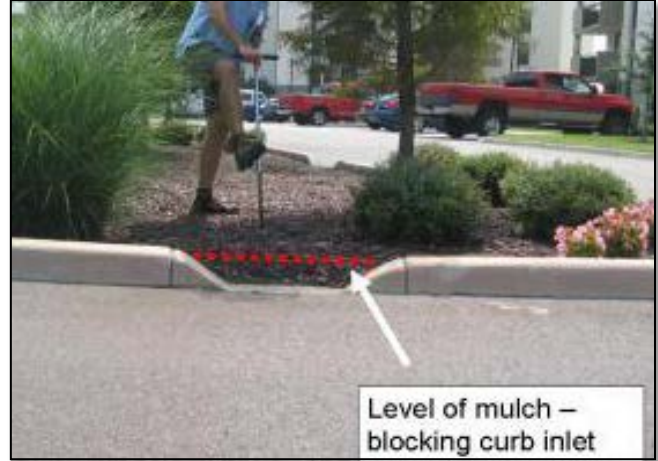
FAIL: Mulch depth is greater than what was specified in the final design and is blocking the inlet to the bioretention cell. (Source: CSN).

MAINTENANCE TRIGGER: Average depth is less than 5 cm or greater than 15 cm. Bare soil areas are present. Mulch depth is impeding the flow of water into the BMP.

FOLLOW-UP TASKS: Add or redistribute mulch to maintain depth between 5 and 10 cm and not impede flow of water into the BMP.

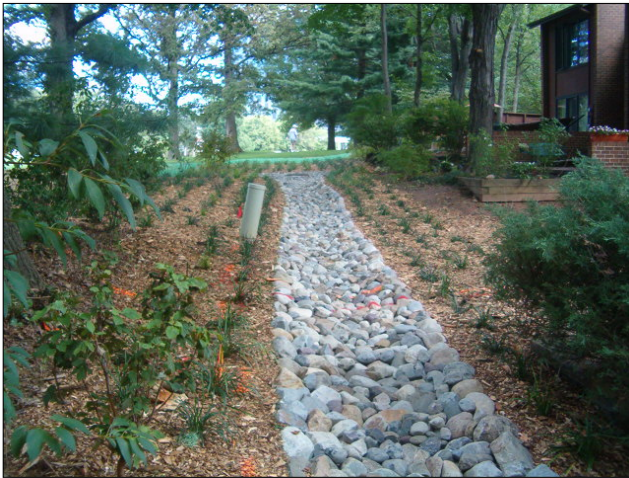
PASS: Mulch depth is within the range specified in the final design (i.e. 5 to 10 cm) and covers all portions of the BMP not covered by stone or vegetation. (Source: Blade Runners)

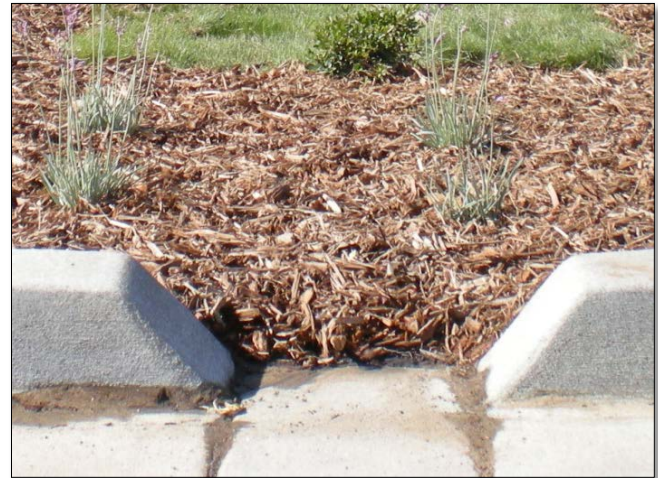
FAIL: Mulch depth is greater than what was specified in the final design and is blocking the inlet to the swale.

MAINTENANCE TRIGGER: Average depth is less than 5 cm or greater than 15 cm. Bare soil areas are present. Mulch depth is impairing flow of water into the BMP.

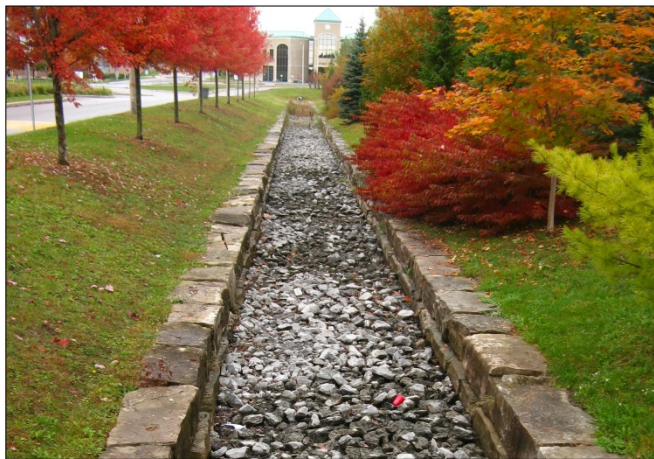
PASS: Depth of accumulated sediment below the stone cover on the filter bed surface is less than 5 cm.

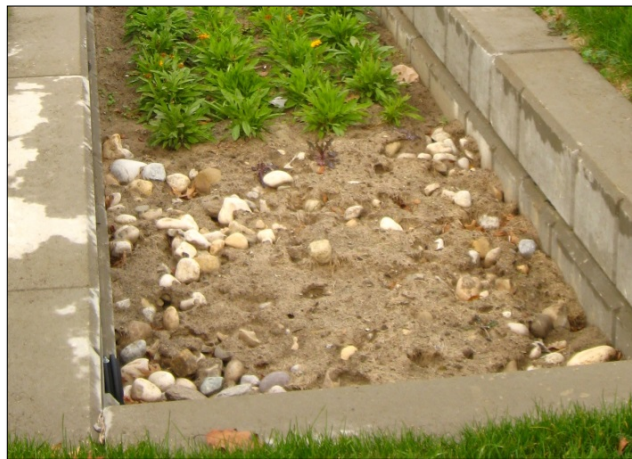
FAIL: Sediment accumulation is visible on the filter bed surface and stone covering it and is greater than 5 cm deep.

MAINTENANCE TRIGGER: Mean or local sediment depth is 5 cm or greater.

FOLLOW-UP TASKS: Remove accumulated sediment and the top 15 cm of filter media by rake/shovel or small excavator, keeping heavy equipment off the filter bed surface. Check for signs of oil or grease contamination (e.g. sheen on surface of water when sediment is submerged). If oil or grease contamination is suspected, submit a sediment sample for contaminant testing by an accredited laboratory to determine the proper disposal method. Restore filter bed surface grading to match final design. Replant and replace mulch/stone cover. Assess the CDA for changes in land cover or point sources of sediment. Inspect and remove sediment from pretreatment devices. If problems persist, consider increasing frequency of routine maintenance.

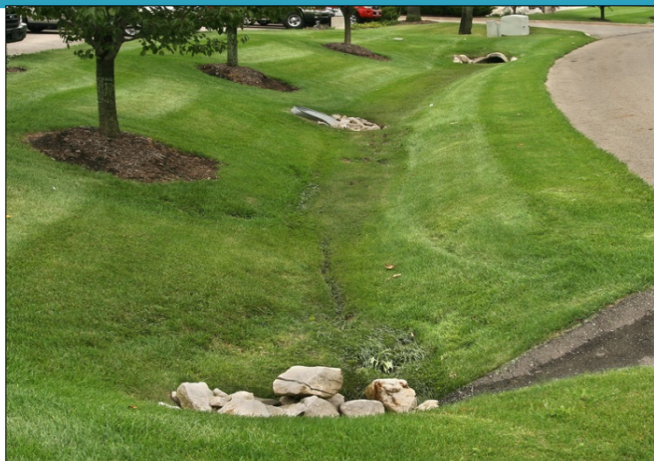
PASS: There are no signs of excessive sediment accumulation on the surface of the swale. (Source: DAA)

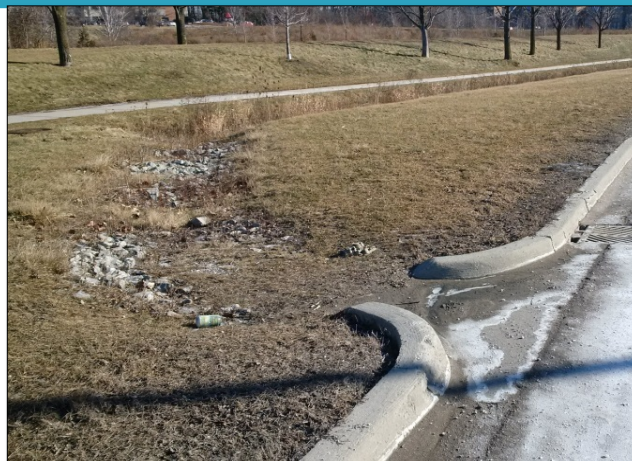
FAIL: Sediment is visible on top of the stone cover on the swale surface near the inlet and is greater than 2.5 cm deep.

MAINTENANCE TRIGGER: Mean or local sediment depth is 5 cm or greater.

FOLLOW-UP TASKS: Remove accumulated sediment by rake/shovel or small excavator, keeping heavy equipment off the filter bed surface. Check for signs of oil or grease contamination (e.g. sheen on surface of water when sediment is submerged). If oil or grease contamination is suspected, submit a sediment sample for contaminant testing by an accredited laboratory to determine the proper disposal method. Restore filter bed surface grading to match final design. Replant and replace mulch cover. Assess the CDA for changes in land cover or point sources of sediment. Inspect and remove sediment from pretreatment devices. If problems persist, consider adding pretreatment devices or increasing frequency of routine maintenance.

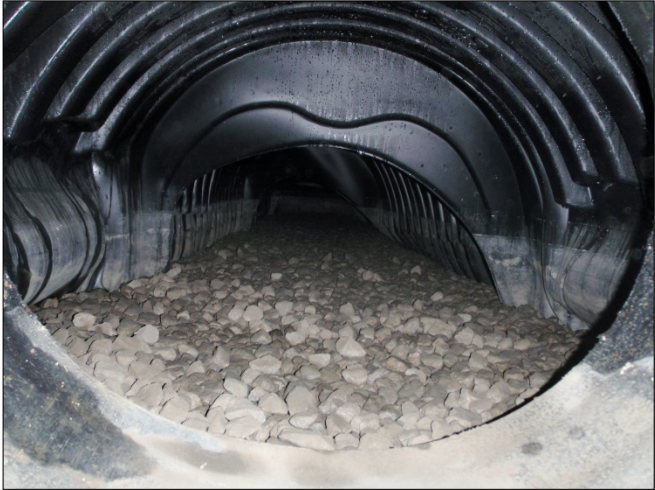
PASS: The coarse gravel filter bed of this infiltration chamber system has very little sediment accumulated on the surface indicating pretreatment devices are working well and that sediment removal from the gravel filter bed is not needed.

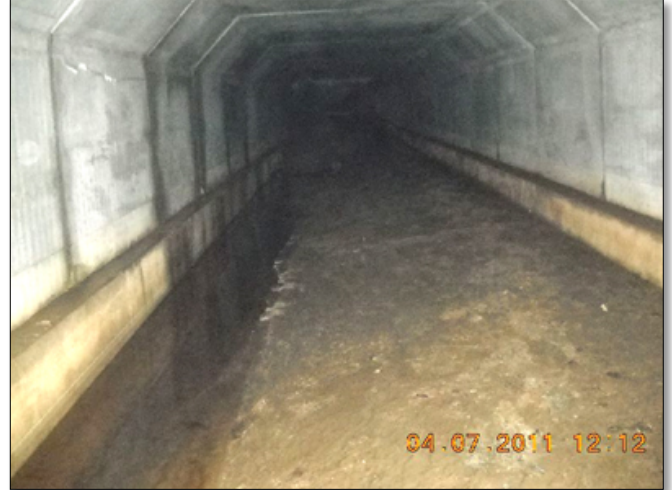
FAIL: A substantial amount of sediment has accumulated on the coarse gravel filter bed of the infiltration chamber system which could be impairing the drainage function of the BMP. (Source: Stormwater Maintenance)

MAINTENANCE TRIGGER: Mean or local sediment depth is 8 cm or greater on the gravel bed surface.

FOLLOW-UP TASKS: Removal of accumulated sediment from infiltration chamber systems requires entry into the chambers themselves by staff trained in confined space entry and equipped with recently certified safety equipment (i.e. tripod, winch, harness) and recently calibrated and tested multi-gas detector. Sediment removal involves the use of a pressure sprayer and shovels to consolidate sediment at the nearest access hatches and a vacuum truck to remove it. Flush inlet and outlet pipes with a hose. Check the removed material for signs of oil or grease contamination (e.g. sheen on surface of water when submerged). If oil or grease contamination is suspected, submit a sediment sample for contaminant testing by an accredited laboratory to determine the proper disposal method. Assess the CDA for changes in land cover or point sources of sediment. Inspect and remove sediment from pretreatment devices. If problems persist, consider adding pretreatment devices or increasing frequency of routine maintenance.

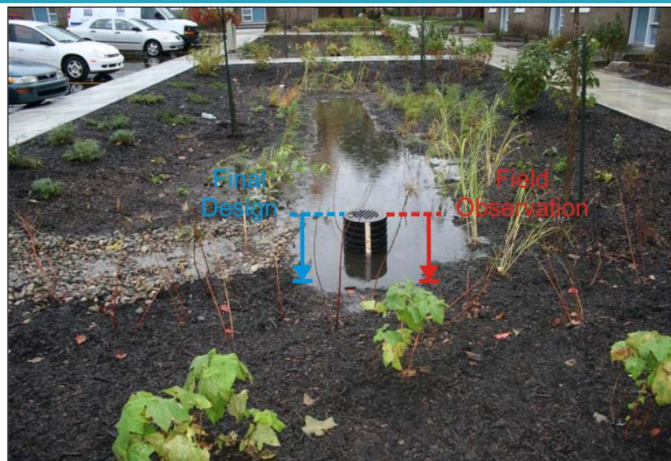
PASS: The maximum surface ponding depth of the bioretention cell matches what was specified in the final design.

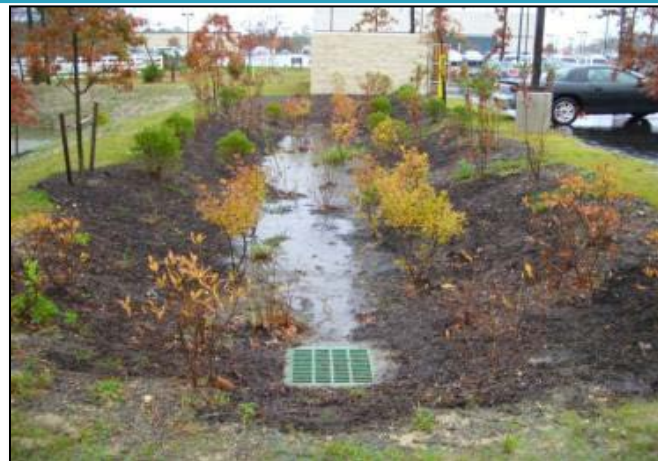
FAIL: The maximum ponding depth of the bioretention cell is significantly shallower than intended as the overflow outlet is at the same elevation as the lowest point on the filter bed. (Source: CSN)

MAINTENANCE TRIGGER: Maximum surface ponding depth differs from design or as built drawing by >10%.

FOLLOW-UP TASKS: Measure filter media depth using a cone penetrometer or soil corer and check if it matches final design specification. Add, remove or redistribute filter media, or adjust the elevation of the overflow outlet to make the maximum surface ponding depth match the final design specification.

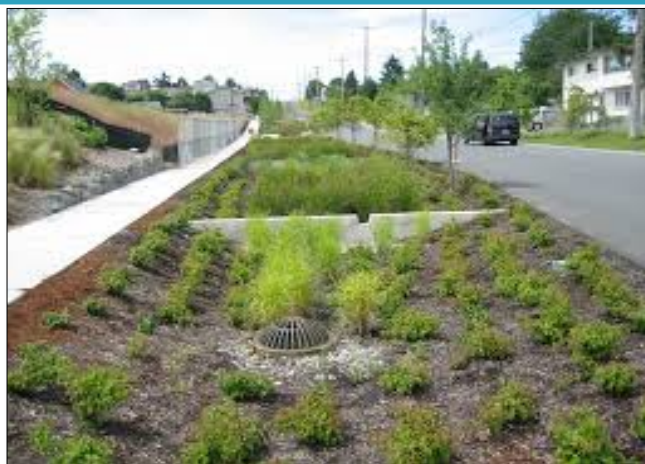
PASS: The maximum surface ponding depth behind check dams matches what was specified in the final design. (Source: NEOSWTC)

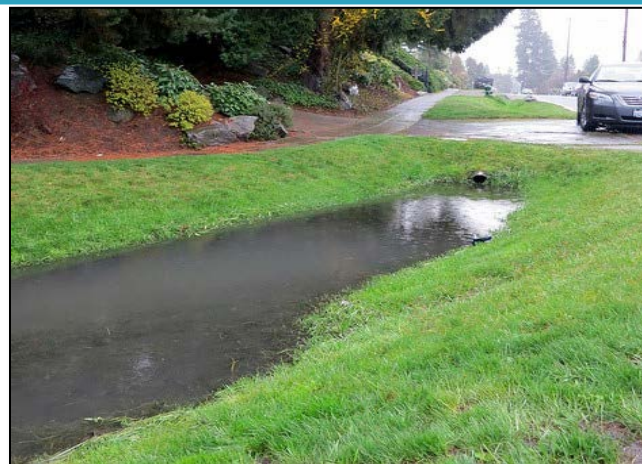
FAIL: The maximum ponding depth of the swale is significantly deeper than intended as the elevation of the check dam or overflow outlet is too high. (Source: CSN)

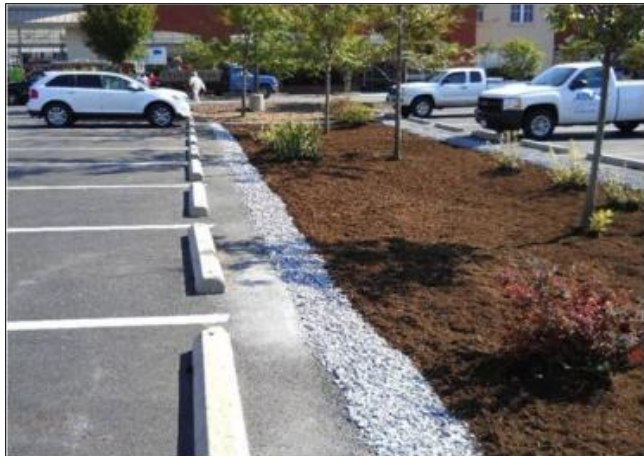
PASS: The filter bed is nearly flat and there are no signs of localized bed sinking. (Source: CSN).

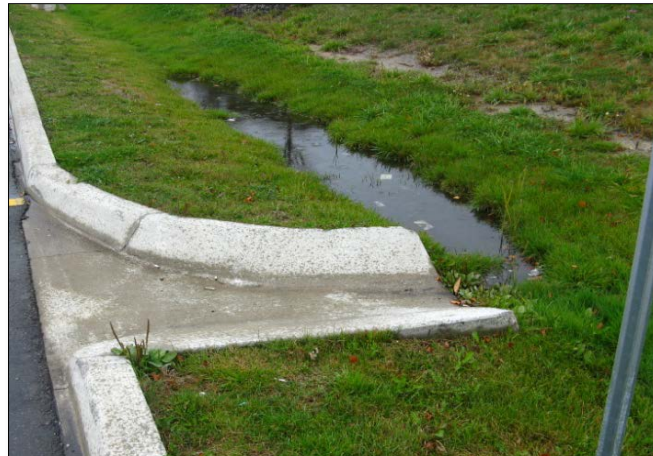
FAIL: Clear evidence of bed sinking is visible, creating a preferential ponding area where vegetation has died off.

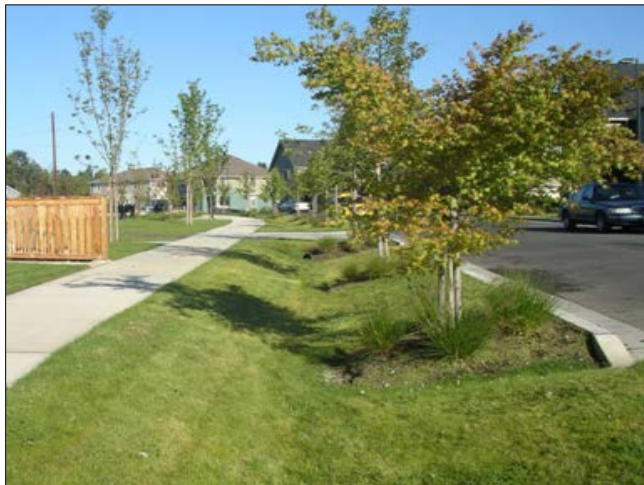
PASS: The filter bed has retained its original grading without any sharp depressions that would indicate surface bed sinking. (Source: SVR Design).

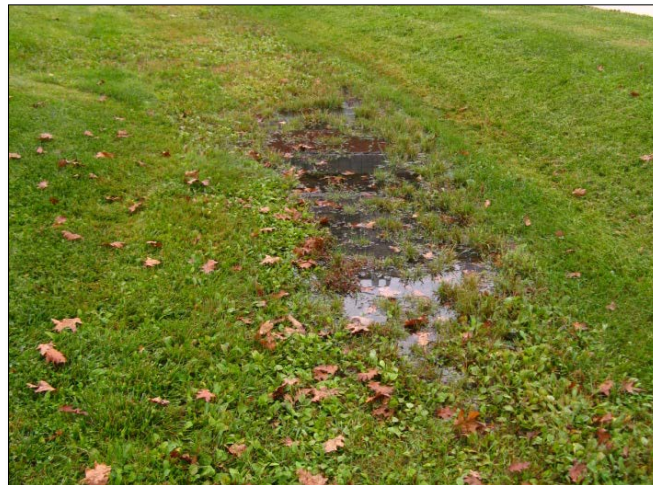
FAIL: Clear evidence of bed sinking is visible, creating a preferential ponding area where vegetation has died off.

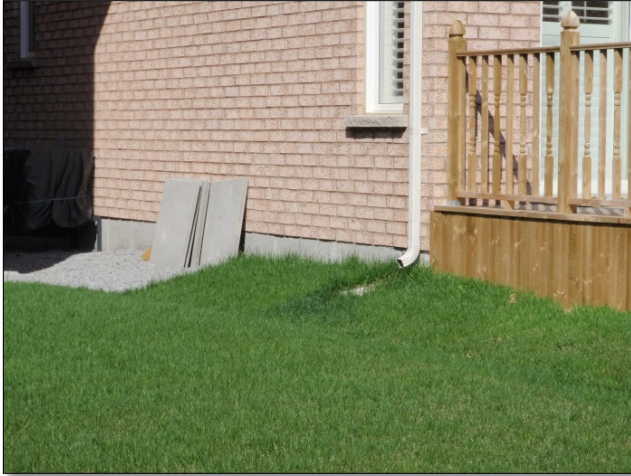
PASS: The lawn where soil amendments have been implemented is well graded with no signs of localized bed sinking , animal burrows or ruts.

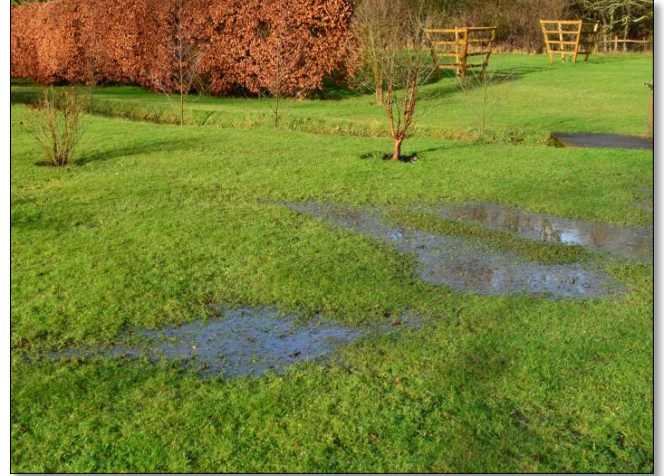
FAIL: Clear evidence of bed sinking on the lawn, creating preferential ponding areas which could cause vegetation to die off (Source: The Anxious Gardener).

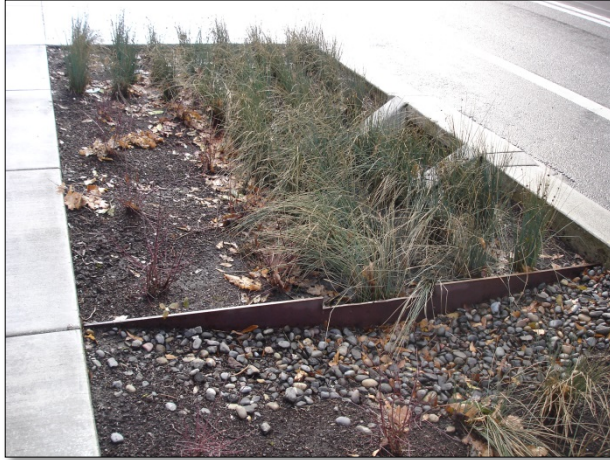
PASS: The check dam is visible and continues to help retain sediment and spread the flow of water across the BMP surface. (Source: Green Girl PDX)

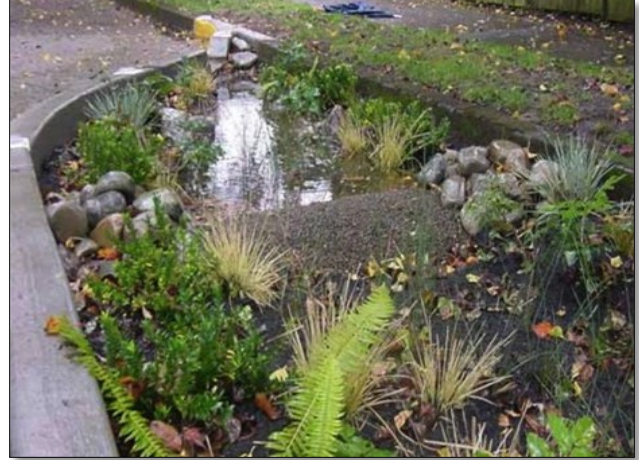
FAIL: Sediment has accumulated on the upstream side of the check dam and is affecting its function. (Source: James Urban).

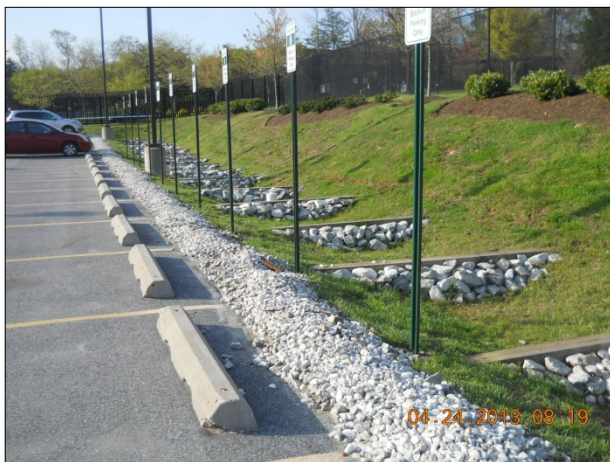
PASS: The check dams are visible and continue to help retain sediment and spread the flow of water across the BMP surface. (Source: CSN).

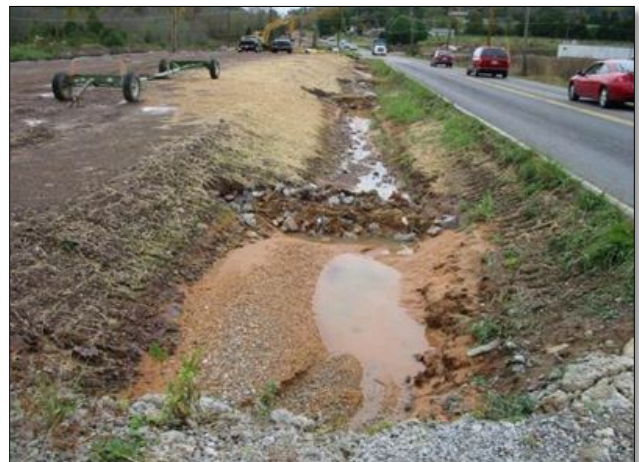
FAIL: Sediment has accumulated on the upstream side of the check dam and is affecting its function. (Source: Tennessee EPSC).

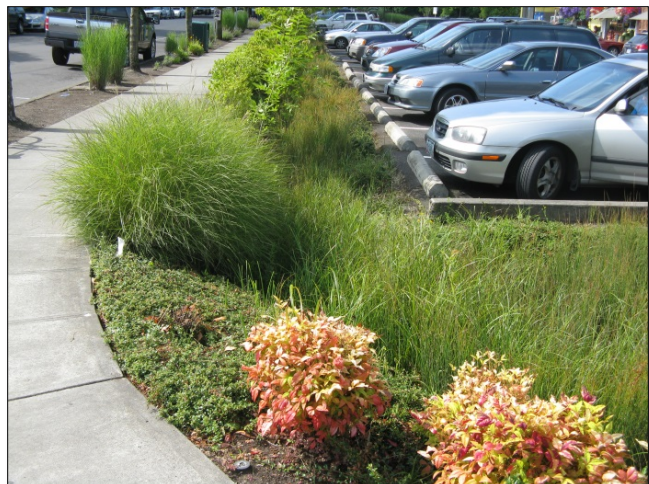
PASS: The planted portion of the bioretention cell is completely covered with dense, attractive vegetation which helps to maintain its stormwater treatment function and aesthetic value.

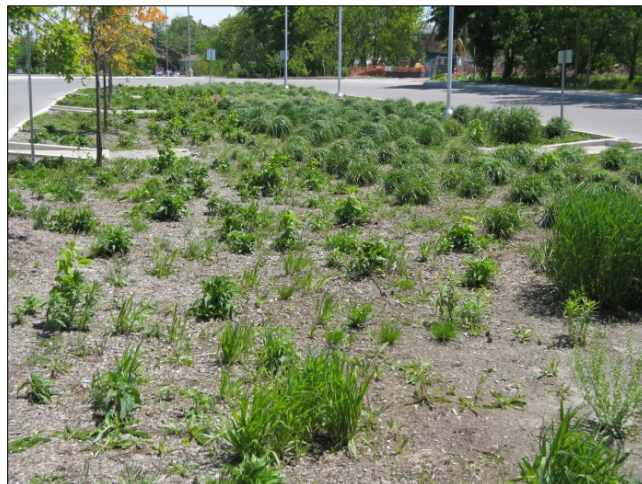
FAIL: A larger portion of the bioretention cell has no vegetation cover which reduces its aesthetic value and could be negatively affecting its stormwater treatment function.

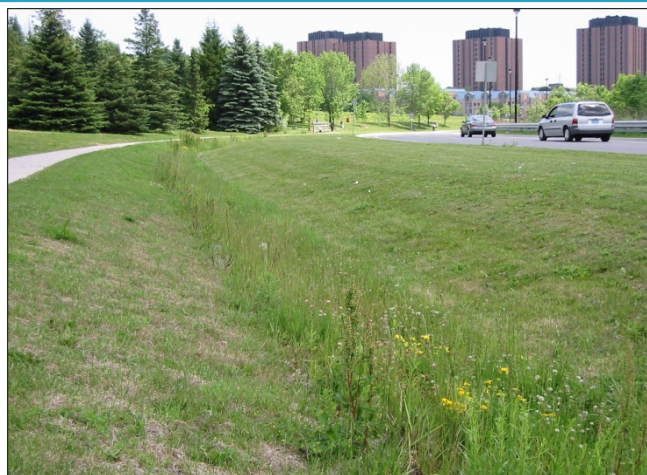
PASS: The planted portion of the swale is well covered with dense, attractive vegetation which helps to maintain its stormwater treatment function and aesthetic value.

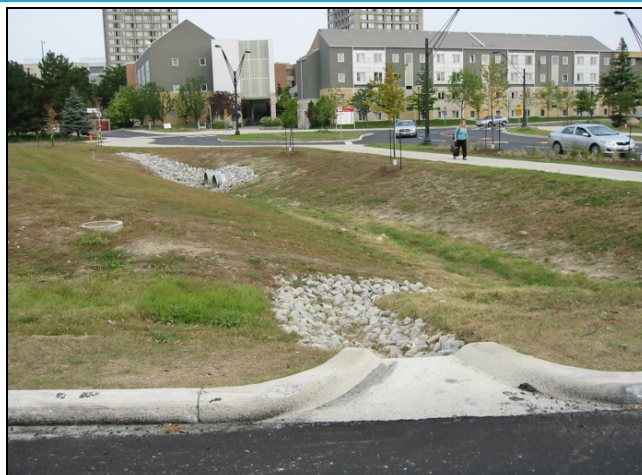
FAIL: Major portions of the swale surface contains dead or dying vegetation which reduces its aesthetic value and could be negatively affecting its stormwater treatment function.

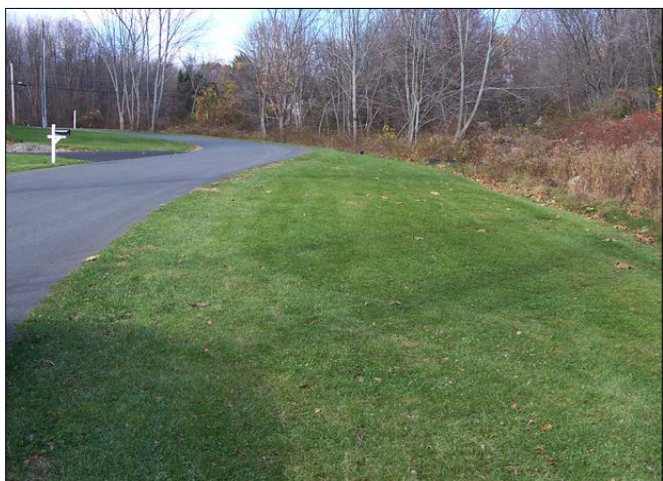
PASS: The vegetated filter strip is evenly covered with dense turf grass which helps to maintain its stormwater treatment function and aesthetic value. (Source: Trinkaus Engineering)

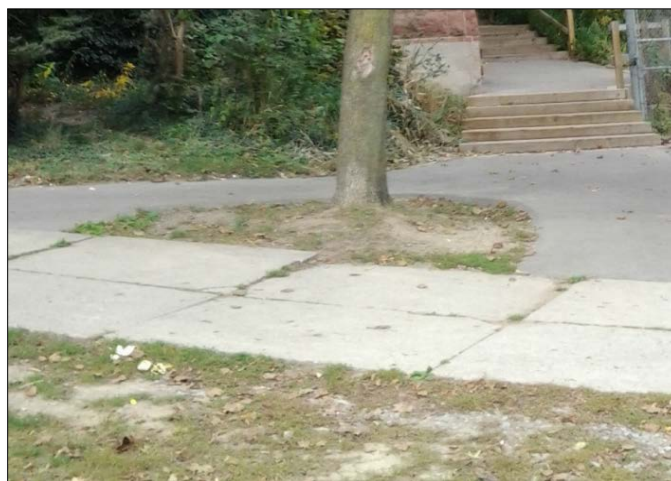
FAIL: Major portions of the filter strip contain bare soil or dead vegetation which reduces its aesthetic value and could be negatively affecting its stormwater treatment function.

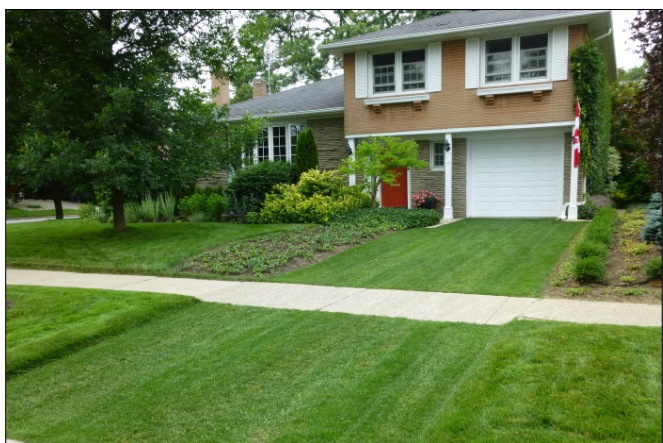
PASS: The permeable driveway is completely covered by dense turf grass which helps to maintain its stormwater treatment function and aesthetic value. (Source: Matthew Hague)

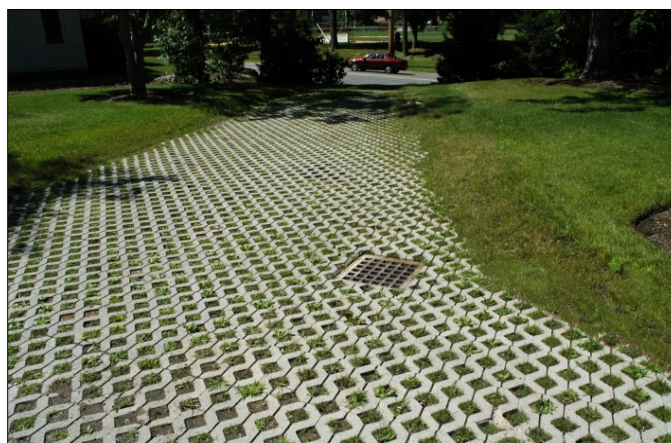
FAIL: Much of the permeable driveway contains bare soil which reduces its aesthetic value and could be affecting its stormwater treatment function. (Source: Dallas Metropolis)

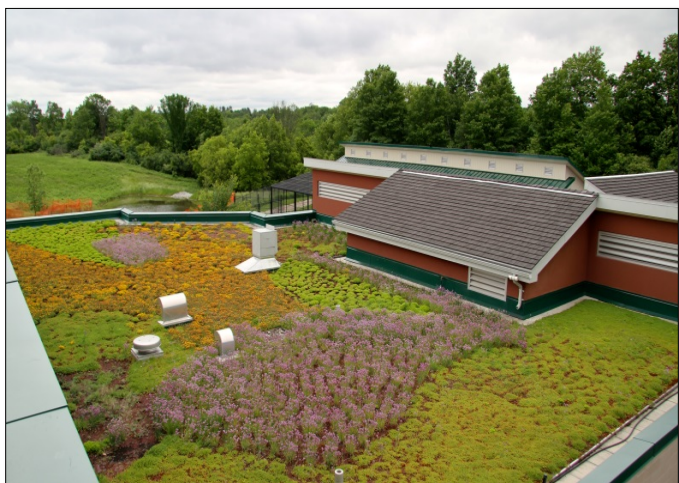
PASS: The green roof is well covered by dense, attractive vegetation which helps maintain its stormwater treatment function and aesthetic value. (Source: Earth Rangers)

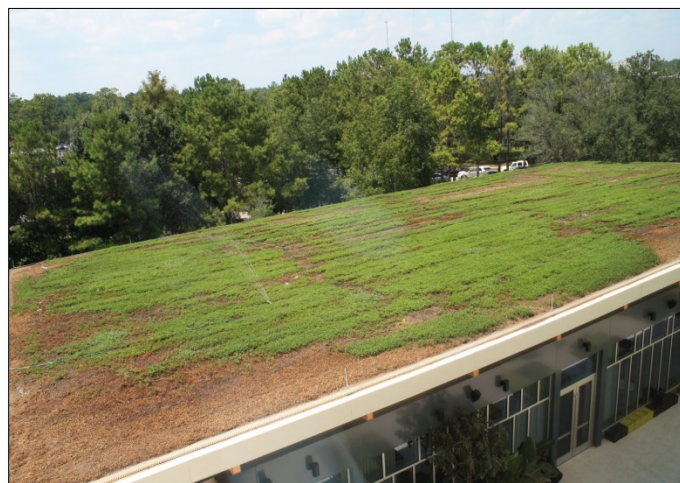
FAIL: A major portion of the green roof contains no living vegetation cover (Source: Kevin Songer).

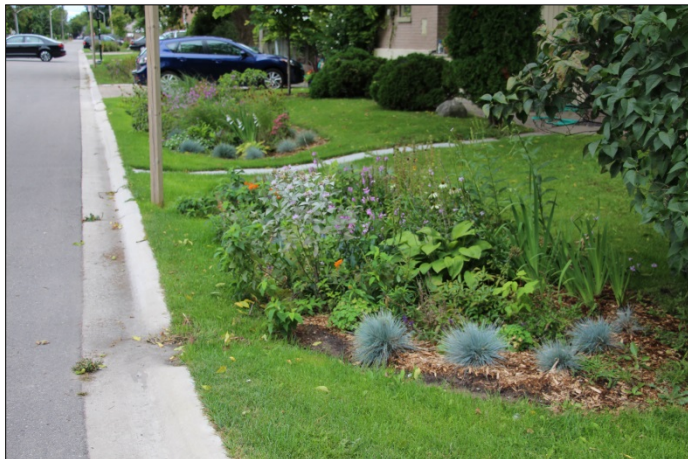
PASS: The vegetation looks healthy and well maintained.

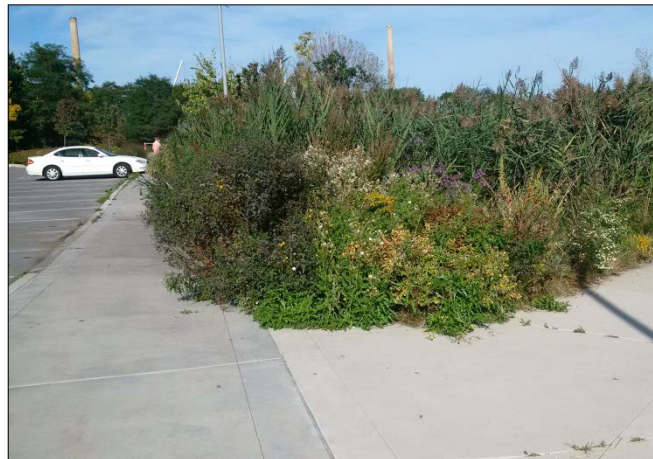
FAIL: The vegetation looks healthy but is overcrowded and overgrown.
