APPENDIX C

VISUAL INDICATOR PROTOCOLS

C.1 CONTRIBUTING DRAINAGE AREA CONDITION

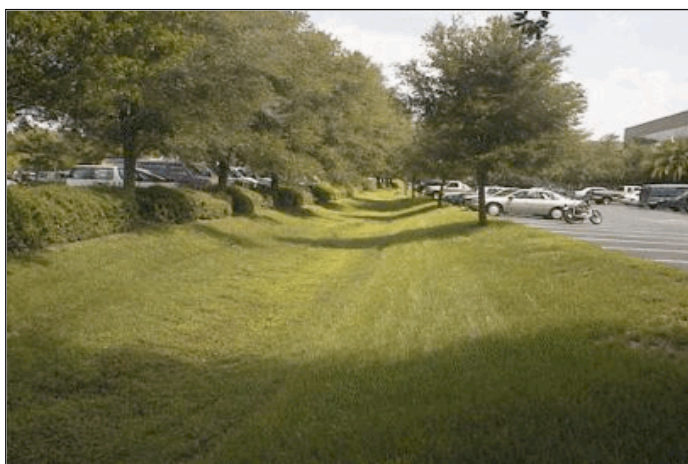
PASS: The turf grass cover looks very healthy and well-maintained. (Source: CSN).

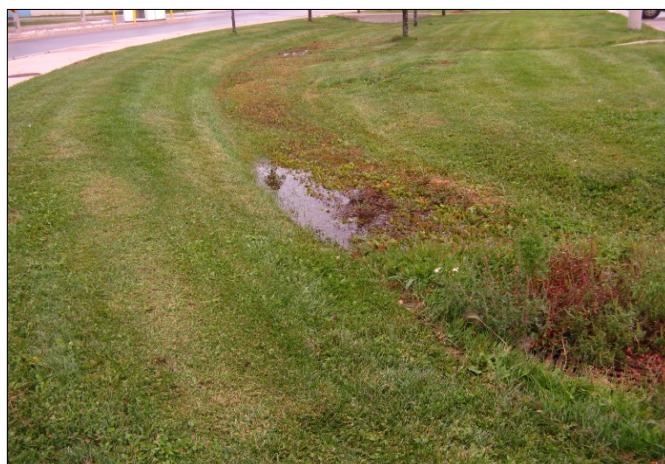
FAIL: Portions of the turf grass looks like it is dying or not flourishing, likely due to frequent surface ponding.

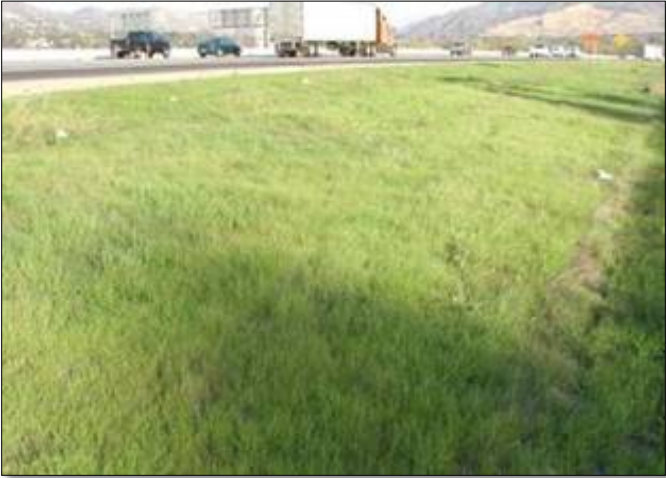
PASS: The turf grass cover on the vegetated filter strip looks healthy and well maintained. (Source: VWRRC)

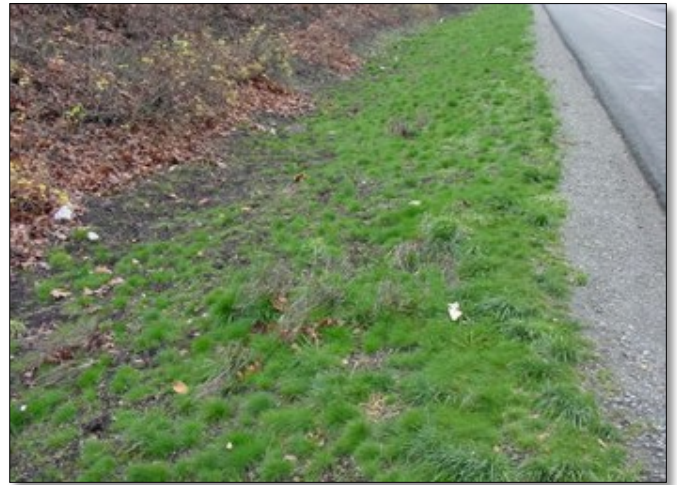
FAIL: The turf grass cover is patchy and not yet thriving. (Source: Washington State DOT).

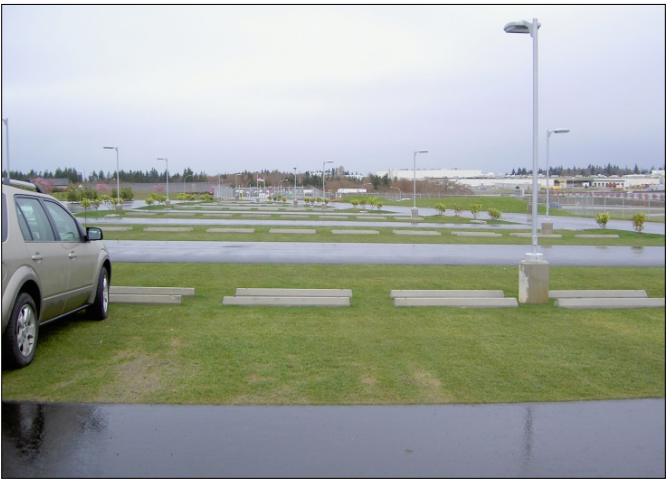
PASS: The turf grass cover on the permeable pavement looks healthy and well maintained. (Source: Herrera Consulting).

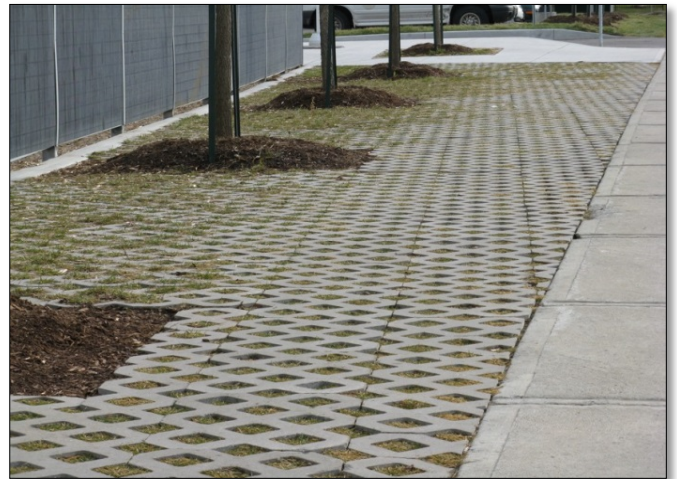
FAIL: The turf grass cover on the permeable walkway is not thriving in some areas and needs cutting in others.

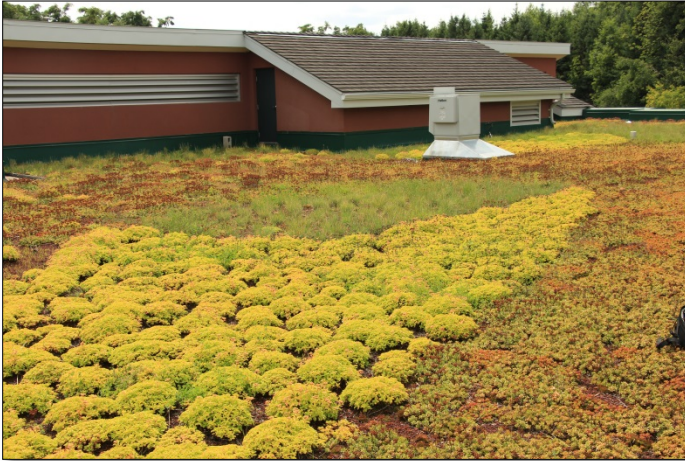
PASS: The green roof vegetation looks healthy and well maintained.

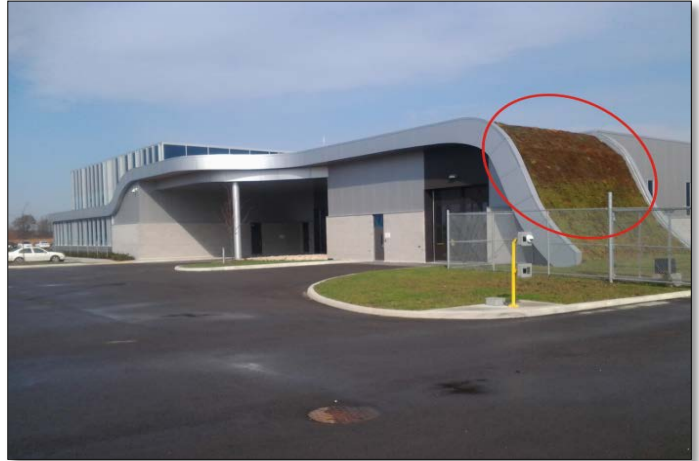
FAIL: A portion of the vegetation on the green roof is dying or not thriving.

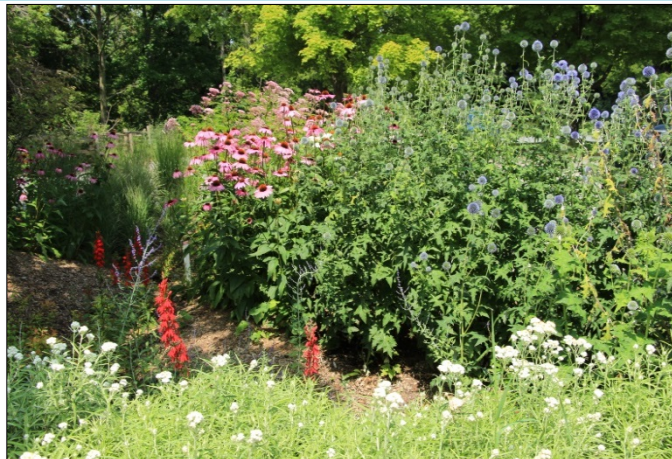
PASS: The species of plants in the bioretention cell matches what was specified in the final design with few weeds and no volunteer tree seedlings present.

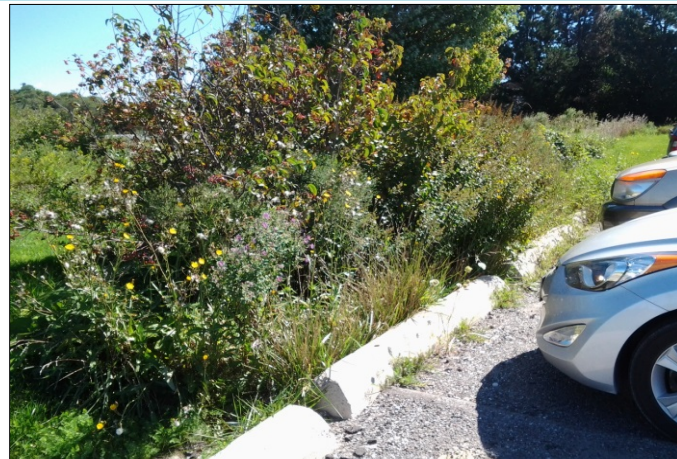
FAIL: Vegetation in the bioretention cell is dominated by invasive species (i.e. weeds) and includes volunteer tree saplings, indicating it is in need of routine maintenance.

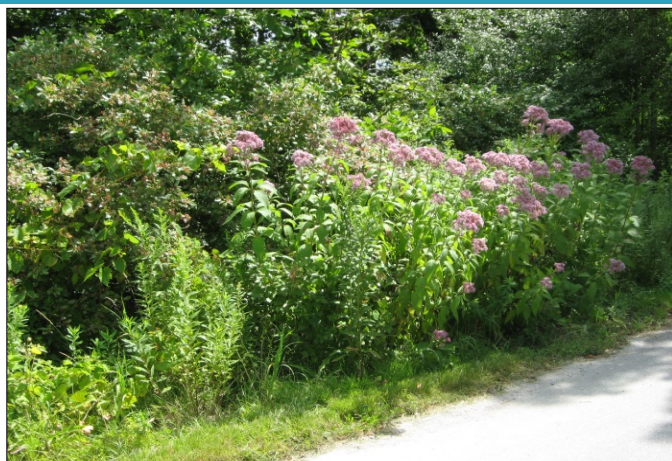
PASS: The species of plants growing in the swale closely matches what was specified in the final design with few weeds.

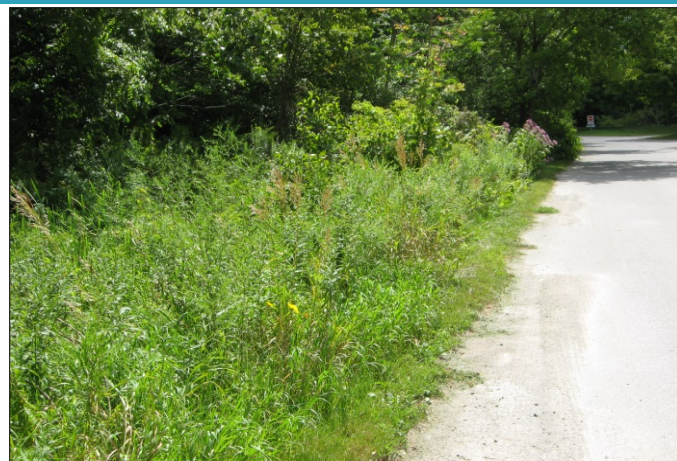
FAIL: Vegetation in the swale is dominated by grasses and invasive species (i.e. weeds) rather than the shrubs and flowers specified in the final design.

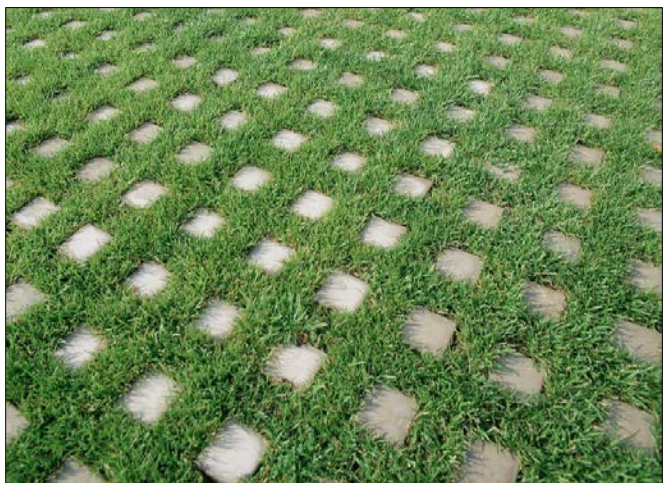
PASS: The vegetation cover on the permeable pavement is turf grass as specified in the final design and contains very few weeds. (Source: WEF)

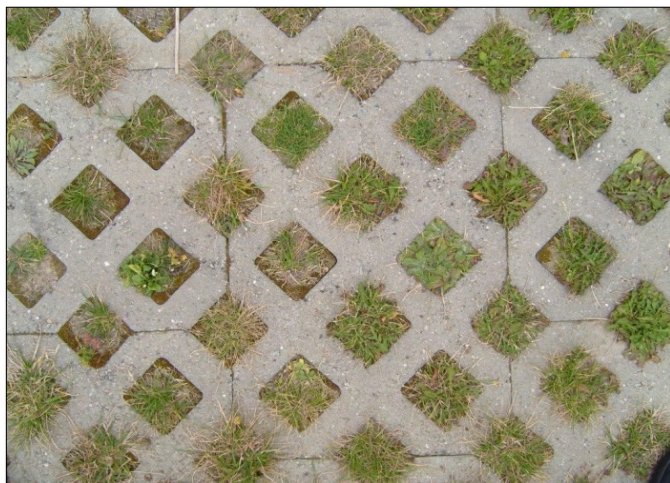
FAIL: The vegetation cover on the permeable pavement is a mixture of turf grass and invasive species (i.e. weeds). (Source: Immanuel Giel)

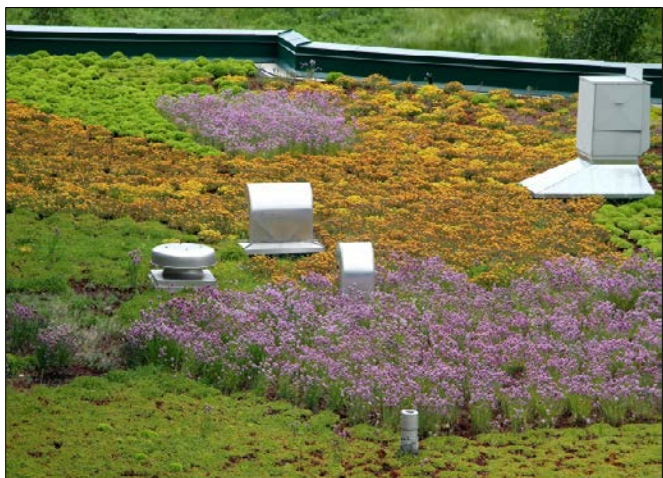
PASS: The green roof contains only the species specified in the final design with few weeds and no volunteer tree seedlings or saplings present. (Source: Earth Rangers)

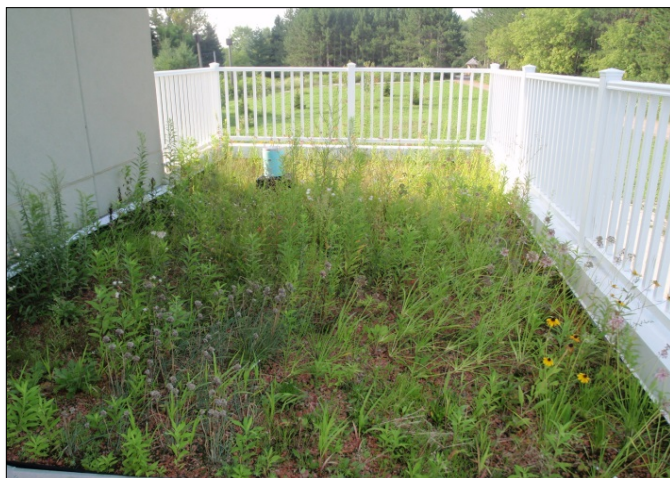
FAIL: Vegetation on the green roof is a mixture of the species specified in the final design and invasive species (i.e. weeds) and needs maintenance.

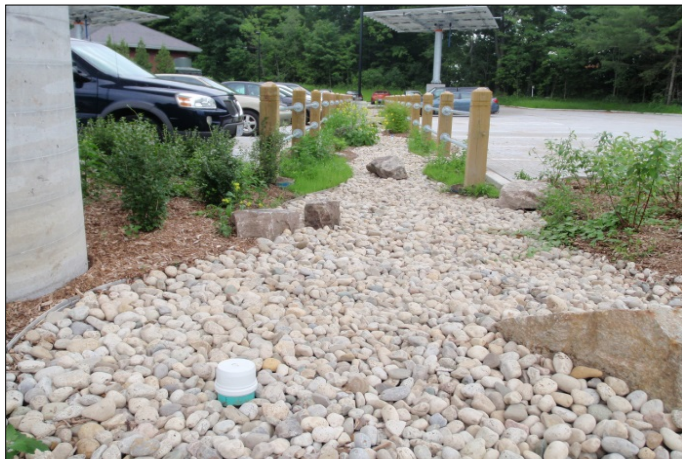
PASS: The well is undamaged and accessible and the cap is in place and secured to prevent unauthorized access.

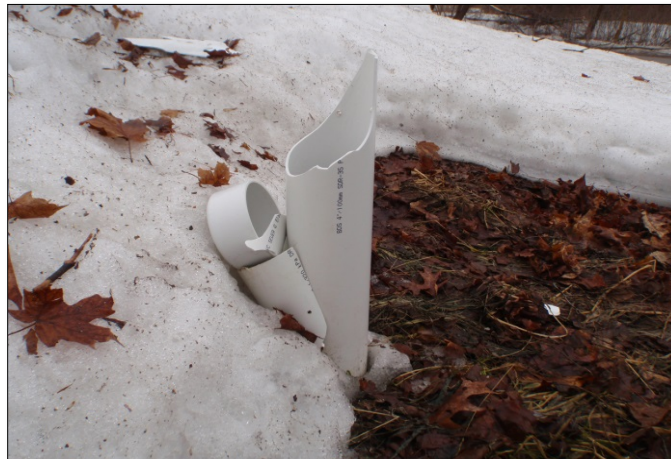
FAIL: The well standpipe has been damaged by snow plowing which impairs its use for monitoring and is a safety hazard.

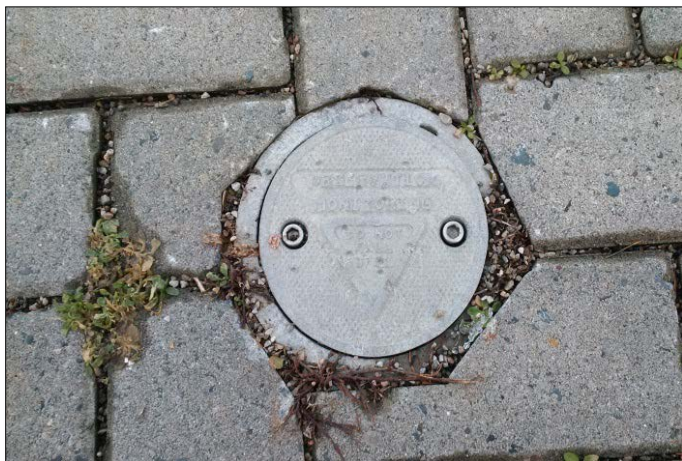
PASS: The well is undamaged and accessible and the cap is in place and secured to prevent unauthorized access.

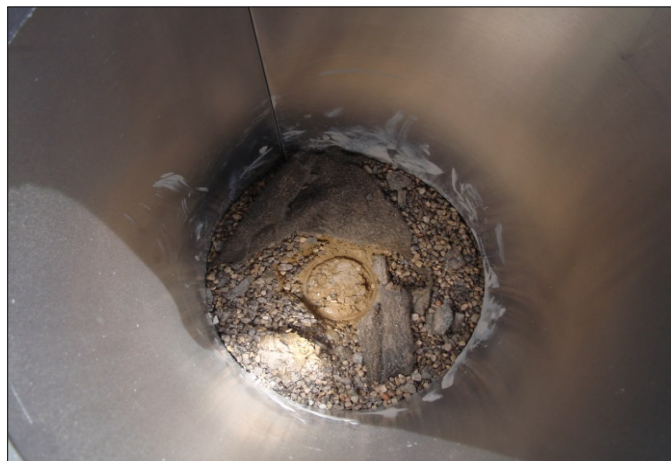
FAIL: The well cap is missing and the casing is clogged by sediment, preventing access for monitoring and allowing sediment to flow into the sub-drain system.

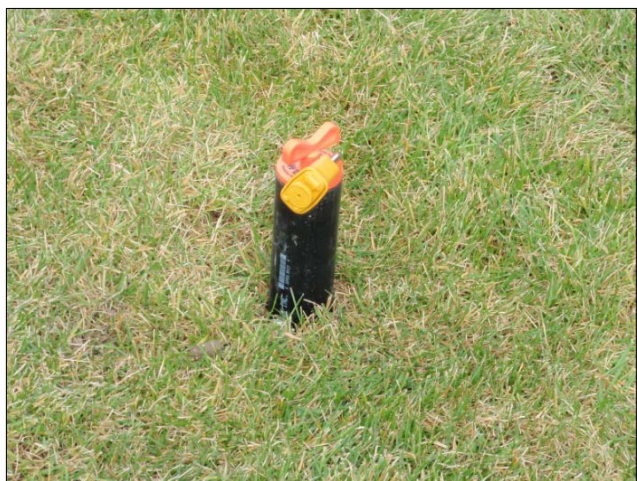
PASS: The well is undamaged and accessible and the cap is in place and secured to prevent unauthorized access.

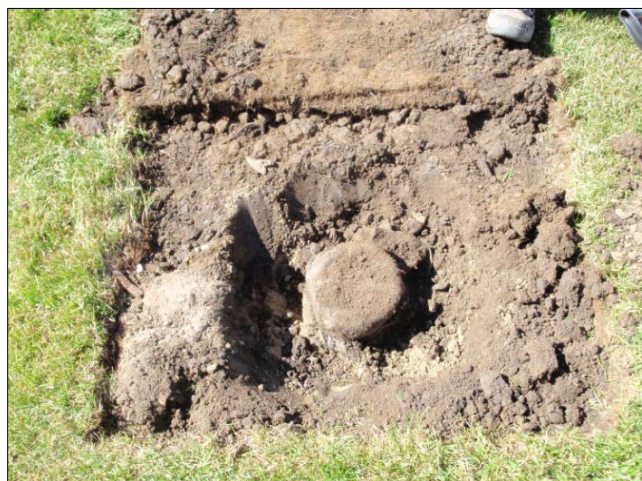
FAIL: The well was buried during landscaping and found covered only by filter cloth (i.e. cap missing).

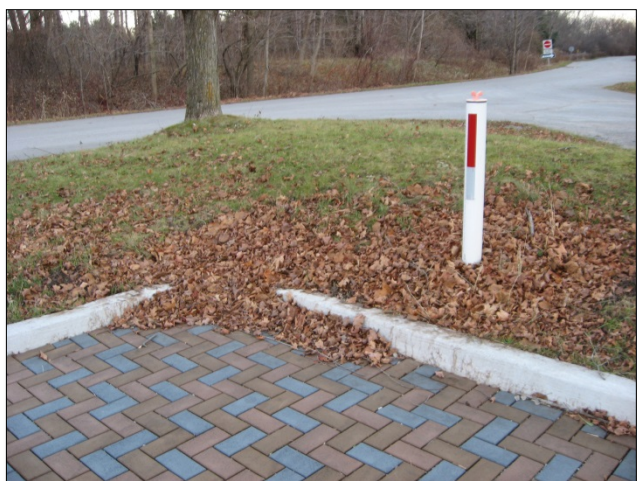
PASS: The well is undamaged and accessible and the cap is in place and secured to prevent unauthorized access.

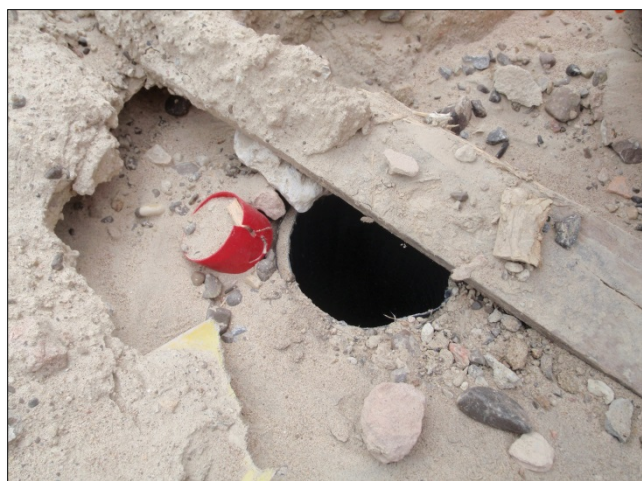
FAIL: The well has been left uncapped and unprotected from erosion and sediment during construction.

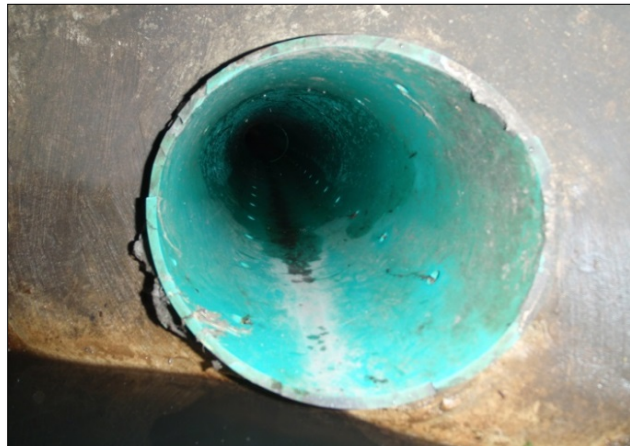
PASS: The perforated sub-drain pipe is not obstructed by sediment, debris or roots and shows no signs of damage.

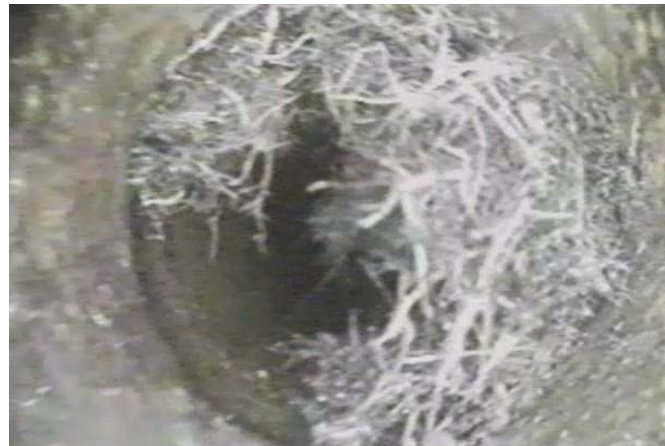
FAIL: Roots have penetrated the sub-drain pipe and are substantially reducing its conveyance capacity. (Source: Pipelining Denver)

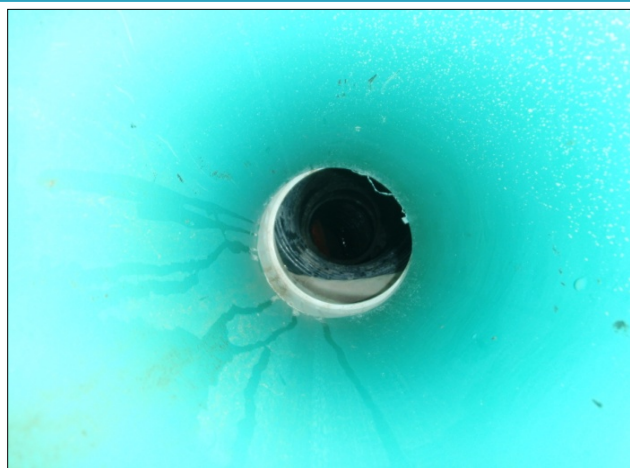
PASS: The solid section of the sub-drain pipe is not obstructed by sediment, debris or roots and shows no signs of damage.

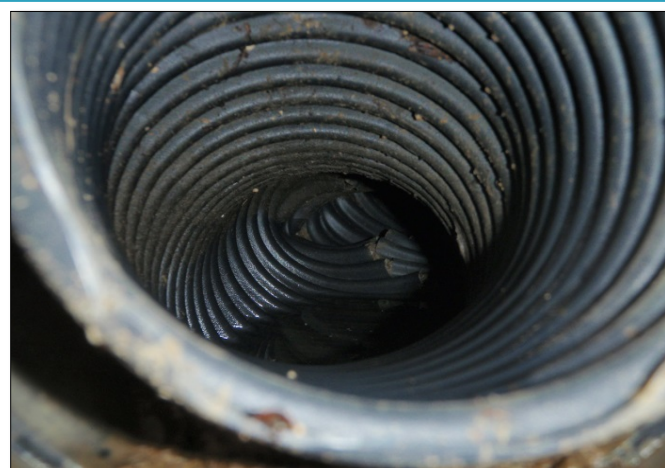
FAIL: A section of the sub-drain pipe has been crushed which substantially reduces its conveyance capacity.

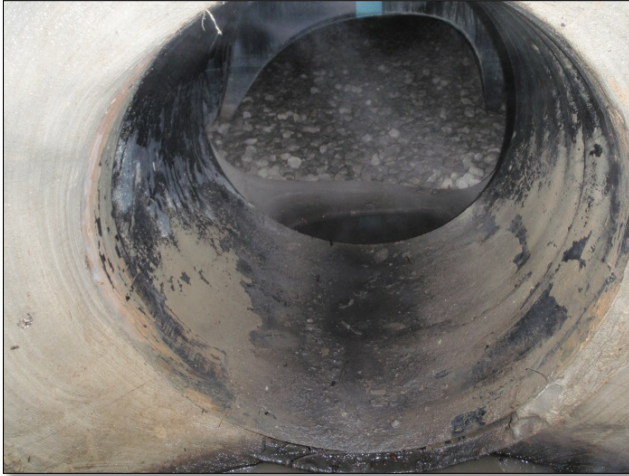
PASS: The sub-drain outlet pipe from the infiltration chamber system is not obstructed by sediment, debris or roots and shows no signs of damage.

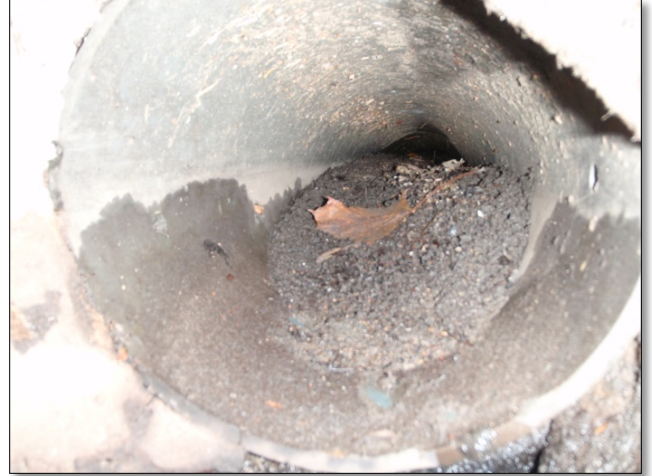
FAIL: A perforated pipe in an exfiltration storm sewer system is clogged by sediment and debris which inhibits its drainage function.

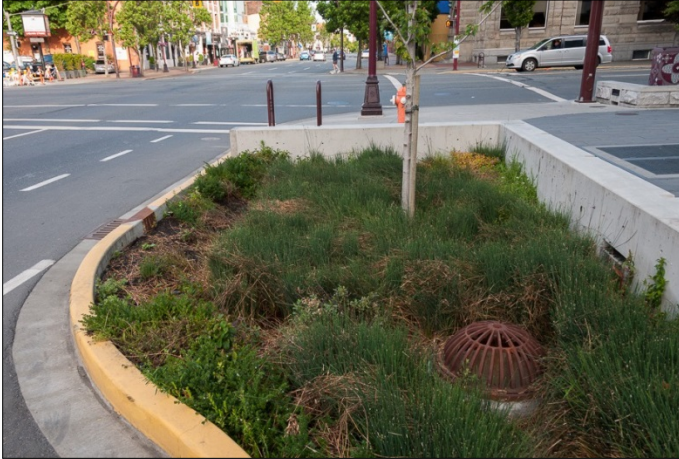
PASS: The overflow outlet is free of damage and obstruction and functions as designed. (Source: Dylan Passmore)

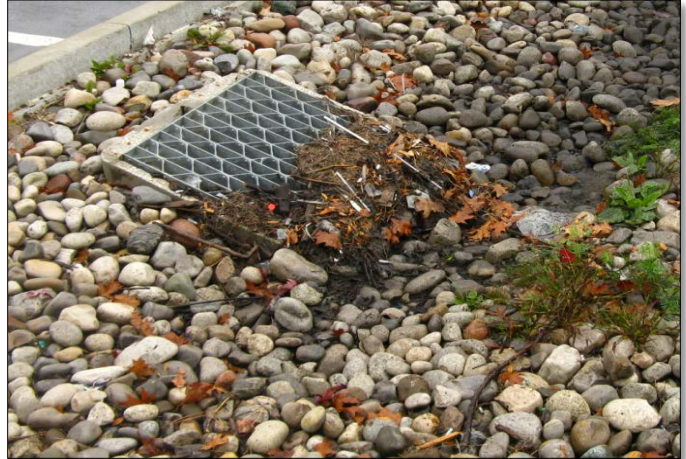
FAIL: The overflow outlet is partially obstructed with trash and debris which reduces its capacity to safely convey excess water from the BMP.

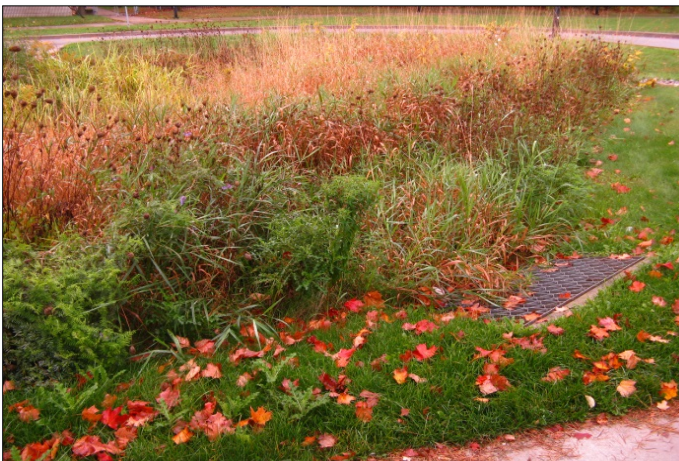
PASS: The overflow outlet of this vegetated swale is free of damage and obstruction and functions as designed to safely convey excess water from the BMP.

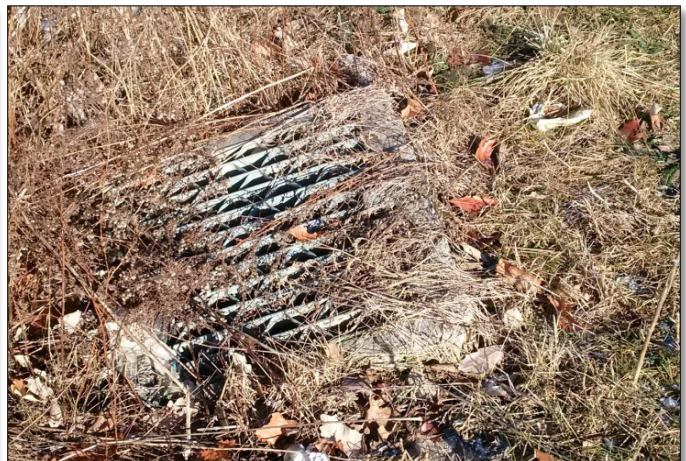
FAIL: Vegetation and debris is partially obstructing the overflow outlet structure which impairs its drainage function.

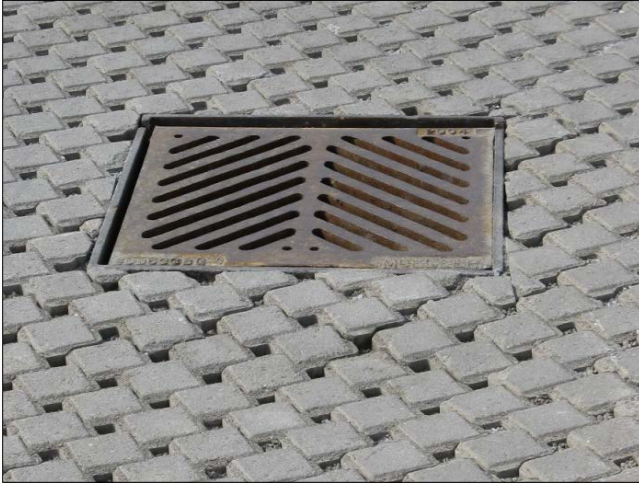
PASS: The overflow outlet is free of damage and obstruction and functions as designed to safely convey excess water from the BMP.

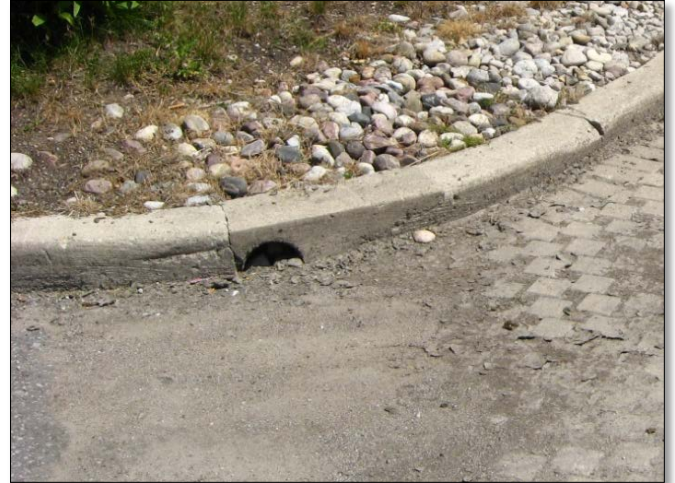
FAIL: The overflow outlet is obstructed with sediment which impairs its function to convey excess water from the BMP.

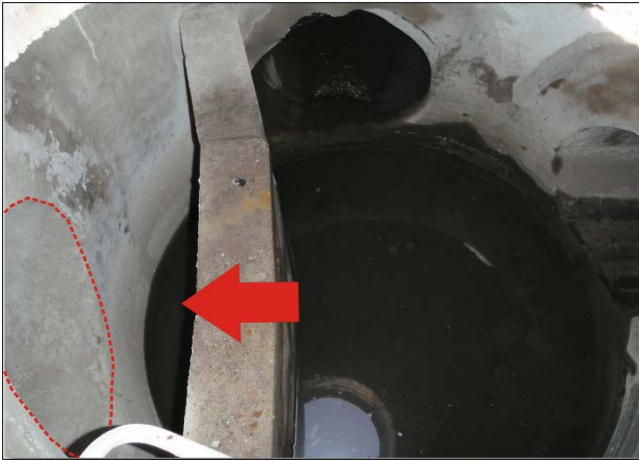
PASS: The overflow outlet weir wall and storm sewer pipe in the control manhole of this infiltration chamber system is free of damage and obstruction and functions as designed to safely convey excess water from the BMP.

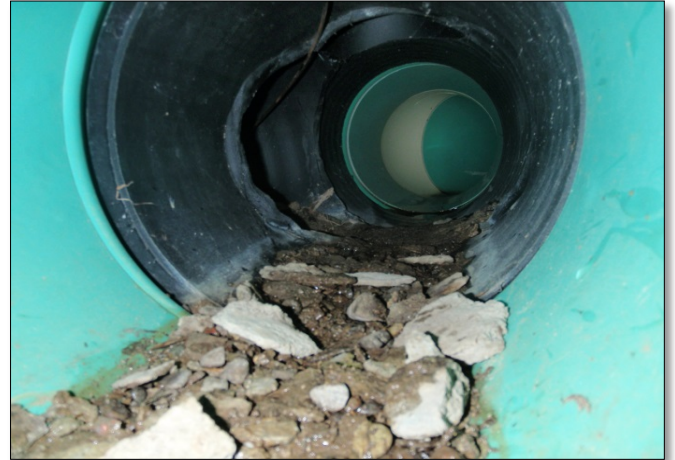
FAIL: Sediment and debris has accumulated in the overflow outlet pipe which impairs its function to convey excess water from the BMP.

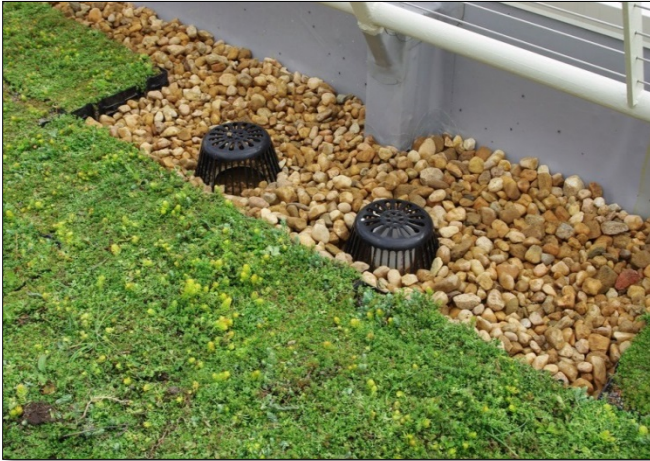
PASS: The overflow outlets of this green roof are free of damage and obstruction and function as designed to safely convey excess water from the BMP. (Source: Vegetal I.D.)

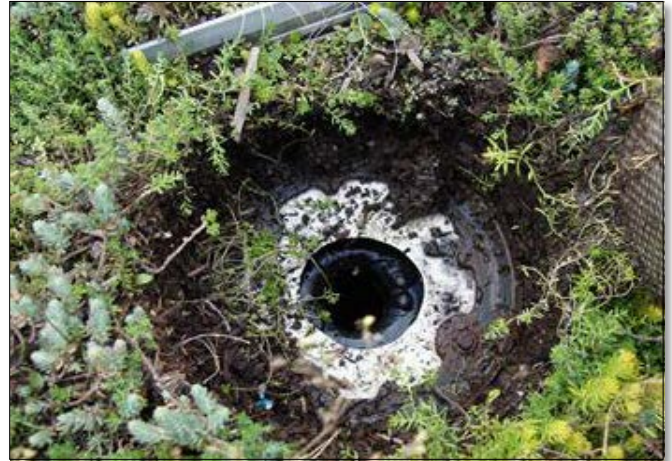
FAIL: Sediment is accumulating at the overflow outlet which could impair its drainage function and cause surface ponding and vegetation die-off. (Source: Jorg Breuning)

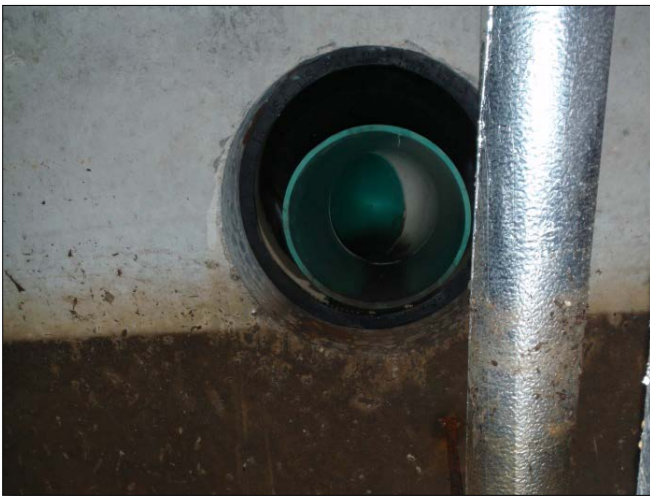
PASS: The overflow outlet pipe diameter matches what was specified in the final design and is free of damage and obstruction.

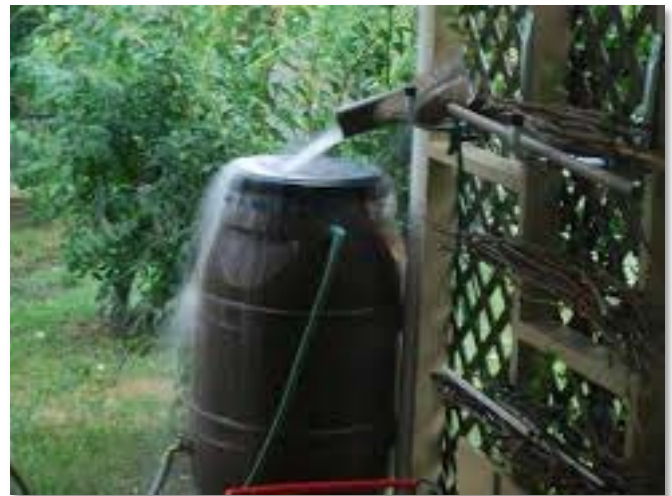
FAIL: The overflow outlet pipe on this rain barrel is undersized and obstructed which impairs its function to safely convey excess water from the BMP. (Source: Melinda Webb)

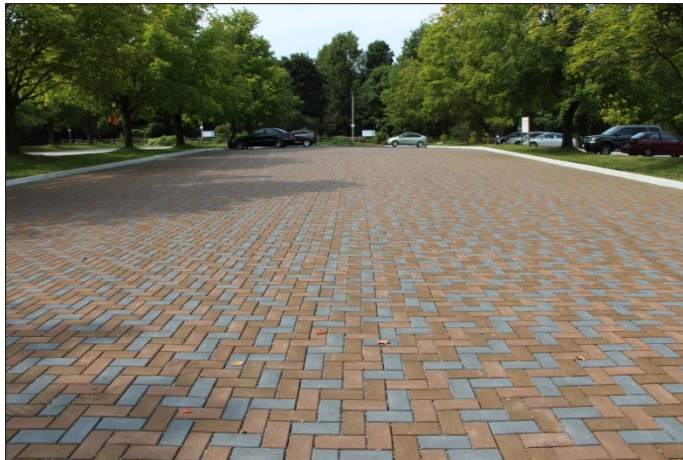
PASS: No damage, displacement or sinking of the permeable surface is visible and there are no weeds growing between paver joints.

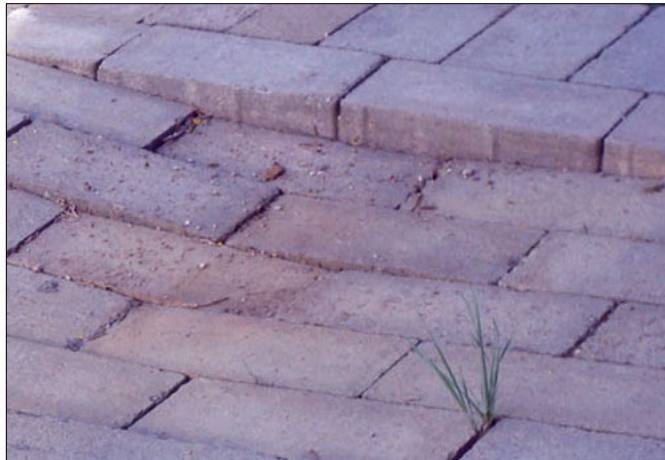
FAIL: The pavement surface has sunk in local areas, creating a trip hazard and the potential for further damage from snow plowing. (Source: Basalite)

MAINTENANCE TRIGGER: Potholes or sinkholes are present or pavers are missing or displaced. Edge restraints are no longer functioning. Ruts or local sinking of 13 mm or greater over a 3 metre length. Adjacent pavers or cracks in pervious concrete or porous asphalt are vertically offset by 6 mm or greater. Aggregate between paver joints is missing or below 17 mm from the paver surface. Weed growth between pavers is extensive and impairing aesthetic value.

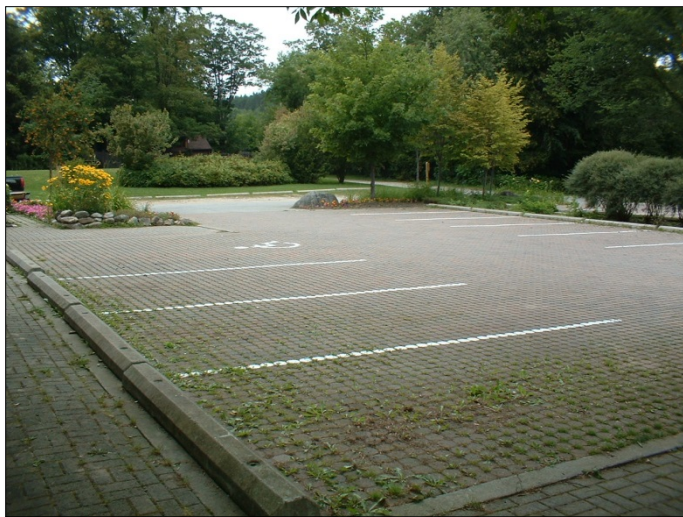
PASS: No damage, displacement or sinking of the permeable surface is visible. Some grass and weeds are growing in the joints between pavers but the affected area is not extensive.

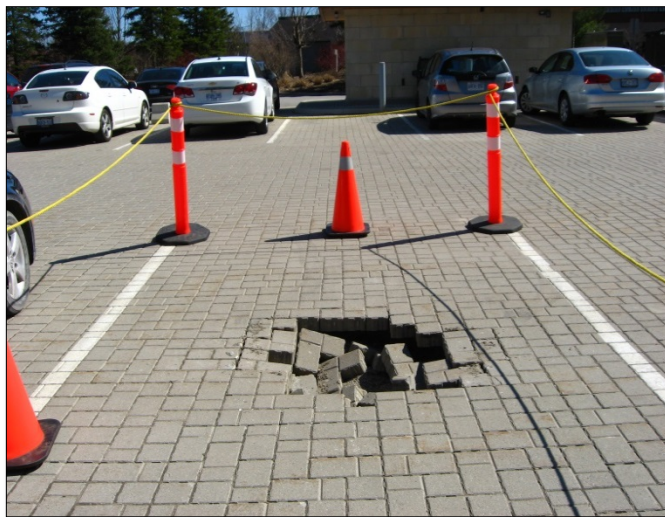
FAIL: A sink hole has formed in one location on the permeable pavement surface, requiring structural repair.

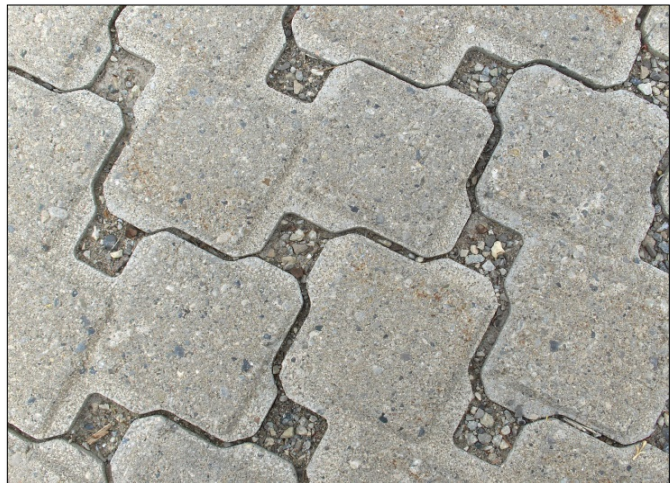
PASS: The fine gravel that fills the joints between pavers is clearly visible and there is no sediment accumulated on the surface of the pavers.

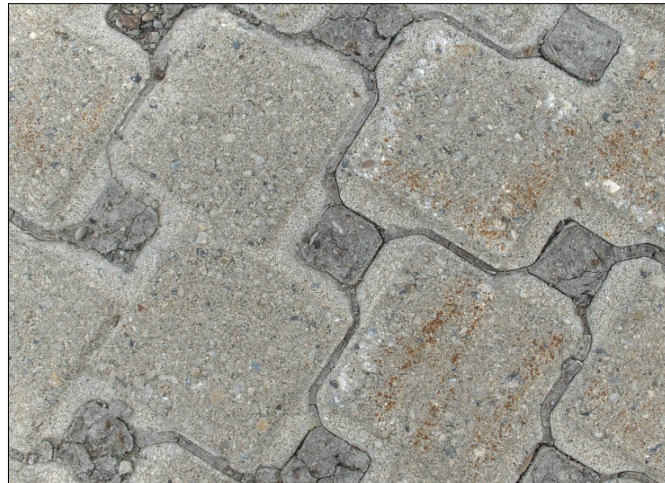
FAIL: The joints between pavers are completely filled with fine sediment and sand.

MAINTENANCE TRIGGER: The joints between pavers or grid cells are completely filled with fine sediment. Any portion of the pavement surface is completely covered with sediment.

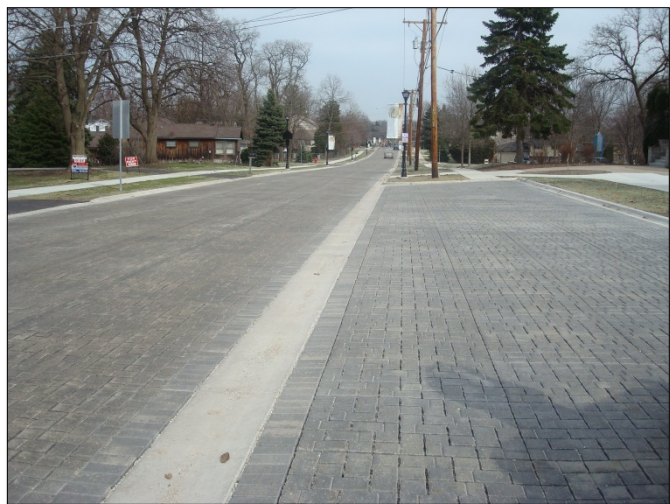
PASS: No portion of the pavement is covered in sediment and fine gravel fill material within the joints between pavers is still visible.

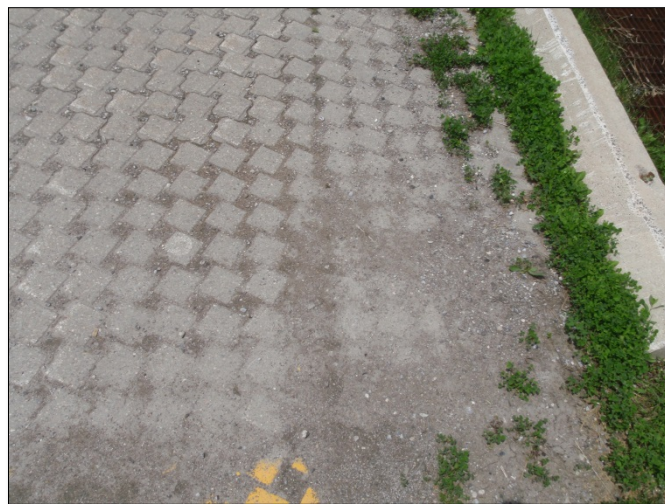
FAIL: The joints between pavers are completely filled with fine sediment in local areas and sediment is accumulating on the surface of the pavers.

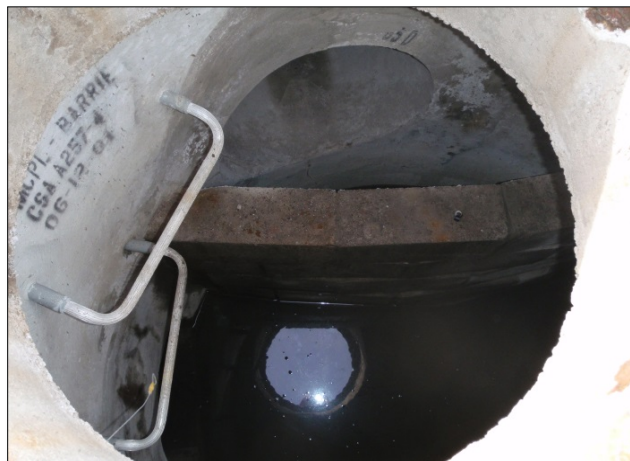
PASS: The control manhole of this infiltration chamber system is accessible with ladder rungs in place and no signs of leaking around the weir wall and pipe connections.

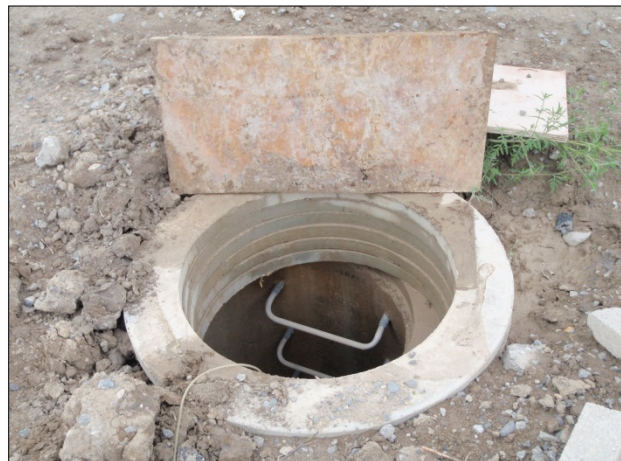
FAIL: The lid of the access hatch is missing which is a safety hazard and the concrete risers are displaced which prevents safe entry for inspection and maintenance tasks.

MAINTENANCE TRIGGER: The manhole is inaccessible or ladder rungs are missing. Damage to the concrete structure or evidence of leaking is visible and may be impairing the function of the BMP.

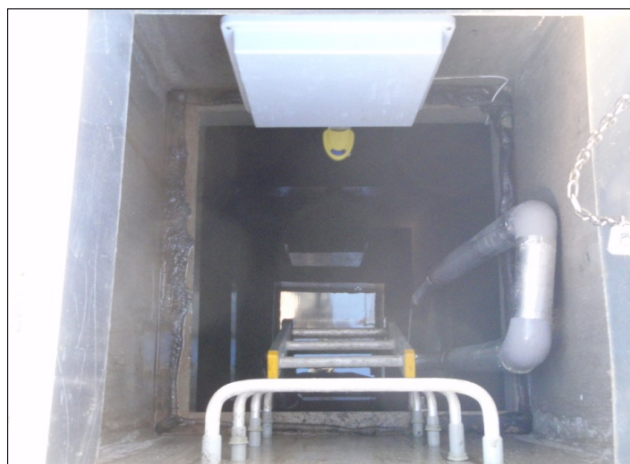
PASS: The access hatch of this cistern is accessible with ladder rungs in place.

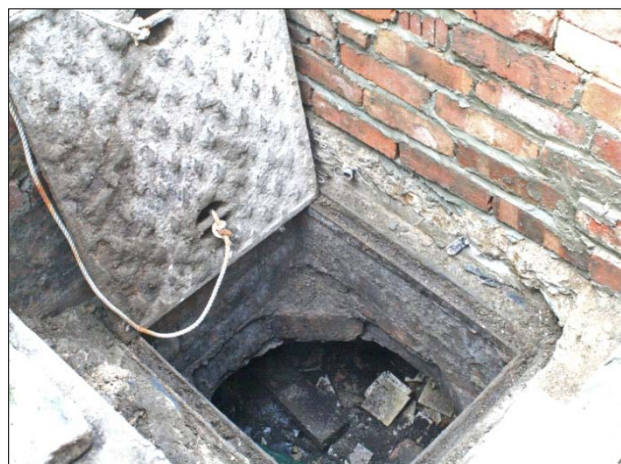
FAIL: The access hatch of this cistern was paved over with concrete and ladder rungs are missing which prevents safe entry for inspection and maintenance tasks. (Source: Miles Golding).

MAINTENANCE TRIGGER: The access hatch is inaccessible or ladder rungs are missing.

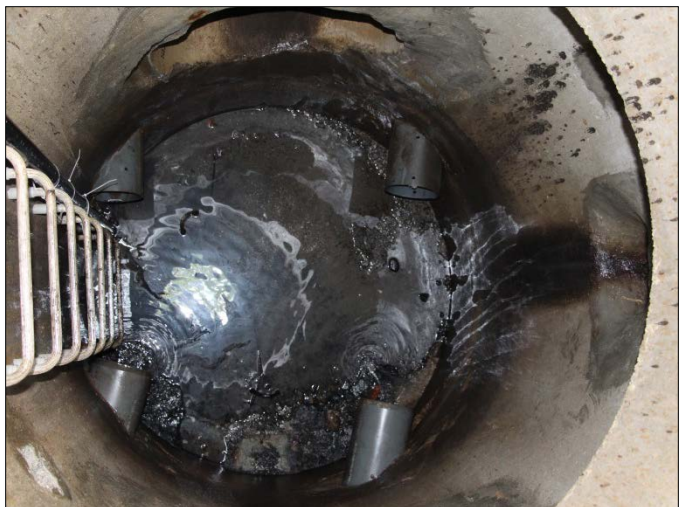
PASS: There is some sediment accumulated in the manhole but it is not impairing the flow of stormwater into or out of the BMP. (Source: SWC Canada)

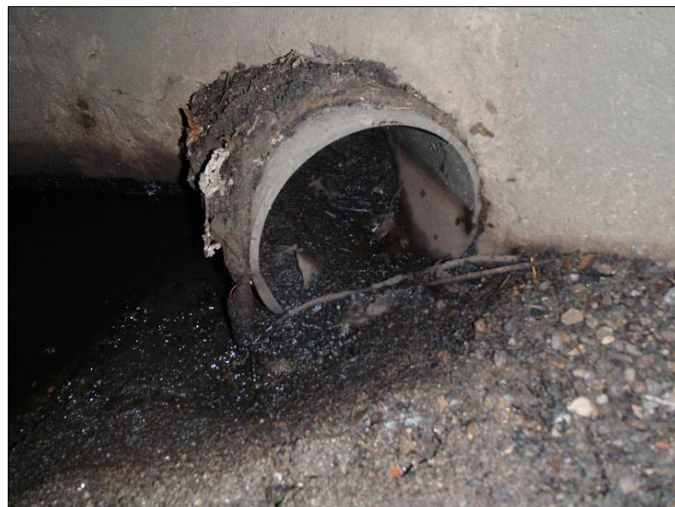
FAIL: The manhole sump is full of sediment and debris and it is beginning to impair flow of stormwater into a perforated pipe of the exfiltration storm sewer system.

MAINTENANCE TRIGGER: Depth of sediment is 10 cm or greater, or is obstructing the flow of stormwater into or out of the BMP.

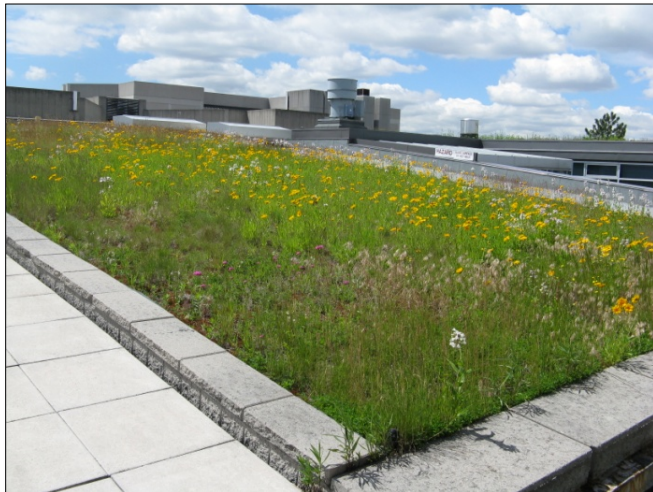
PASS: There are no signs of damage to the concrete parapets along the perimeter and no uplift of green roof layers.

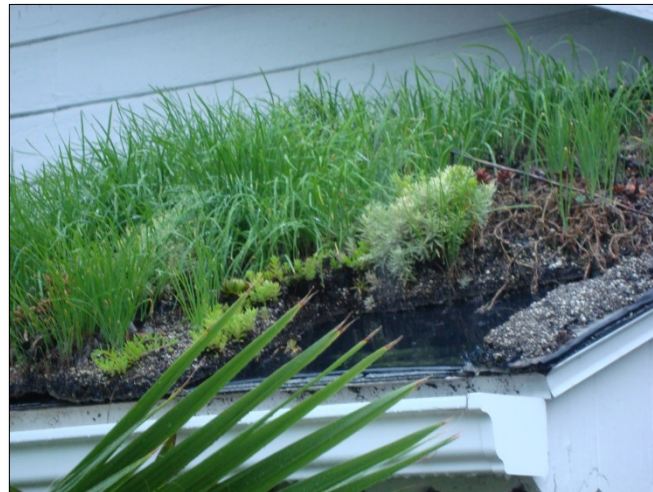
FAIL: One of the green roof growing media structures has been displaced and requires replacement and repair. (Source: Kevin Songer)

MAINTENANCE TRIGGER: Signs of damage to green roof structures are visible or protective membranes are exposed.

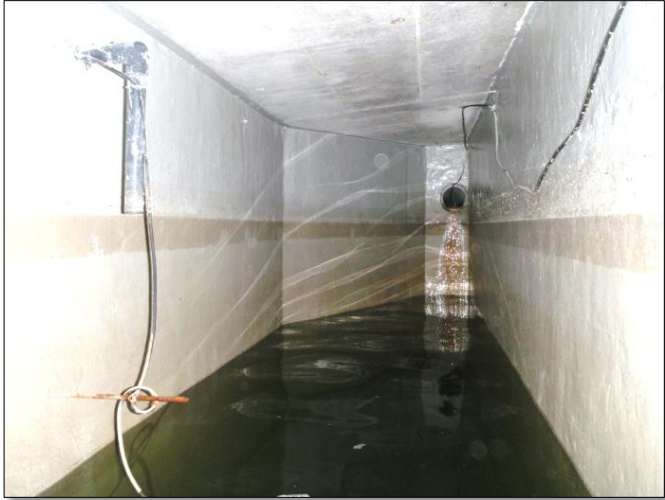
PASS: There are no cracks or leaks visible in the cistern structure.

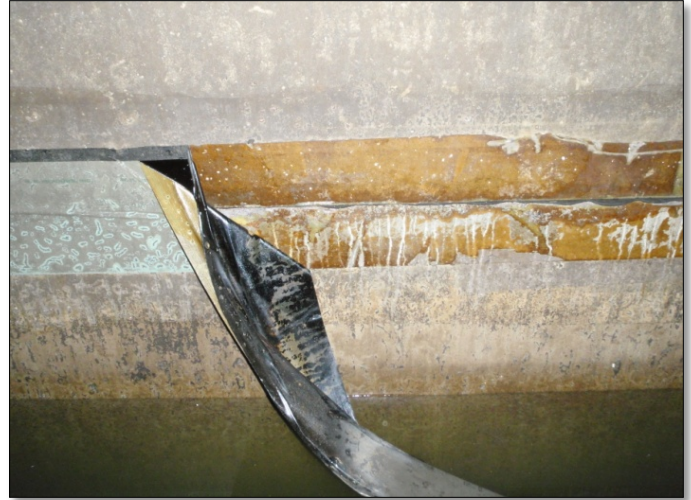
FAIL: A section of sealing tape over two pieces of the concrete cistern structure is displaced, raising the potential for leaks in the future.

MAINTENANCE TRIGGER: There are one or more cracks or leaks visible in the cistern. Water level in the cistern is declining when no rainwater use is occurring or never fills completely.

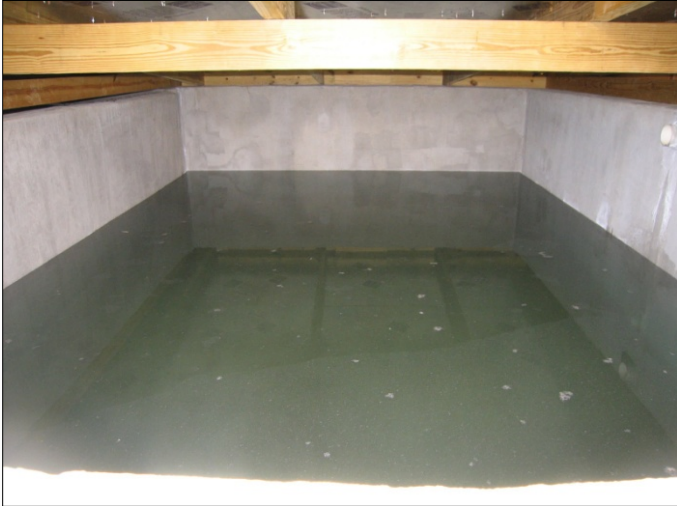
PASS: Very little sediment and no coarse debris has accumulated on the bottom of the cistern and the sediment is not at the level of the distribution system intake structure.

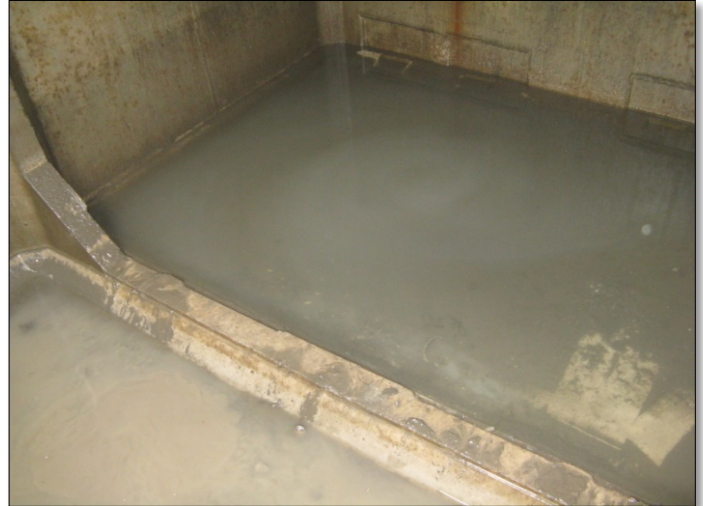
FAIL: Enough sediment has accumulated in the cistern to cause water delivered from the distribution system to be turbid and discoloured when cistern water levels are low.

MAINTENANCE TRIGGER: Levels of turbidity or discolouration of water drawn from the cistern are aesthetically displeasing. The depth of accumulated sediment in the cistern is at the level of the distribution system intake structure when cistern water levels are at their lowest operating level.
