# Winter Mechanical Dredging of a Stormwater Pond Forebay

**CASE STUDY**

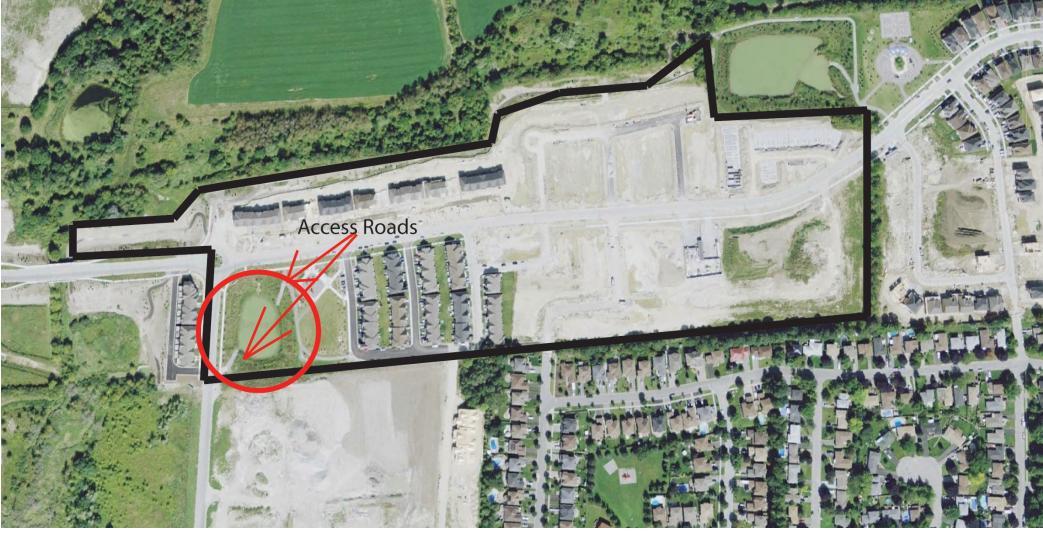
Figure 1. Location of Stouffville RC5 pond and associated drainage area. Aerial photo was captured prior to completion of the planned development.

The RC5 pond in the Town of Whitchurch-Stouffville is located east of Highway 48, south of Bethesda Sideroad and north of Stouffville Road. The pond was constructed in 2006 as part the Northwest Stouffville Secondary Plan lands that incorporate approximately 385 ha of land. These lands are within the Rouge River watershed and drain to the Little Rouge Creek and the Stouffville Creek. The RC5 pond is servicing the Geranium Residential Development and outlets to the Little Rouge Creek. A 14.55 ha drainage area feeds residential stormwater runoff to the RC5 pond with a normal surface area of 2489 m<sup>2</sup> (Figure 1). The pond design includes two access roads at the northeast and southwest corners.

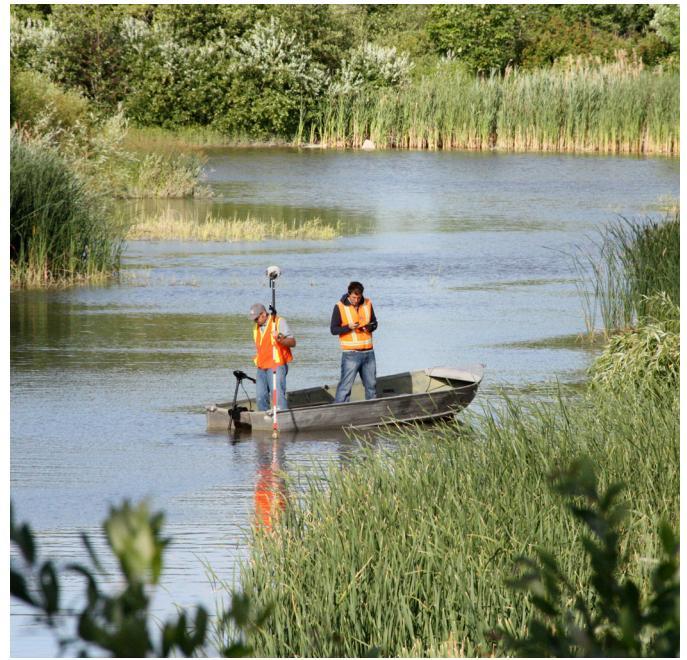
Figure 2. Bathymetric survey of a pond using a rod, disk and a GPS unit.

The pre-cleaning bathymetric survey conducted by SCS Consulting took place in July, 2013. A Trimble R8 model GPS device was used to obtain high resolution pond bottom measurements with a 15 mm vertical accuracy (Figure 2). The device was attached to the top portion of a metal rod with a flat metal plate feeding into the bottom of the rod. A GPS reading was taken when the disk reached and rested on top of the sedi-

ment. The original as-built survey was overlayed with the existing bathymetric survey, and the difference between the two measurements was used to determine the existing pond sediment volume. To increase the efficiency of the method, the as-built bathymetric survey was uploaded to the GPS device, which compared the live feed of GPS points to the uploaded as-built survey. This allowed the survey technicians to concentrate their measurements in areas that showed large depth deviations between the two surveys. This process increased the accuracy of the survey by isolating the sediment accumulation hot spots, capturing key pond contours and structures, and diverting efforts to those locations. Based on the survey, it was

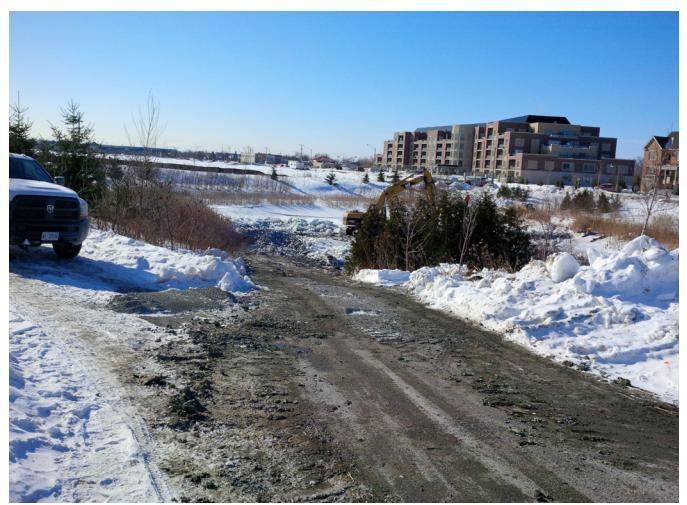
Figure 3. Access road snow clearing and grading prior to pond dredging.

The stormwater pond had been designed with two access roads, which improved the site access and preparation process (Figure 3). As these roads had not been in use for an extended period of time, some regrading and snow clearing was required to ensure that the machinery had a safe and stable access route. The timing of the dredging operations nearly eliminated the need for vegetation clearing to ensure clear access for equipment.

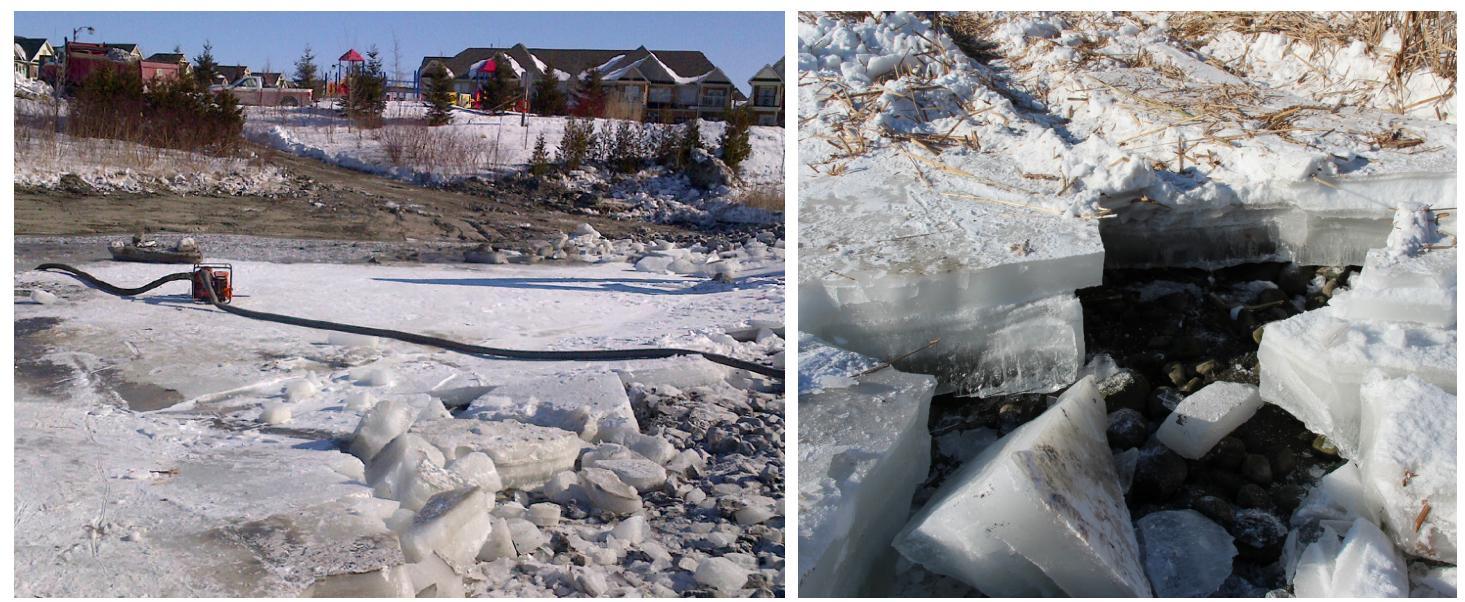
Figure 4. Pumping of sediment forebay water through the ice layer (left) which was 375 mm thick (right).

Unlike hydraulic dredging, mechanical dredging requires that the maximum possible amount of water is removed from the pond before dredging operations begin. Due to the timing of operations and relatively cold winter, the pond had frozen almost to the bottom, resulting in an ice layer that was 375 mm thick, leaving very little water that needed to be pumped (Figure 4). A hole was punctured in the ice through which a 3" pump nozzle was inserted. The pumped

water was directed to a 4 m<sup>2</sup> geotextile sediment bag, which retained less than 0.1 m<sup>3</sup> of sediment. Filtered water from the bag was directed back into the aftbay of the pond. The frozen layer of ice restricted the generation of turbulence in the pond, thereby allowing the sediment to settle to the bottom. This resulted in relatively clean discharge from the outlet, as suspended sediment was minimal.

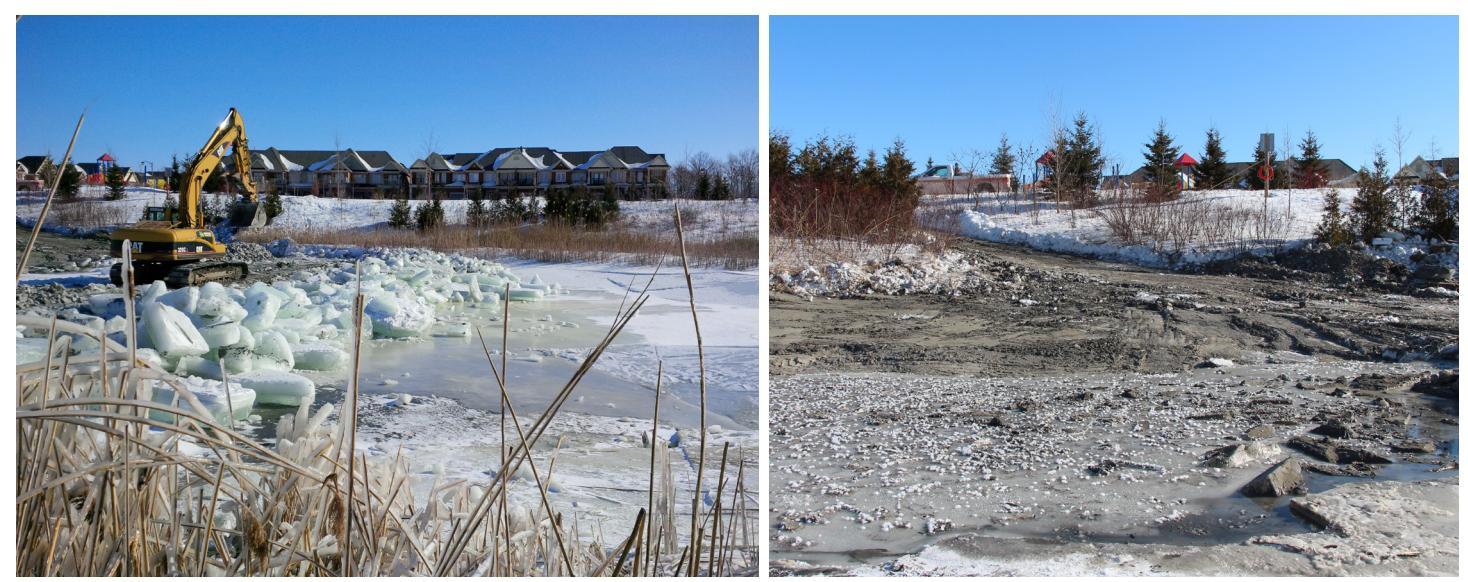
Figure 5. Ice break-up and removal by a mechanical excavator (left); exposed pond sediment forebay bottom after ice has been removed and some sediment had been dredged.

The ice removal and dredging activities were conducted simultaneously; the excavator moved further into the center of the forebay after removing the ice and dredging newly exposed sections (Figure 5). A CAT 330 excavator was used to break the forebay ice into chunks and move them into the aftbay area of the pond. The frozen state of the water made the work easier as it allowed the ice to be moved around as a solid material. The ice remained in the aftbay until warmer spring weather redistributed the meltwater throughout the entire pond.

The same excavator was used to dredge the nearly frozen pond bottom sediment from the pond sediment forebay area. The lack of vegetation and cattails at the perimeter of the pond allowed the excavator to freely move around the edges of the forebay and work its way towards the center without sinking into pond muck. When the excavator reached about 2/3 of the way to the center of the forebay, it was estimated that the required amount of sediment had
