Evaluating the Effectiveness of 'Natural' Channel Design Projects:

An Introduction and Preliminary Assessment
of Sites in TRCA's Jurisdiction

Final Report 2009

February 2009

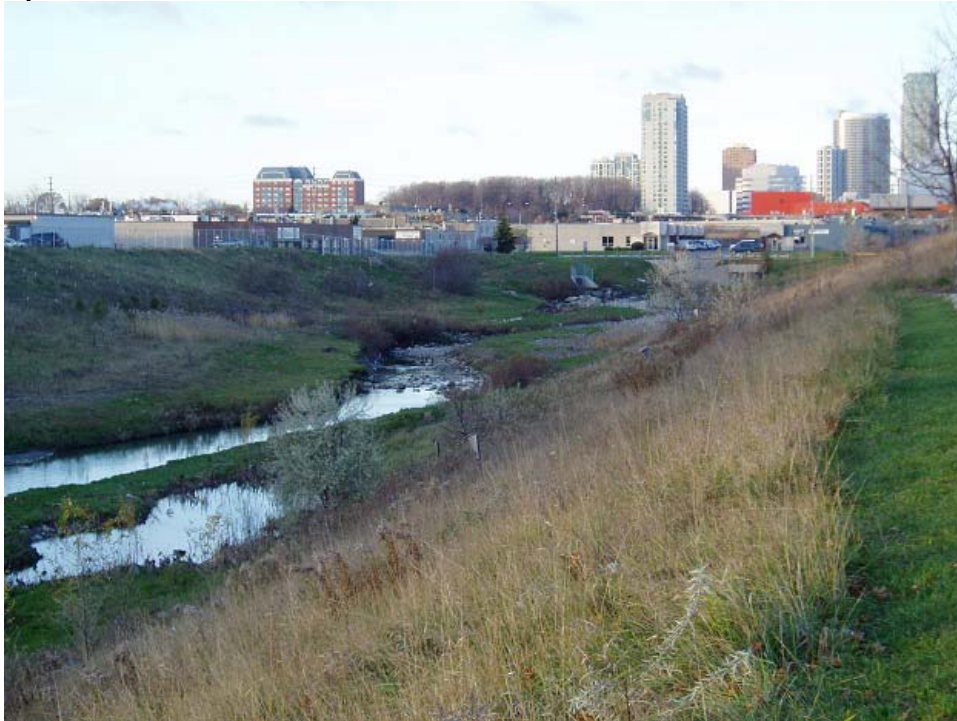
Highland Creek viewed upstream toward Bellamy Road.

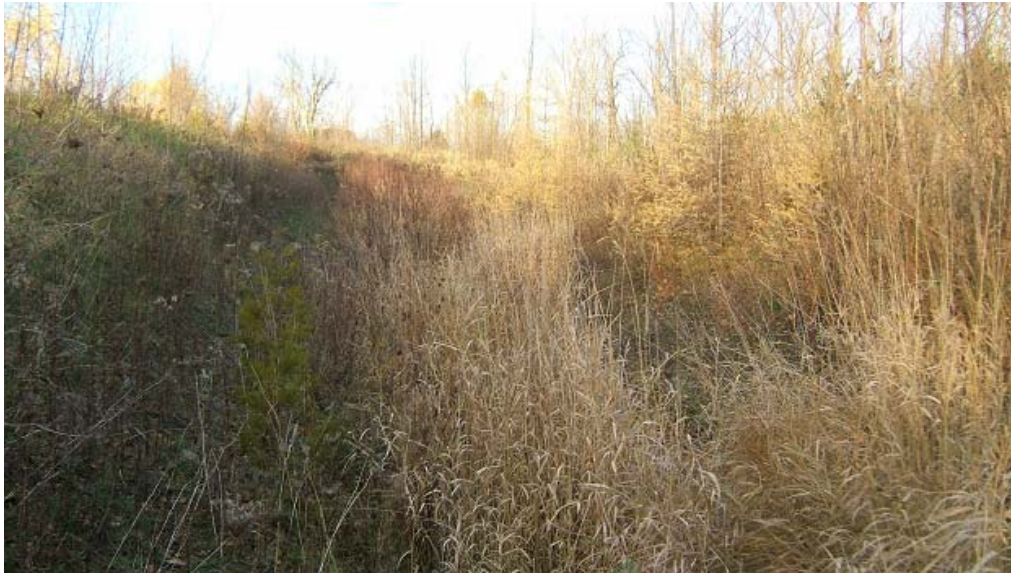
View of channel looking upstream. Note: vegetation encroachment and steep banks.

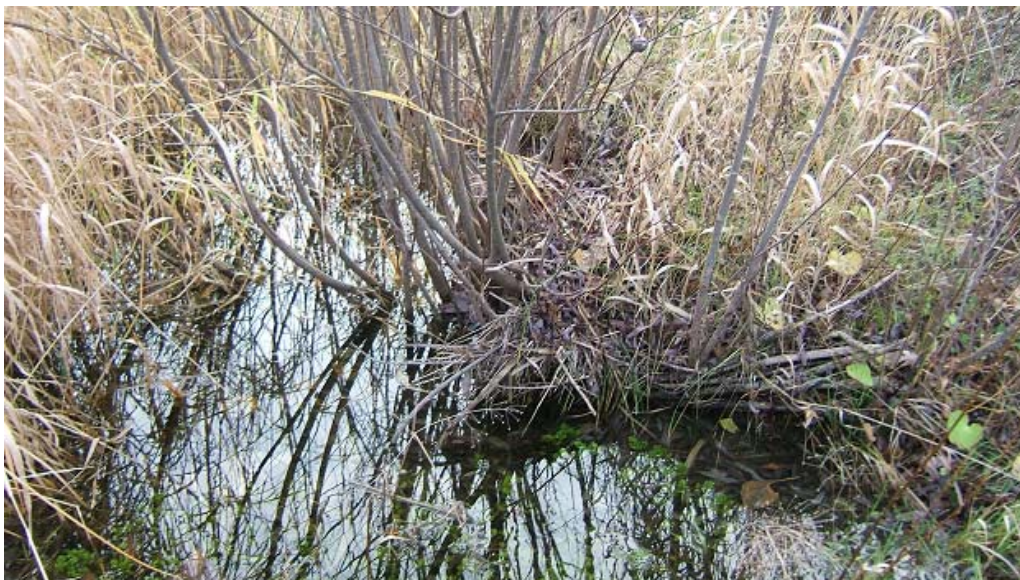
View of riparian plantings.

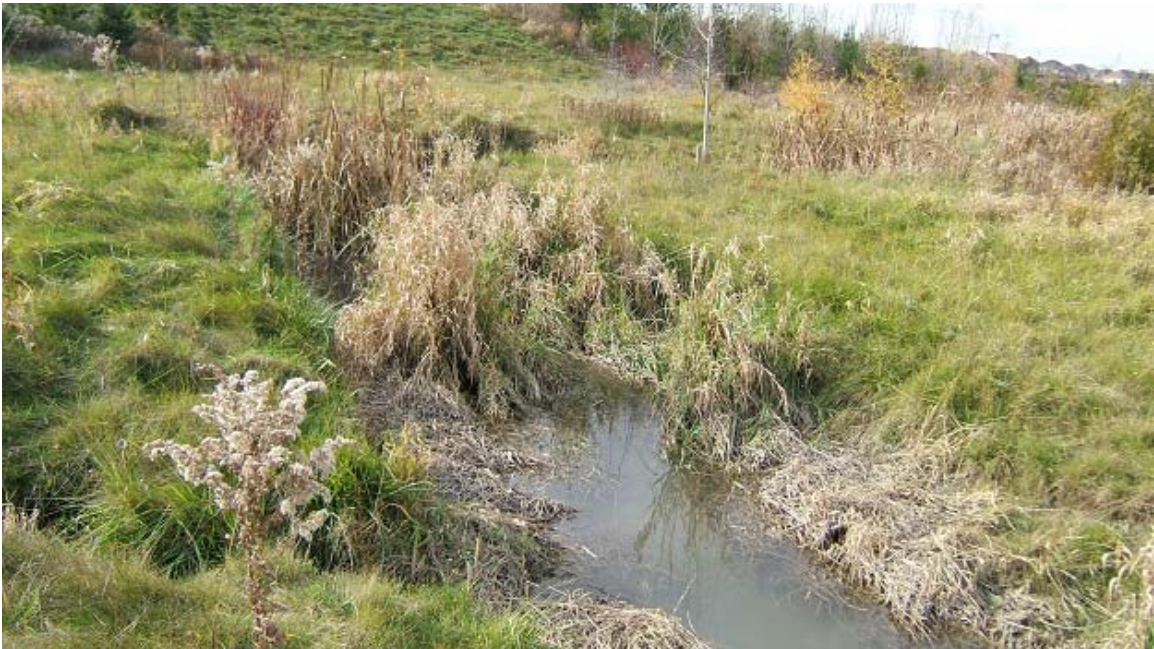
Typical stream section.

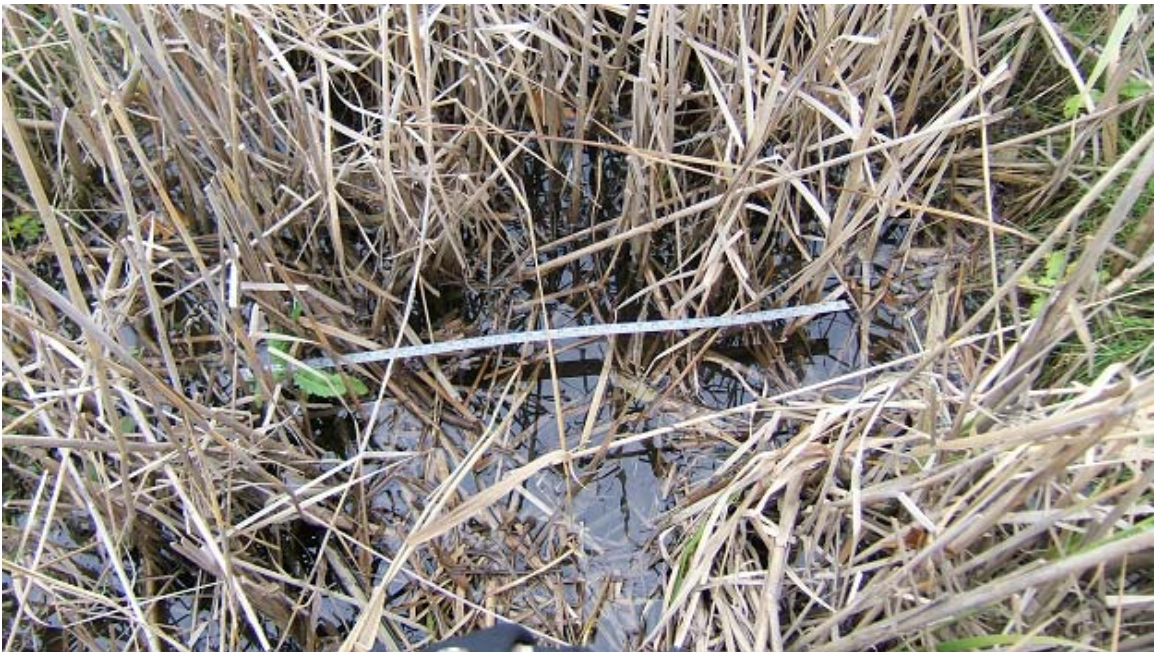
Typical instream section with vegetation.

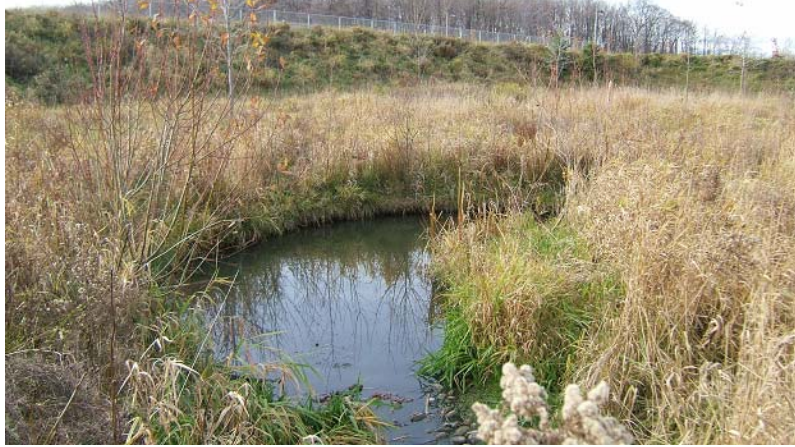
Pool with coir log along outside bank for stabilization. Note the dense grass in the riparian area.

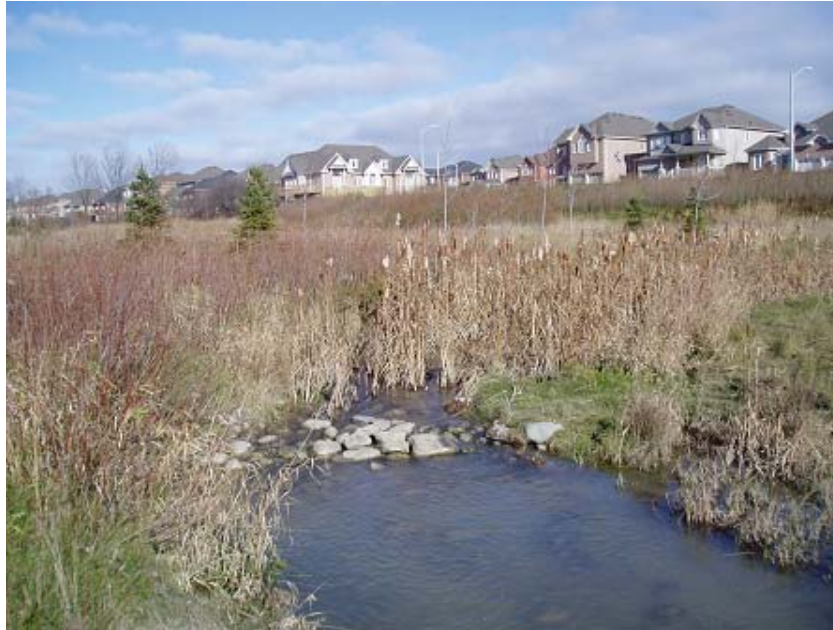
View of channel looking upstream. Note: vegetation encroachment and exposed riffle materials.

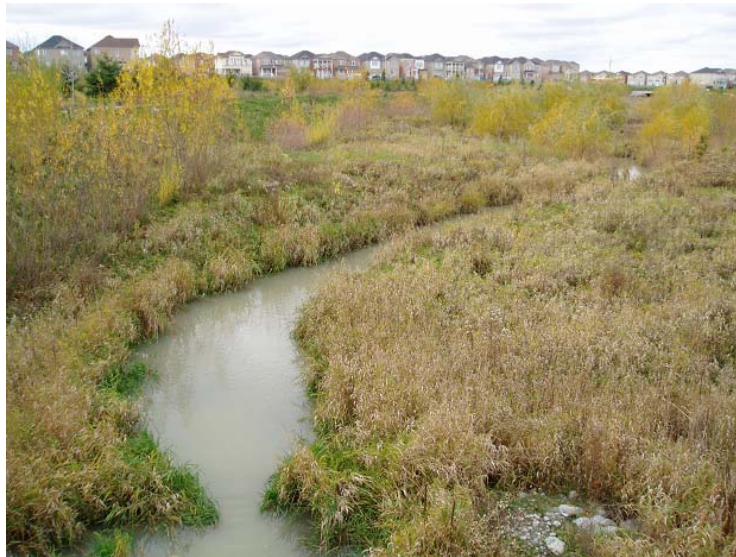
View looking upstream from Highway 400. Note: well established riparian vegetation

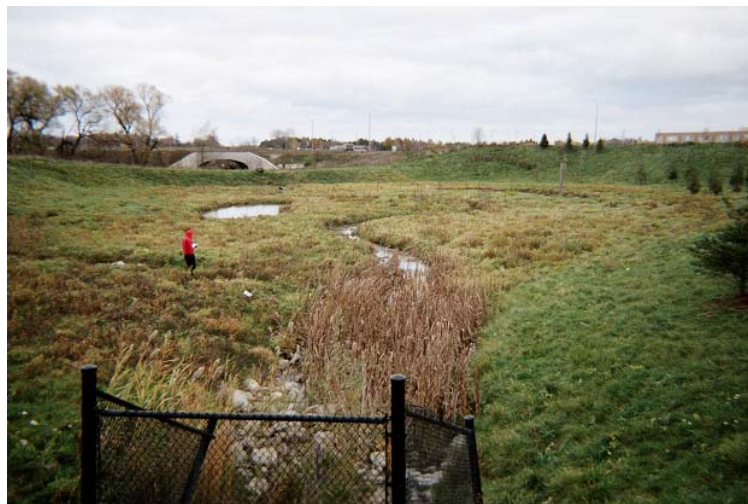
View looking upstream from most downstream extent of NCD. Note: wide floodplain, offline pond features, sinuous channel.

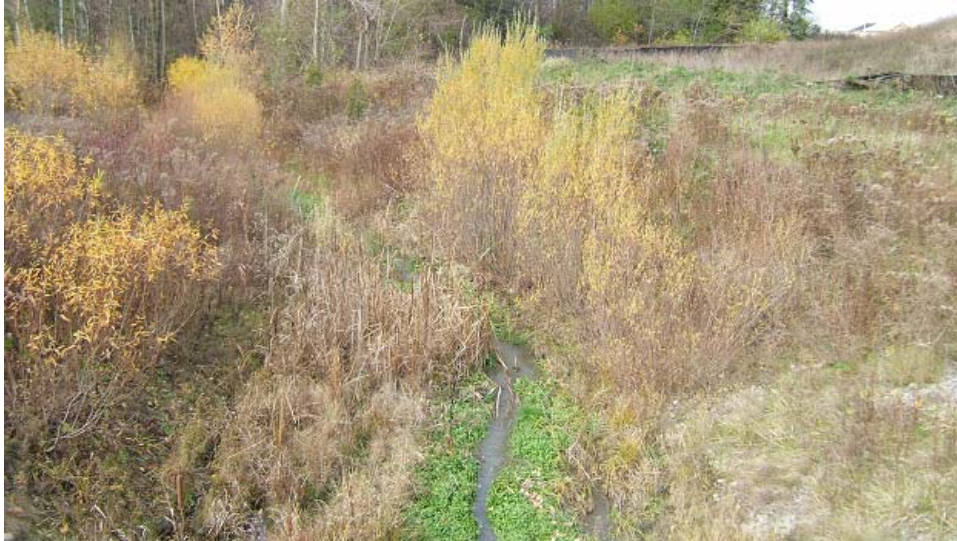
Channel corridor viewed upstream from Brookside Road.

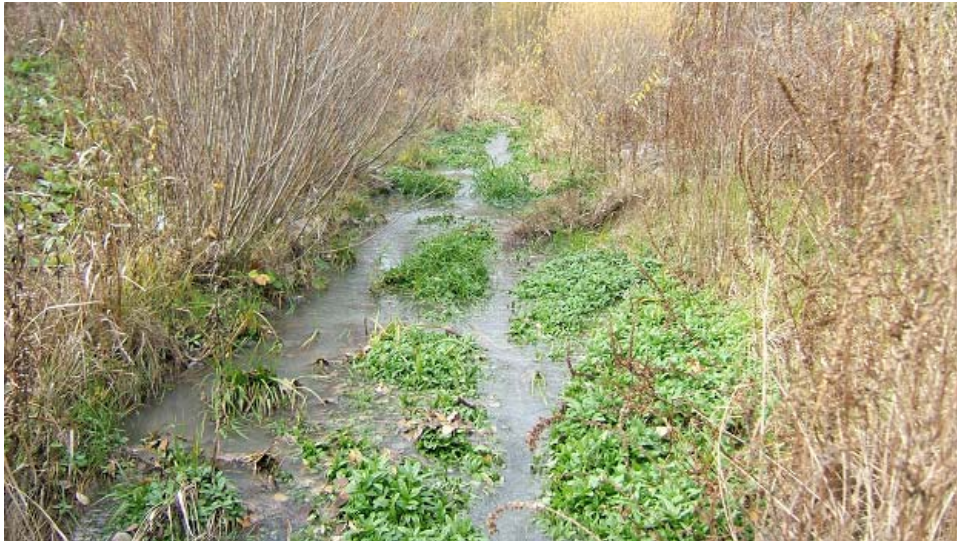
Channel with abundant macrophyte.

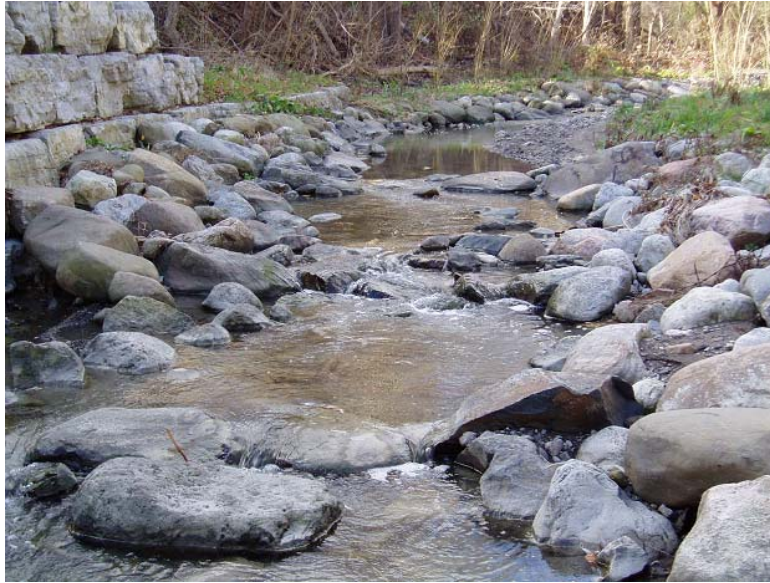
View of channel looking upstream. Note: well developed pool riffle sequences. Vortex weirs appear to be functioning as intended.

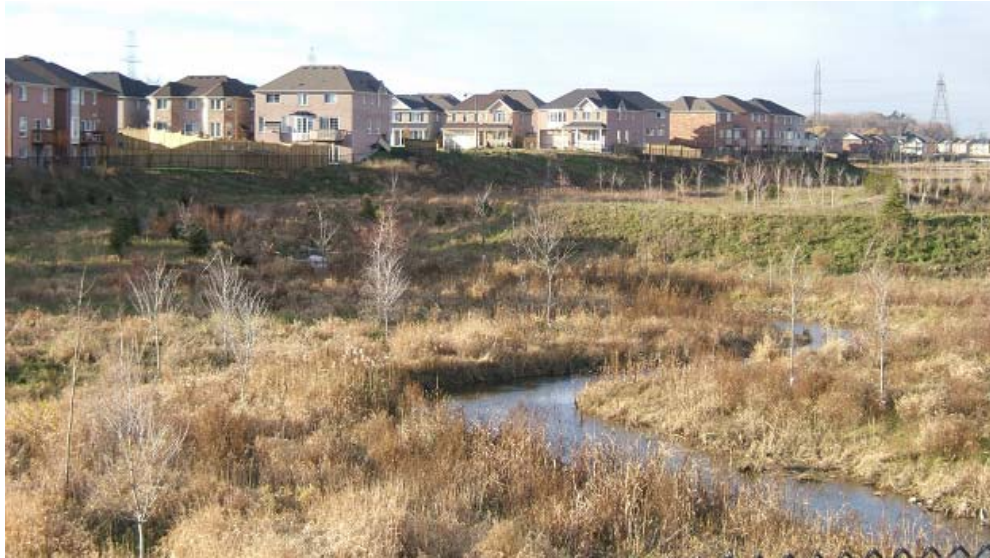
View of channel looking upstream. Note: sinuous channel and well vegetated banks.

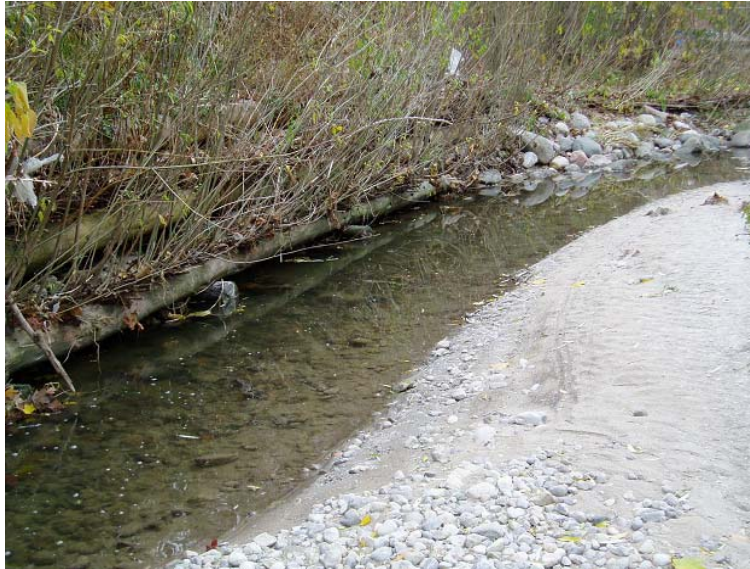
View of channel looking downstream. Note: good point bar development, high survival rate of crib wall plantings and crib wall providing good pool development.

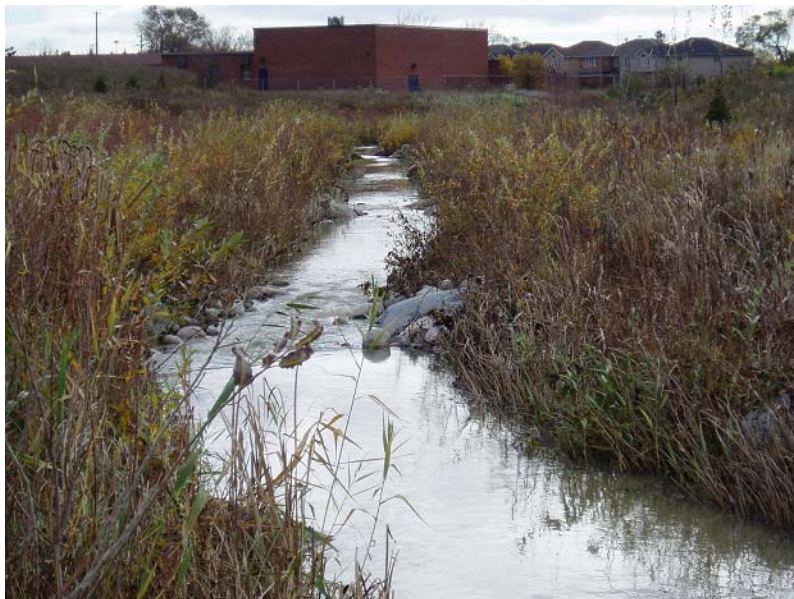
View of channel looking downstream. Note: riparian vegetation appears to be functioning well.

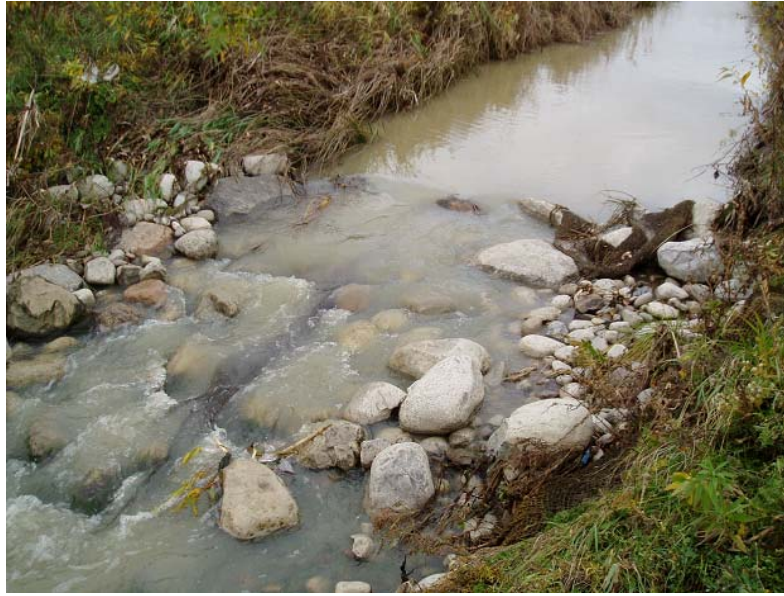
View of channel looking upstream. Note: riffle structures generally functioning as intended.

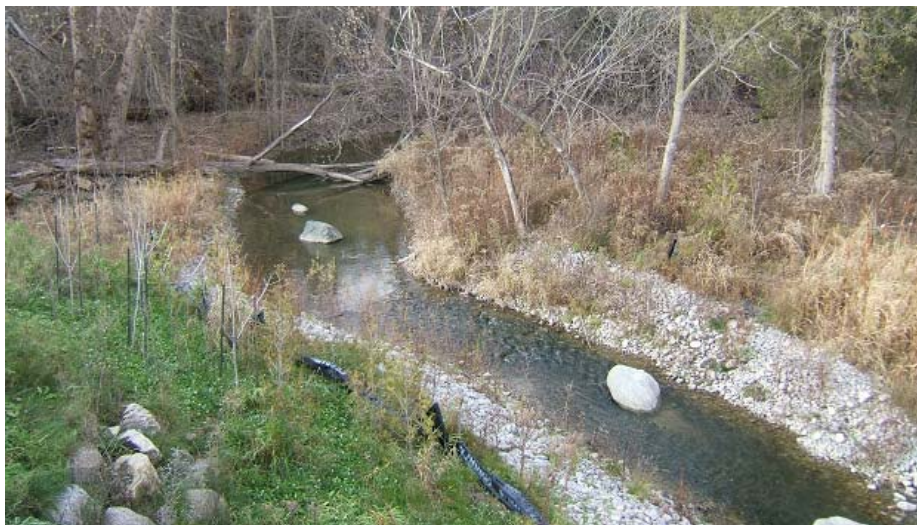
View of channel looking upstream. Note: vegetated rip rap lining both banks.

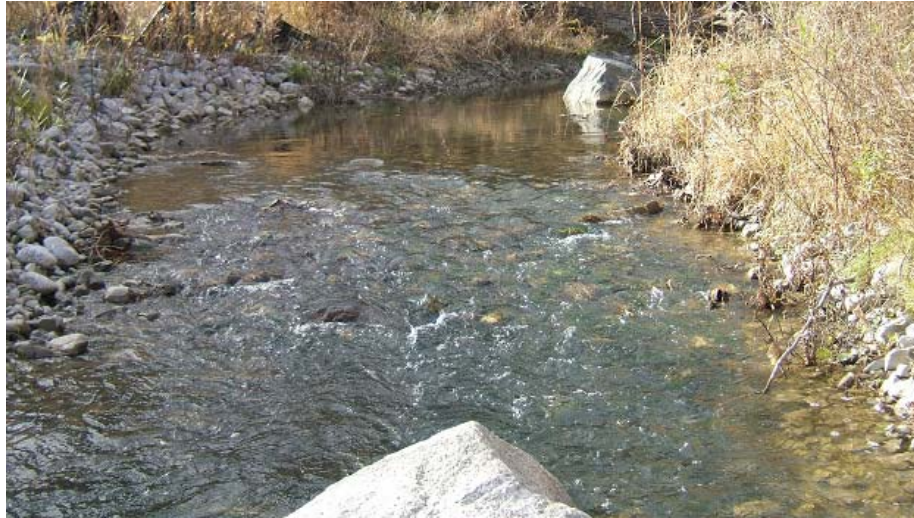
View of channel looking upstream. Note: riffle structure and boulder placement generally functioning as intended.

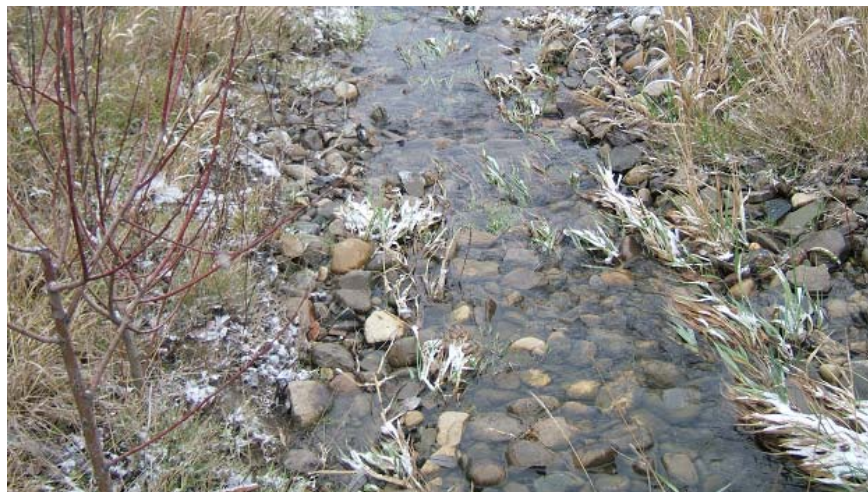
View of channel looking downstream. Note: riffle section appears to be functioning as intended.

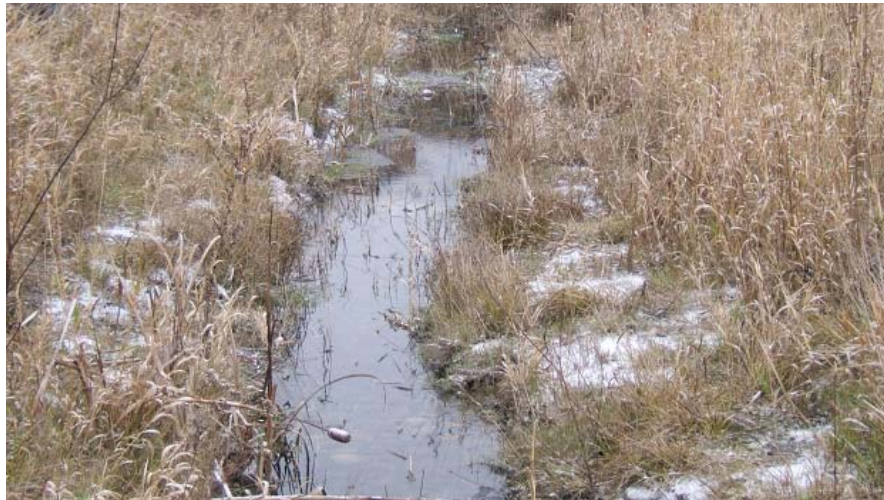
View of channel looking downstream. Note: well vegetated banks and riparian zone.

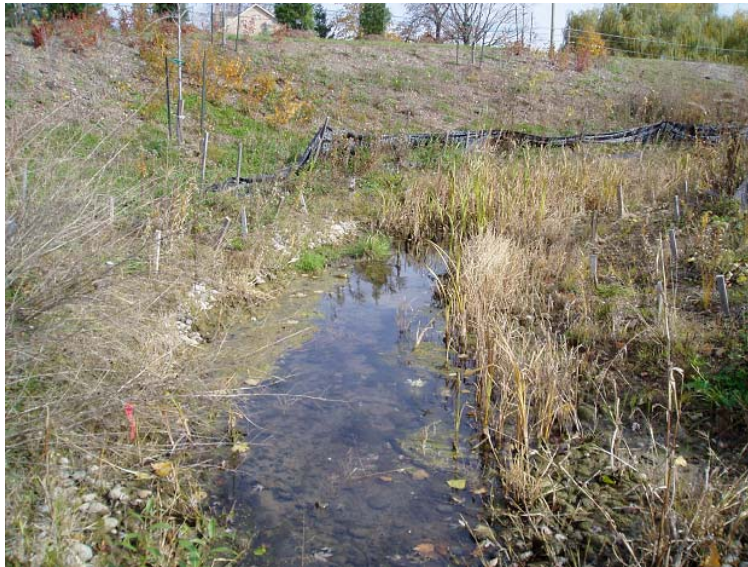
View of channel looking downstream. Note: low flow and vegetation encroachment into channel.

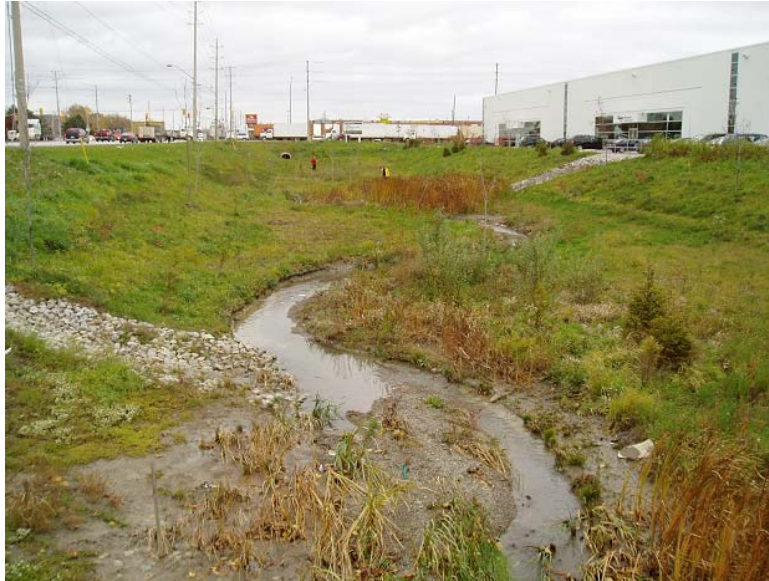
View of channel looking upstream. Note: riparian vegetation becoming well-established.

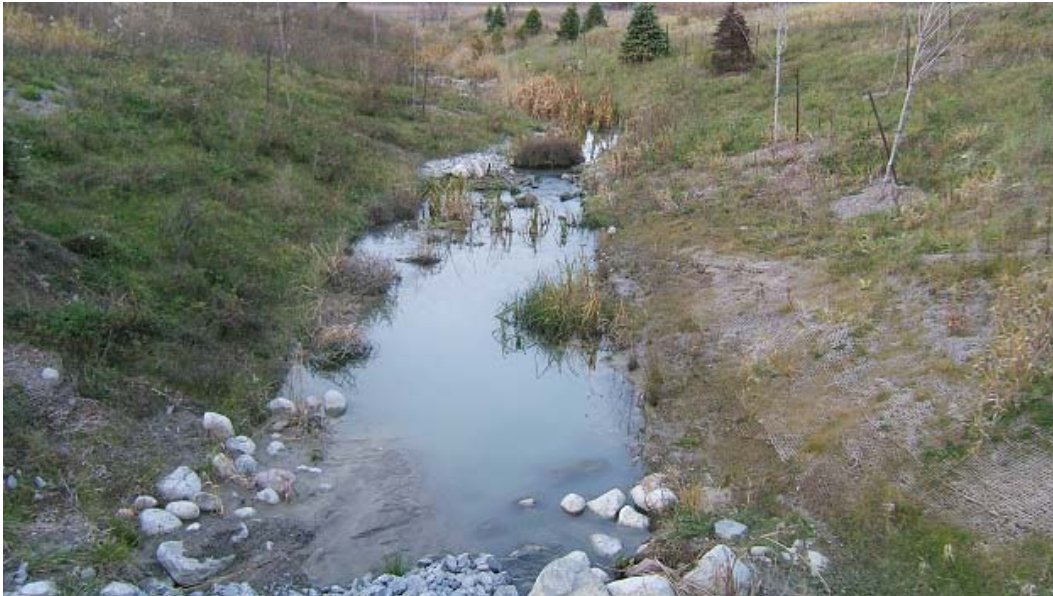
The 100 m channel is slightly sinuous with riffle and pool sequences. Installed at the upstream end of riffle sections are rock vortex weirs, which are either buried, partially exposed or largely emergent. The channel is aggrading at the upstream end of the channel design. In total, about half of the length of the channel, in both riffle and pool sections, is colonized by grasses and cattails. Algae are also found in riffle and pools. The downstream end of the channel design is composed of a relatively steep rocky ramp-type feature. Water flows mostly between and under the small boulder sized material.

Channel viewed downstream from culvert.

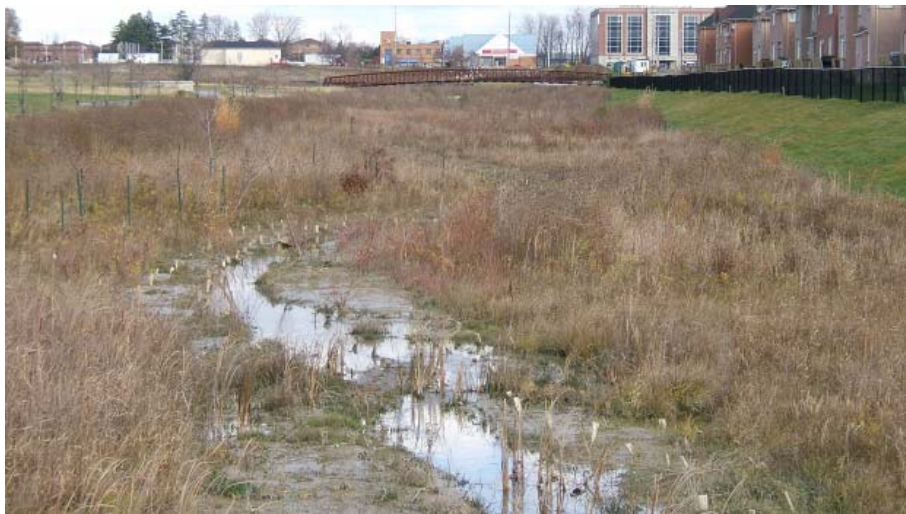
| Type of Assessment | Score | Condition | Type of Adjustment / Limiting Factors |
|---|---|---|---|
| RSAT (modified) | 4 | Poor | Structural failure of riffles; bioengineering not functioning as designed |

View of channel looking upstream. Note: low flow and vegetation encroachment into channel.

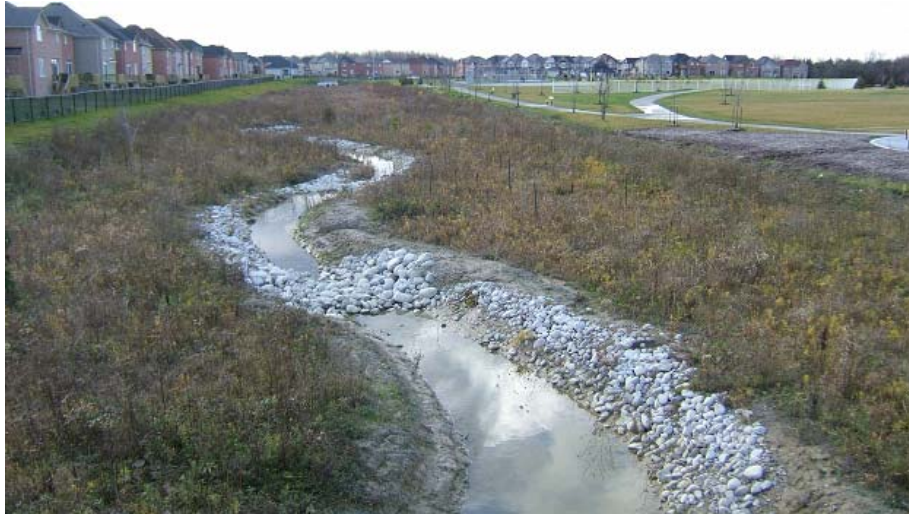
View of channel looking downstream. Note: riparian vegetation becoming well-established, rip rap placement and exposed riffle materials.

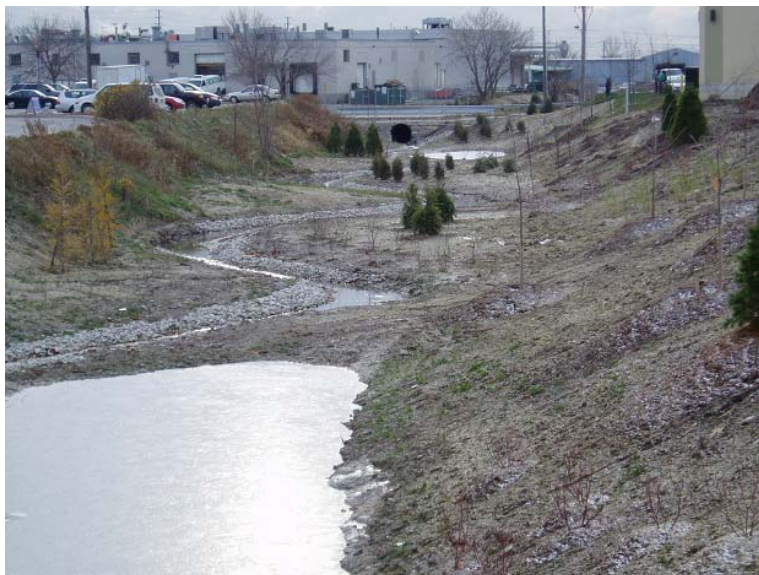
View of channel looking downstream. Note: newly constructed channel with low gradient and high sinuosity.

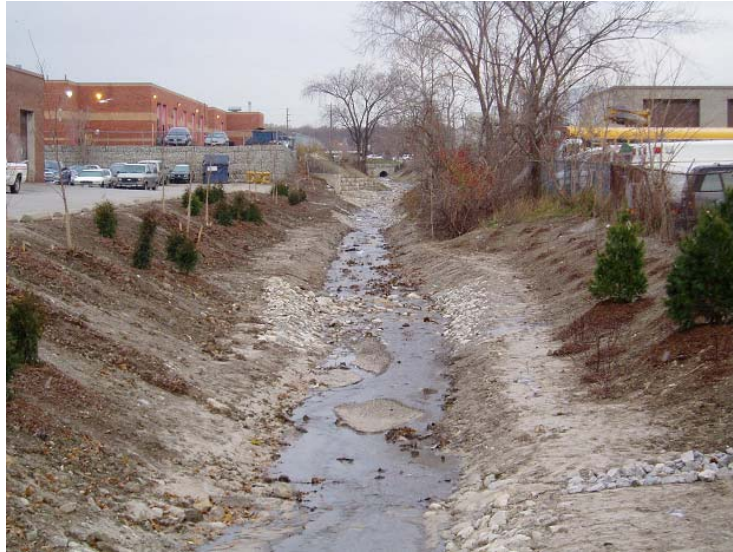
View of channel looking upstream. Note: some channel adjustments occurring since construction (medial bars and sediment deposition).
